ASBESTOS SURVEY REPORT FOR CALL STAND, BARRACKS BANK, SUNDERLAND PORT

**Asbestos Register for
Call Stand, Barracks Street, Port of Sunderland**

Date: 25 October 2023

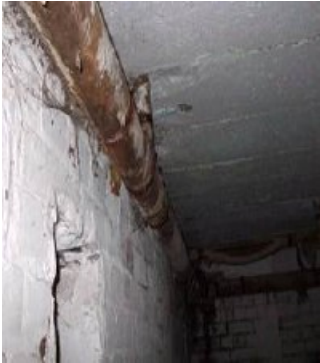
Item 1 – VP002142

The pipe lagging to the sub floor store room does not contain asbestos.

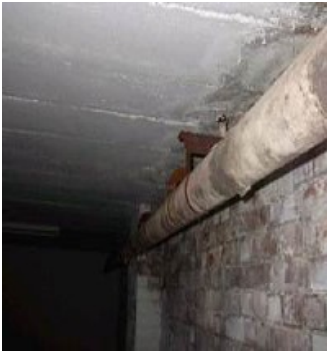
Item 2 – VP002143

The pipe lagging to the sub floor main room does not contain asbestos.

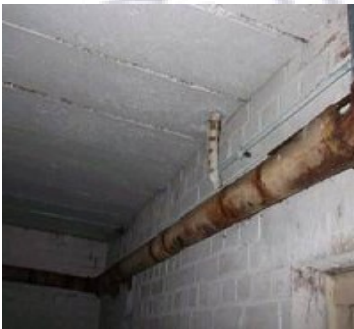
Item 3 – As VP002143

The pipe lagging to the Sub floor rear room does not contain asbestos.

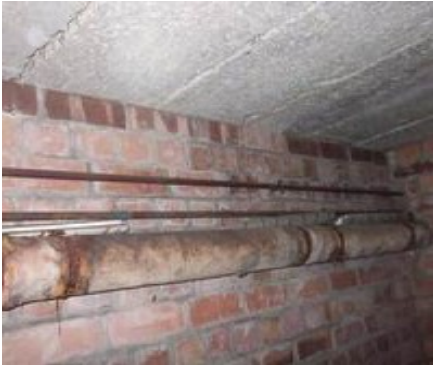
Item 4 – VP002144

The pipe lagging to the sub floor tank room does not contain asbestos.

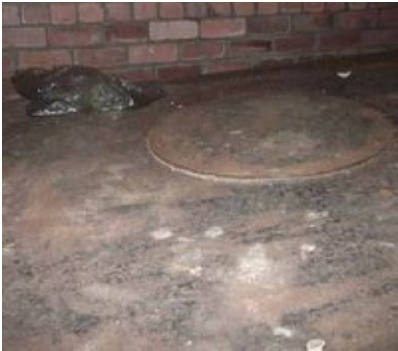
Item 5 – VP002145

The gasket on top of the tank in the sub floor tank room contains asbestos.

This item has been removed

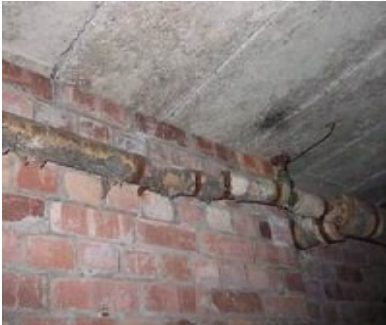
Item 6 – VP002143

The pipe lagging to the Sub floor rear room does not contain asbestos.

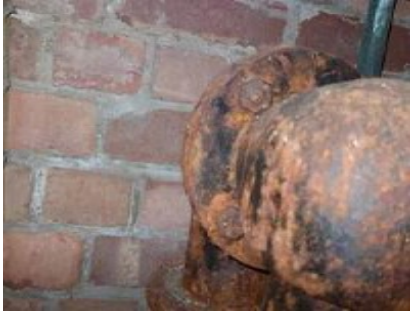
Item 7 – VP002147

The gasket to the pipework under the tank in the sub floor tank room does not contain asbestos.

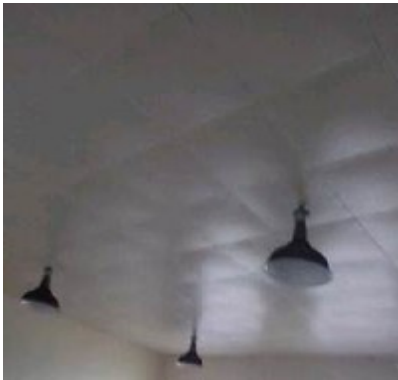
Item 8 – VP002130

The ceiling tiles to the office do not contain asbestos.

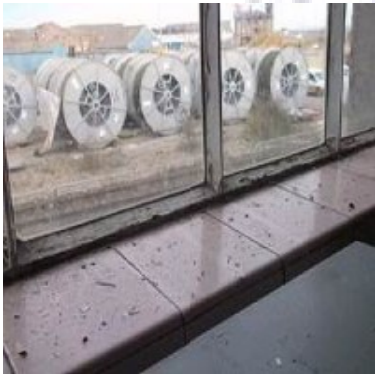
Item 9 – VP002133

The window putty to the office does not contain asbestos.

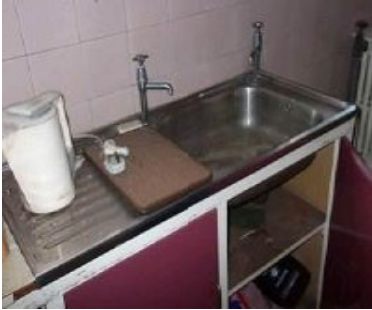
Item 10 – VP002137

The sink pads to the office contain asbestos.

Item 10	Sink pads to Office	Very Low	12 Monthly	03.10.24
<i>Item 11</i>	<i>No Asbestos</i>	<i>Is Present</i>		
<i>Item 12</i>	<i>No Asbestos</i>	<i>Is Present</i>

Any change in appearance should be noted and passed to Property Services.

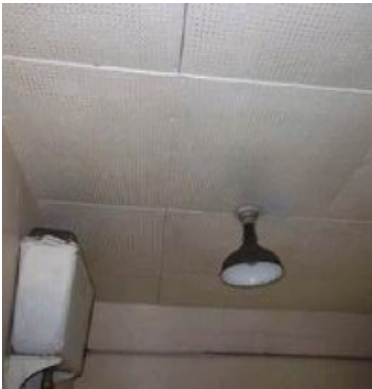
Item 11 – As VP002130

The ceiling tiles to the toilets do not contain asbestos.

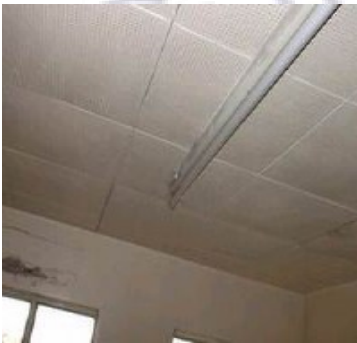
Item 12 – As VP002130

The ceiling tiles to the office do not contain asbestos.

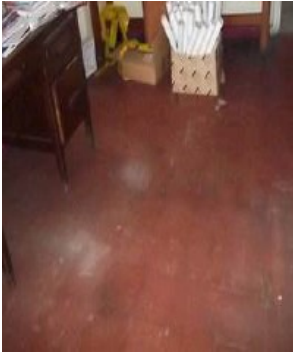
Item 13 – VP002134

The floor tiles to the office contain asbestos.

Removed Sept 21

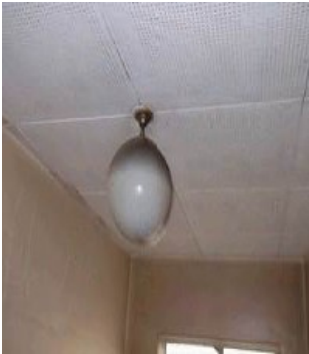
Item 14 – As VP002130

The ceiling tiles to the wash up area do not contain asbestos.

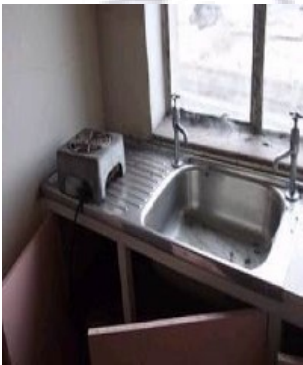
Item 15 – VP002135

The sink pads to the wash up area contain asbestos.

Any change in its appearance should be noted and passed to Property Services.

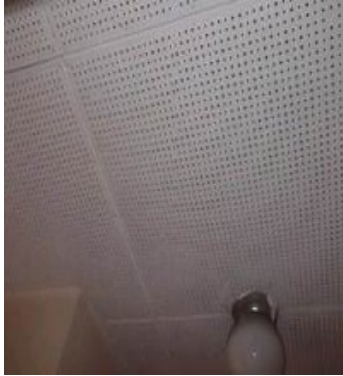
Item 16 AsVP002130

The ceiling tiles to the sink area do not contain asbestos.

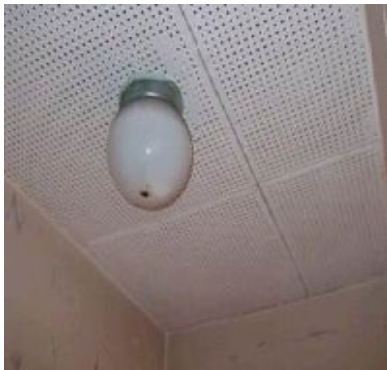
Item 17 – As VP002130

The ceiling tiles to the female wc do not contain asbestos.

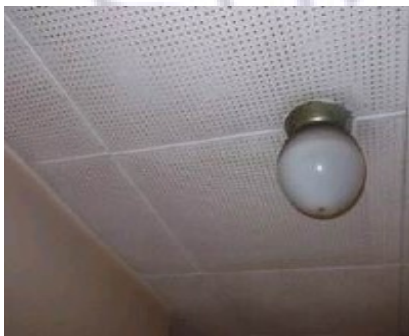
Item 18 As VP002130

The ceiling tiles to the Male WC do not contain asbestos.

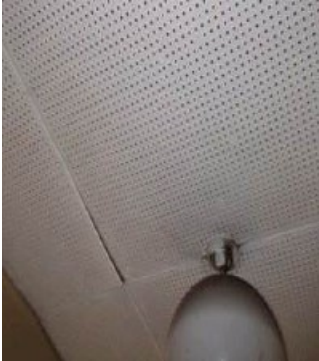
Item 19 As VP002130

The ceiling tiles to the entrance lobby do not contain asbestos.

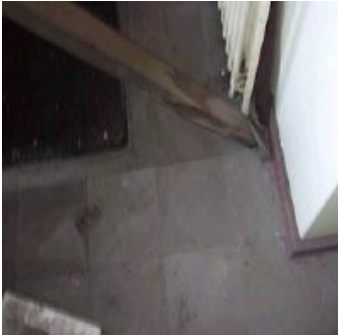
Item 20 Ref – As VP002134

The floor tiles to the entrance lobby contain asbestos.

Removed Sept 21

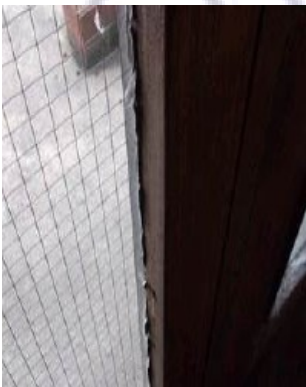
Item 21 ref: VP002136

The putty to the glass in the door in the entrance lobby contains asbestos.

Removed February 2020.

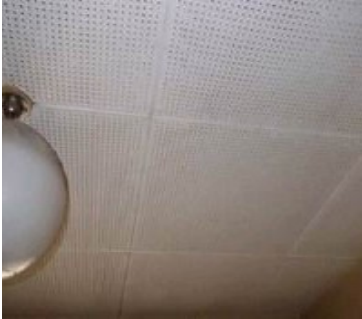
Item 22 Ref: VP002130

The ceiling tiles to the store do not contain asbestos.

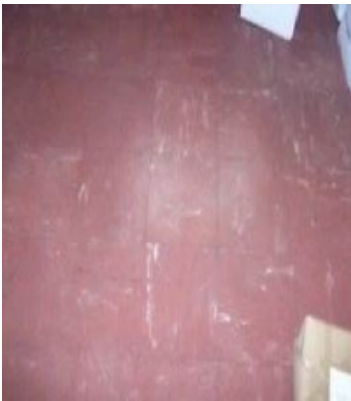
Item 23 As VP002134

The floor tiles to the store contain asbestos.

Removed Sept 21

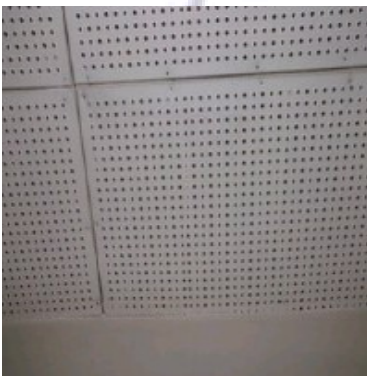
Item 24 ref: VP002136

The ceiling tiles to the store do not contain asbestos.

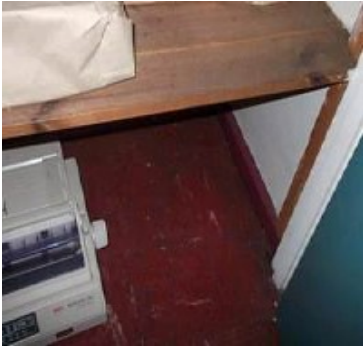
Item 25 As VP002134

The floor tiles to the store room contain asbestos.

Removed Sept 21

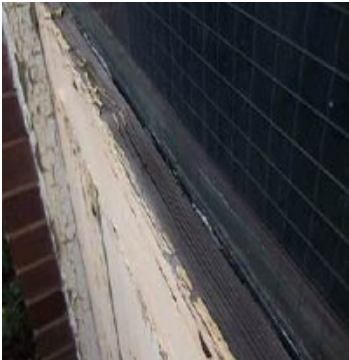
Item 26 Ref: VP002148

The putty to the glass door frame (External) contains asbestos.

Removed February 2020.

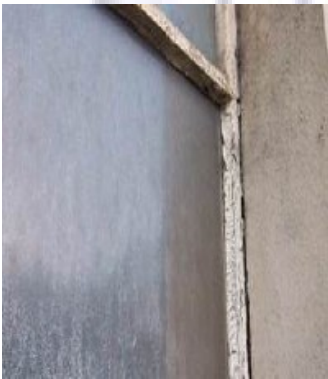
Item 27 Ref: VP002149

The window putty to the external does not contain asbestos.

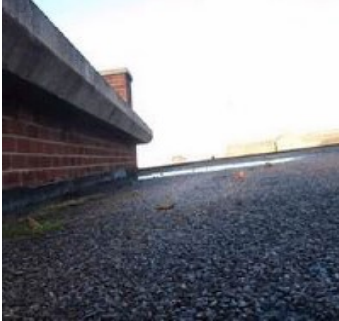
Item 28 Ref: VP002150

The bitumen to the flat roof does not contain asbestos.

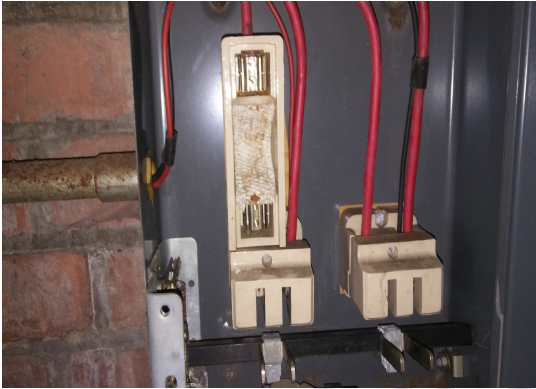
Item 29 Ref: 393067-1

The flashguards to electrics in the former boiler room (Rm 0/001) does contain asbestos.

Removed February 2020.

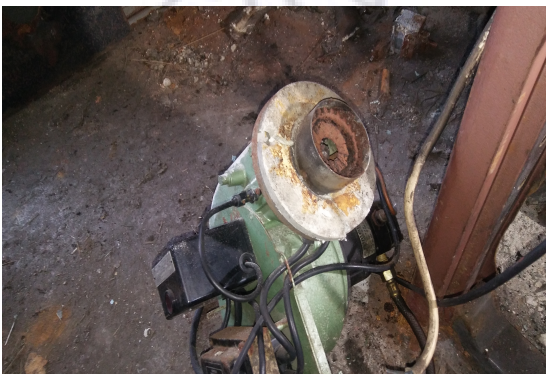
Item 30 Ref: 393067-2

The gasket to pump in the former boiler room (Rm 0/001) does contain asbestos.

Removed February 2020.

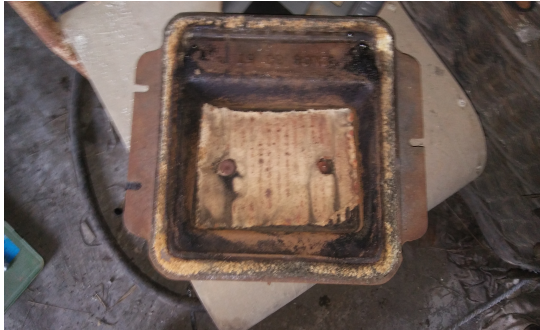
Item 31 Ref: 393067-3

The gasket to boiler door in the former boiler room (Rm 0/001) does contain asbestos.

Removed February 2020.

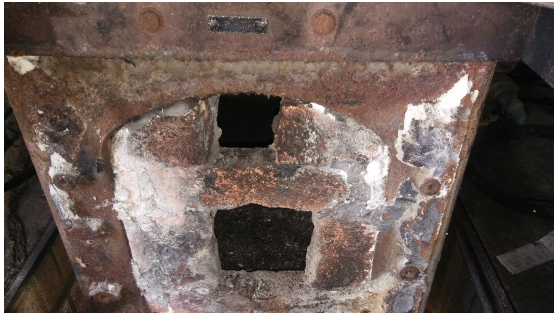
Item 32 Ref: 393067-4

The gasket to front of boiler in the former boiler room (Rm 0/001) does contain asbestos.

Removed February 2020.

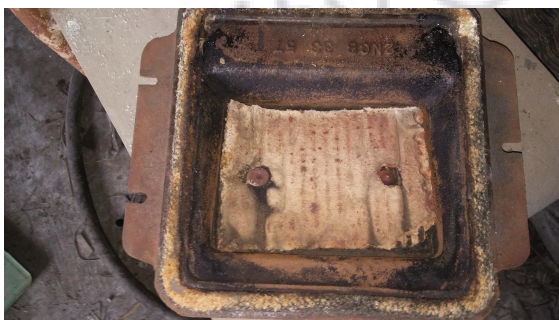
Item 33 Ref: 393067-5

The insulation to boiler door in the former boiler room (Rm 0/001) does contain asbestos.

Removed February 2020.

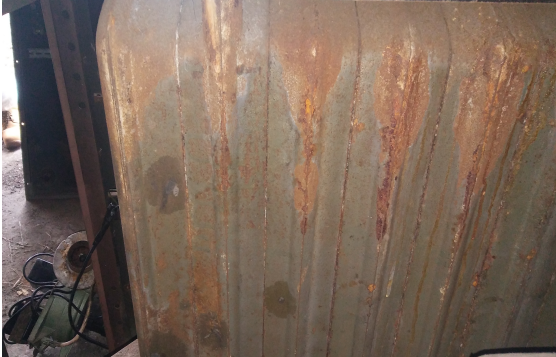
Item 34 Ref: 393067-6

The gasket to boiler joints in the former boiler room (Rm 0/001) does contain asbestos.

Removed February 2020.

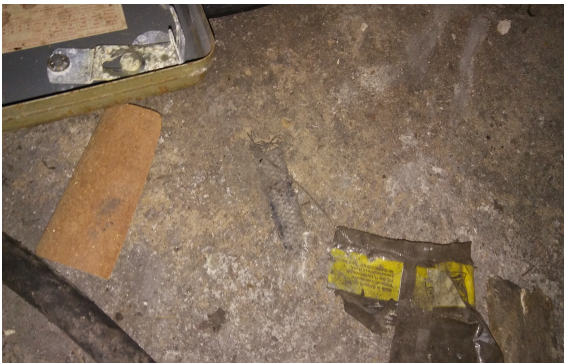
Item 35 Ref: 393067-7

The flashguard to floor in the former boiler room (Rm 0/001) does contain asbestos.

Removed February 2020.

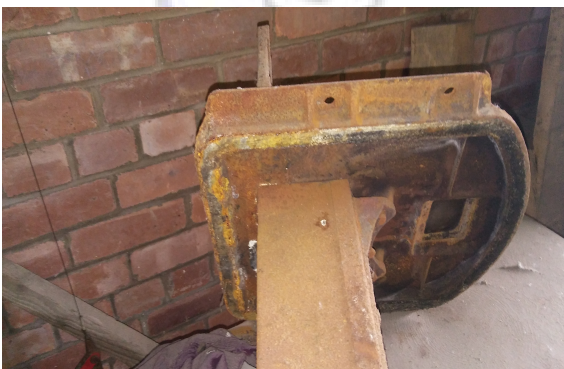
Item 36 Ref: As 393067-3

The gasket to boiler loose boiler part in the former boiler room (Rm 0/001) does contain asbestos.

Removed February 2020.

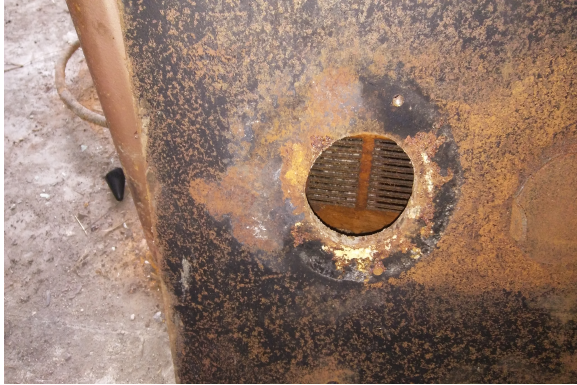
Item 37 Ref: As 393067-2

The residue gasket from pump to boiler part in the former boiler room (Rm 0/001) does contain asbestos.

Removed February 2020.
