### ASBESTOS SURVEY REPORT FOR WEST HOUSE, WEST SIDE HUDSON DOCK, PORT OF SUNDERLAND

**Asbestos Register for**

**WEST HOUSE, WEST SIDE HUDSN DOCK  
PORT OF SUNDERLAND**

**Date: 07 December 2022**

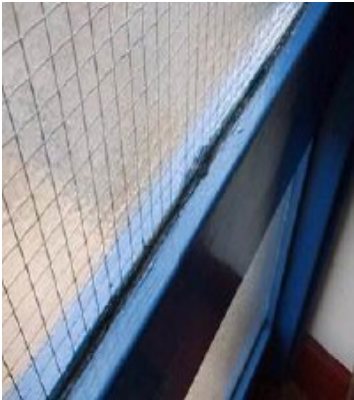
### **Item 1 Ref: VP002185**

The window putty to the door in the entrance (Room 1) does not contain asbestos.

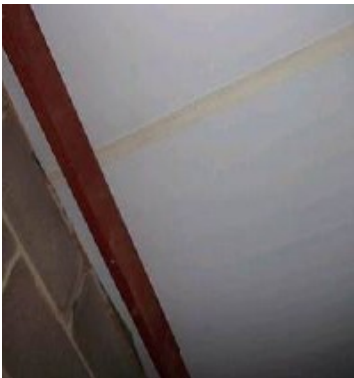
### **Item 2 - Ref: VP002186**

The paper lined foam tiles to the entrance (Room 1) do not contain asbestos.

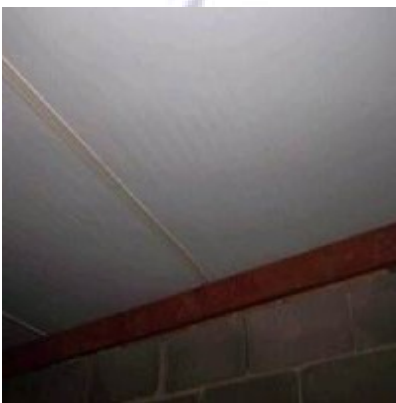
### **Item 3 – As VP002186**

The paper lined foam tiles to the ceiling in the library (Room 2) do not contain asbestos.

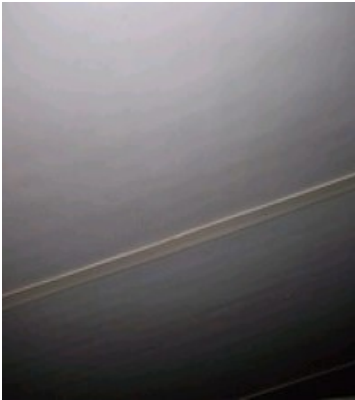
**Item 4 – VP002186**

The paper lined foam ceiling tiles to the lounge (Room 3) do not contain asbestos.

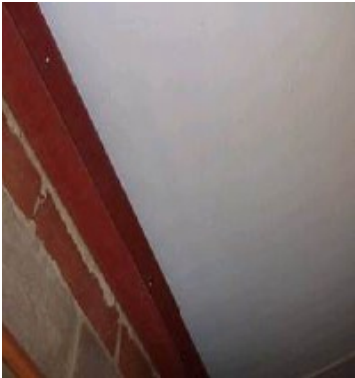
**Item 5 – As VP002186**

The paper lined foam panels to the ceiling in the toilet (Room 4) do not contain asbestos.

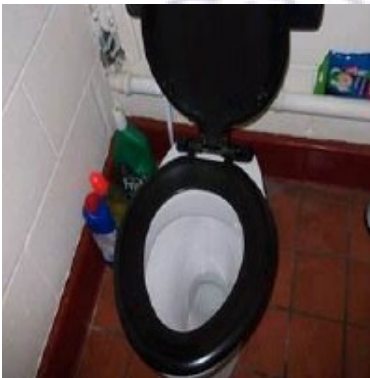
**Item 6 - Ref: Sample 06**

The wc seat to the toilet (Room 4) does not contain asbestos.

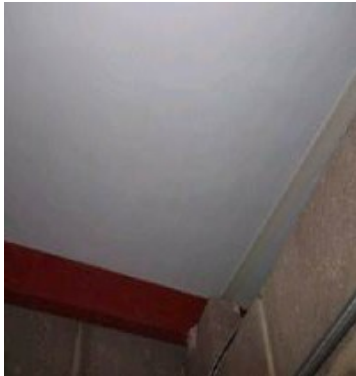
**Item 7 – As VP002186**

The paper lined foam panels to the kitchen (Room 5) do not contain asbestos.

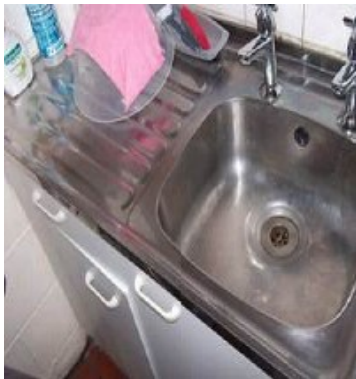
**Item 8 - Ref: VP002188**

The sink pad in the kitchen (Room 5) does not contain asbestos.

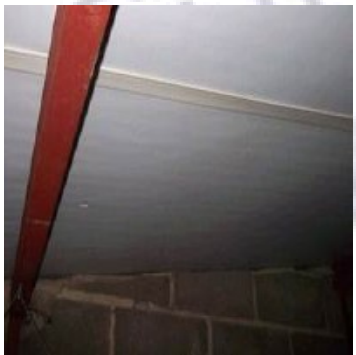
**Item 9 – As VP002186**

The paper lined foam panels to the roof of the chapel (Room 6) do not contain asbestos.

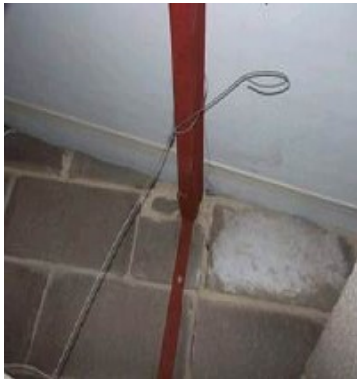
**Item 10 – As VP002186**

The paper lined foam panels to the roof of the cleaners cupboard (Room 7) do not contain asbestos.

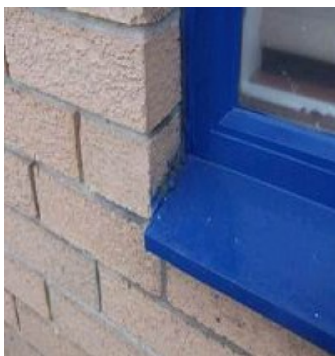
**Item 11 – Ref: VP002189**

The window putty around the windows to the exterior does not contain asbestos.

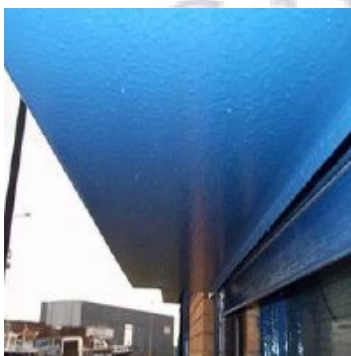
**Item 12 – Ref: VP002190**

The textured coating to the underneath of the metal shutter casings does not contain asbestos.
