ASBESTOS SURVEY REPORT FOR SRM WORKSHOPS AND OFFICE, PORT OF SUNDERLAND

**Asbestos Register for
SRM WORKSHOPS AND OFFICES, PORT OF
SUNDERLAND**

Date: 2nd August 2022

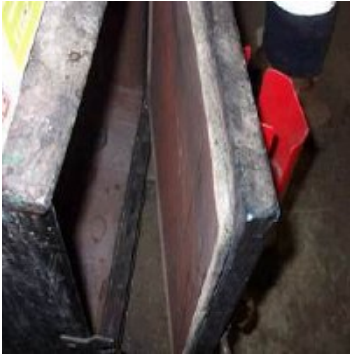
Item 1 Ref: VP002385

The rope seal around the oven door in the workshop (Room 1) contains asbestos.

Any change in its appearance should be recorded, and passed to Property Services.

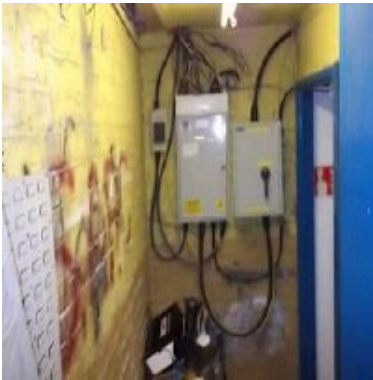
The passage (Room 2) was accessed and no suspect materials were found.

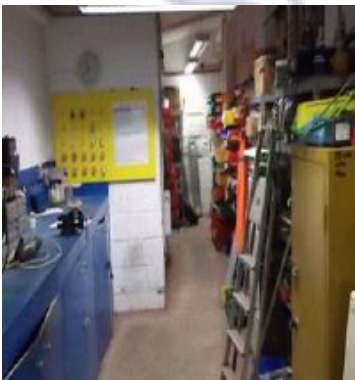
The electric workshop (Room 3) was accessed and no suspect materials were found.

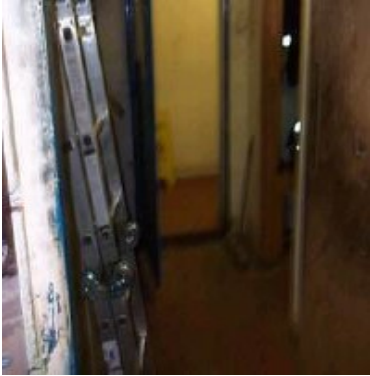
The circulation area (Room 4) was accessed and no suspect materials were found.

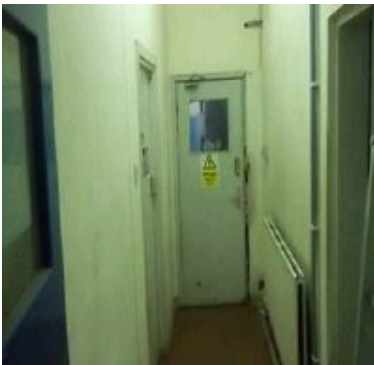
The circulation area (Room 5) was accessed and no suspect materials were found.

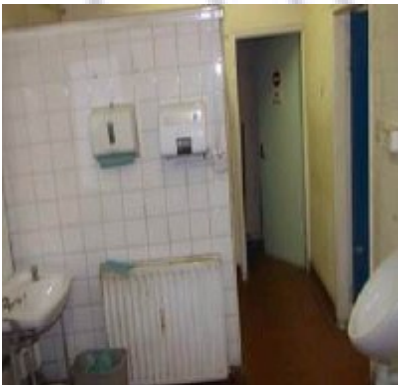
The toilets (Room 6) were accessed and no suspect materials were found.

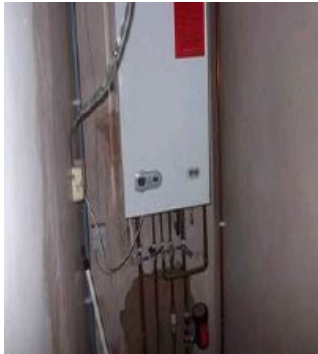
The cleaners cupboard (Room 7) was accessed and no suspect materials were found.

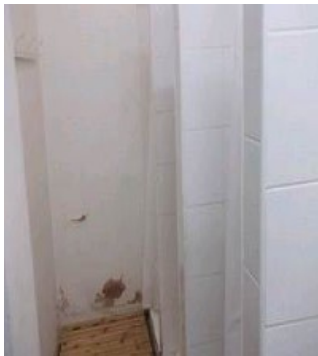
The shower room (Room 7) was accessed and no suspect materials were found.

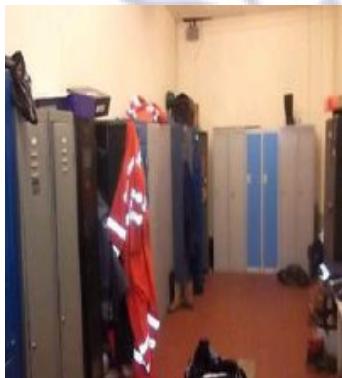
The locker room (Room 9) was accessed and no suspect materials were found.

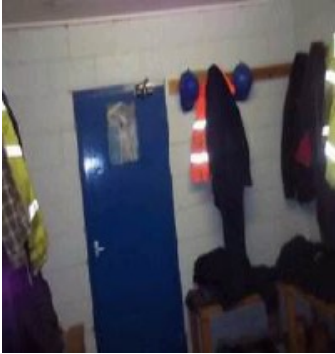
The changing room (Room 10) was accessed and no suspect materials were found.

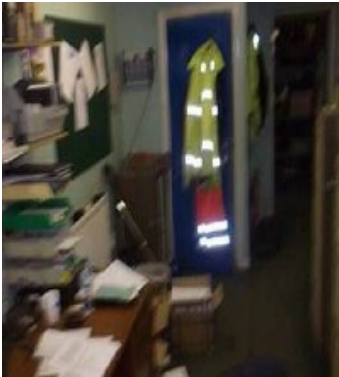
The office (Room 11) was accessed and no suspect materials were found.

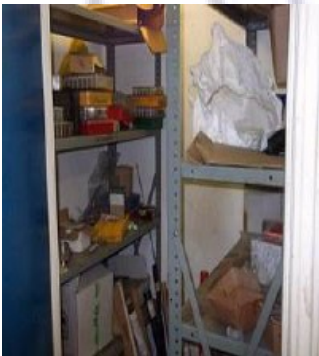
The office cupboard (Room 12) was accessed and no suspect materials were found.

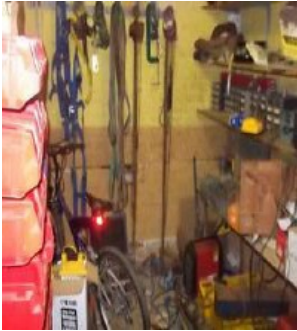
The store (Room 13) was accessed and no suspect materials were found.

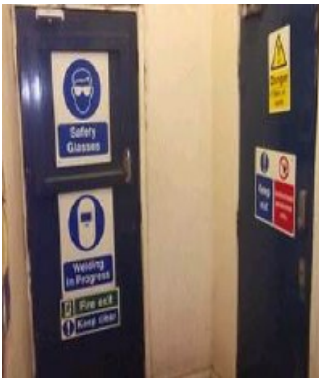
The hall (Room 14) was accessed and no suspect materials were found.

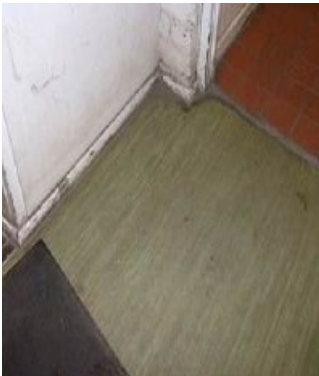
Item 2 Ref: VP002388

The green vinyl flooring to the corridor (Room 15) does not contain asbestos.

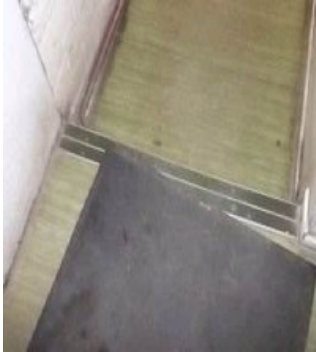
Item 3 Ref: VP002389

The stair nosing to the corridor (Room 15) does not contain asbestos.

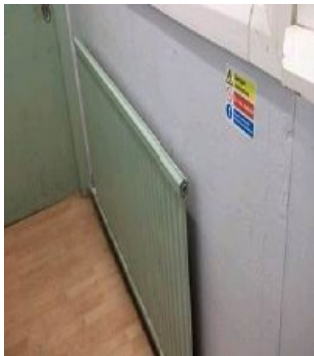
Item 4 Ref: VP002390

The board panel beneath the window in the hall (Room 16) contains asbestos.

Any change in its appearance should be recorded, and passed to Property Services.

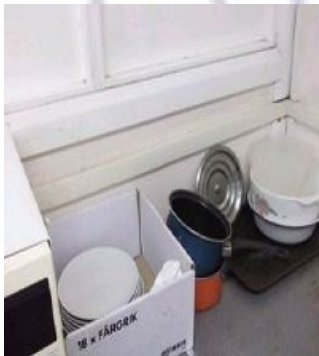
Item 5 As VP002390

The board panel beneath the window in the canteen (Room 17) contains asbestos.

Any change in its appearance should be recorded, and passed to Property Services.

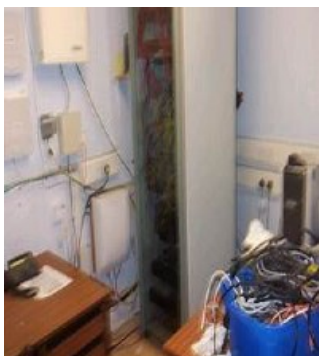
The computer room (Room 19) was accessed and no suspect materials were found.

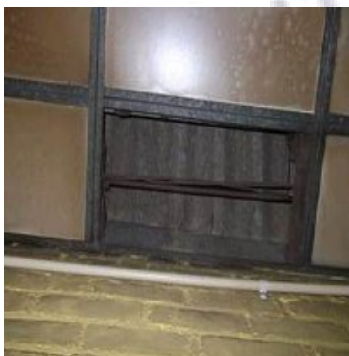
Item 7 Ref: VP002386

The cement roof in the roof void of the workshop contains asbestos.

Any change in its appearance should be recorded, and passed to Property Services.

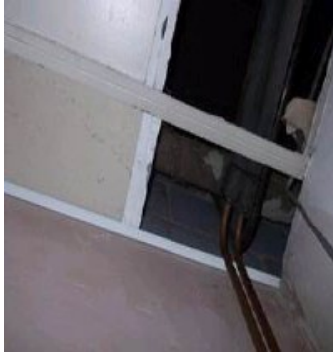
Item 8 Ref: VP002387

The lagging to the pipework in the workshop roof void does not contain asbestos.

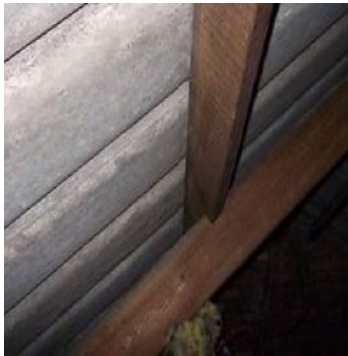
Item 9 Ref: VP002393

The cement roof to the roof void in the canteen contain asbestos.

Any change in its appearance should be recorded, and passed to Property Services.

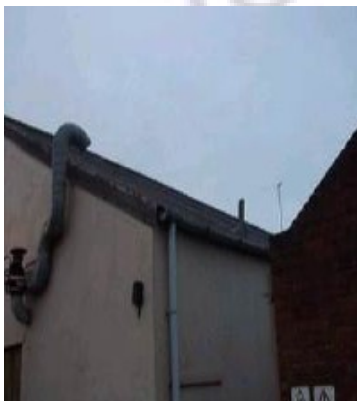
Item 10 Ref: VP002393

The external cement roof to the workshop contains asbestos.

Any change in its appearance should be recorded, and passed to Property Services.

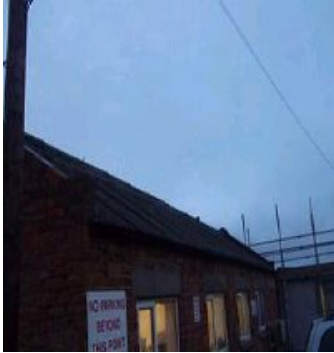
Item 11 As VP002393

The external canteen roof contains asbestos.

Any change in its appearance should be recorded, and passed to Property Services.

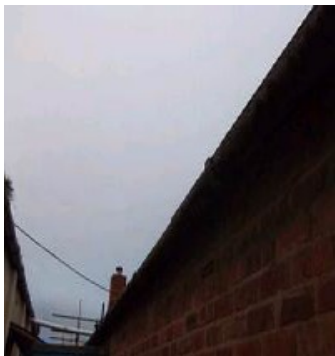
Item 12 Ref: VP002394

The guttering to the external of the canteen contains asbestos.

Any change in its appearance should be recorded, and passed to Property Services.

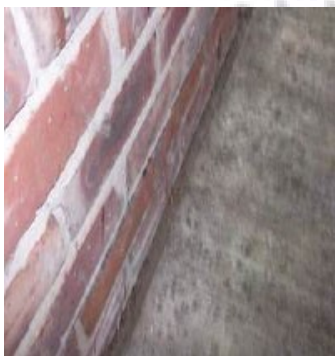
Item 13 Ref: VP002393

The external damp proof course does not contain asbestos.
