ASBESTOS SURVEY REPORT FOR PORT 019A1, SUB STATION,
SUNDERLAND PORT, HENDON, SUNDERLAND

PORT 019A1, SUB STATION, SUNDERLAND PORT, HENDON, SR1 2BU

Date: 2nd August 2022

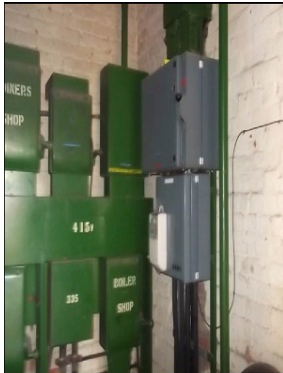
Room 1 (Sub-station 1)
(ground floor) was accessed
and no suspect materials were
found.

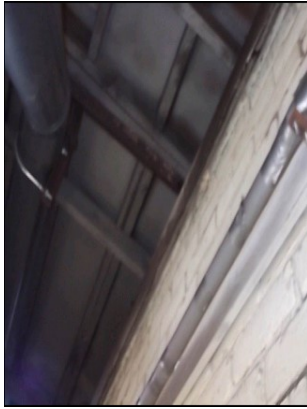
Item 1 - Ref: VP002191

The bitumen felt to flat roof
Room 1 (External) does not
contain asbestos.
