ASBESTOS SURVEY REPORT FOR UK DOCKS OLD STORES BUILDING, THE PORT, SUNDERLAND. SR1 2BU

**Asbestos Register for**

**UK Docks Old Stores Building**

**Premises Manager / Samo: - Tenant      Date: 13 May 2024**

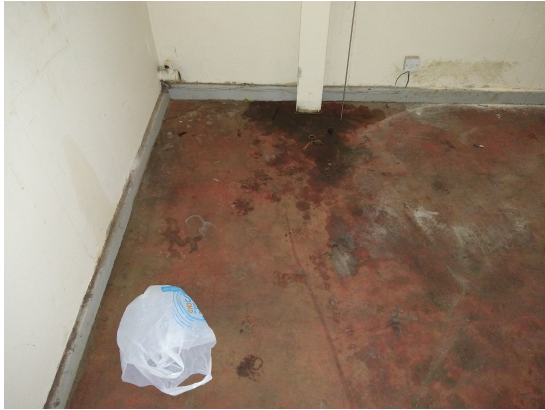
### **Item 1 Ref: 323974-1**

The Floor covering (010/office) does not contains asbestos.

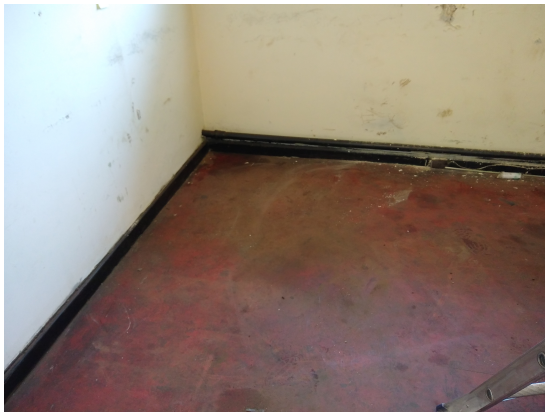
### **Item 2 Ref: As 323974-1**

The Floor covering (011/office) does not contains asbestos.

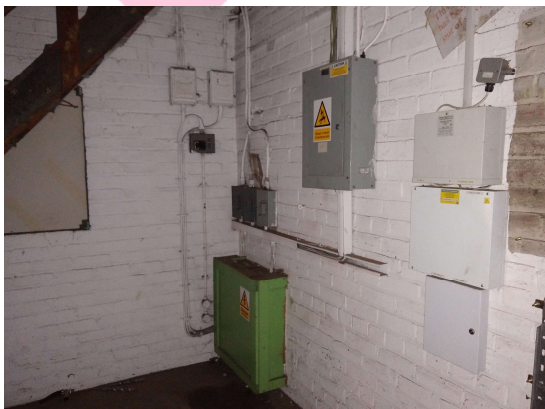
### **Item 3 Ref: Presumed**

The Electrics (013/warehouse) is presumed to contain asbestos.

Any change in appearance should be recorded and passed to Property Services.

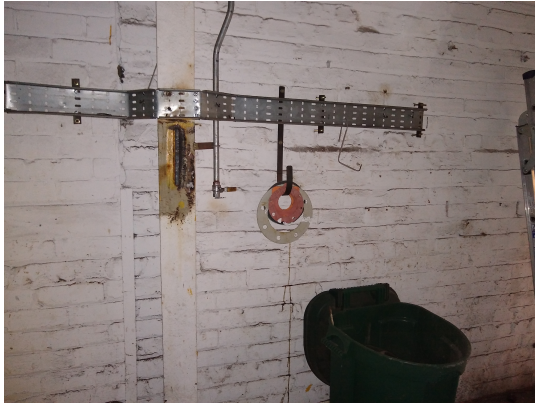
#### **Item 4 Ref: 323974-3**

The Loose lying gaskets (013/warehouse) do not contain asbestos.

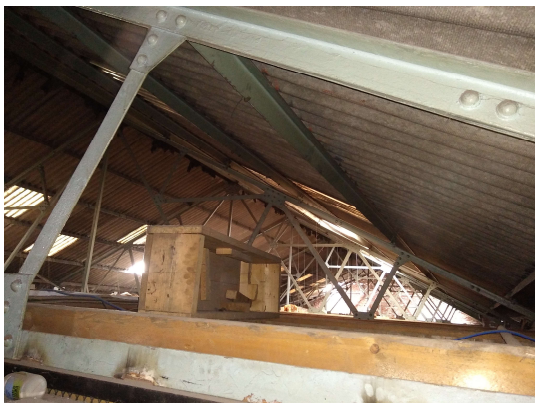
#### **Item 5 Ref: 323974-2**

The Underside of roof (013/warehouse-void above) contains asbestos.

Any change in appearance should be recorded and passed to Property Services.

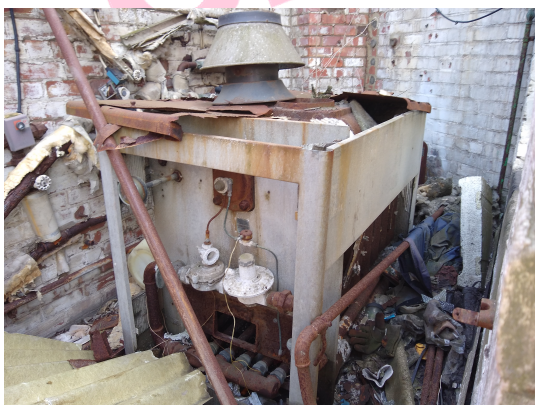
#### **Item 6 Ref: 323974-8**

The Insulation to large boiler (014/derelict boiler house) contains asbestos.

*Removed May 2019*

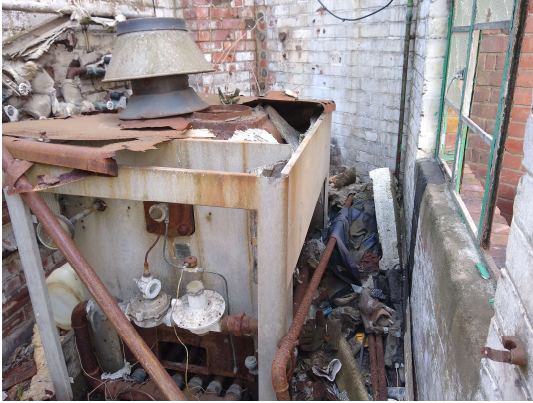
**Item 7 Ref: 323974-9**

The Debris to floor  
(014/derelict boiler house)  
contains asbestos.

*Removed May 2019*

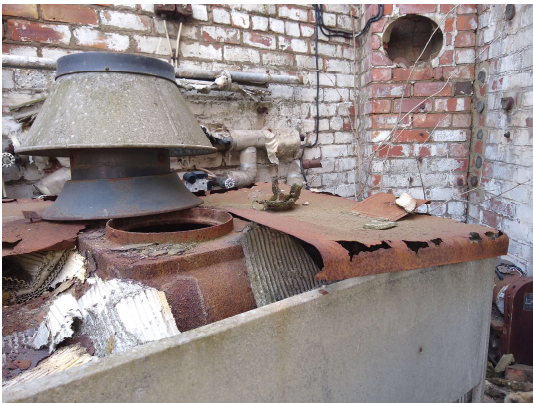
**Item 8 Ref: 323974-10**

The Debris to top of large  
boiler (014/derelict boiler  
house) contains asbestos.

*Removed May 2019*

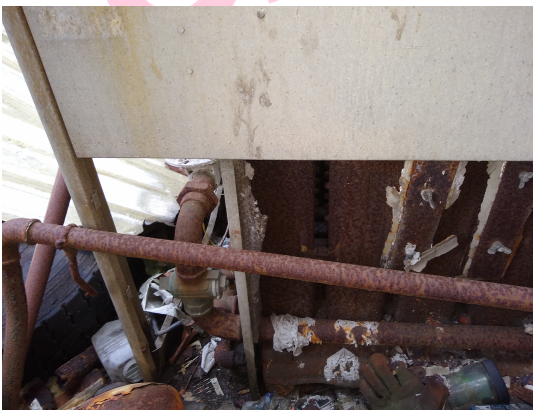
**Item 9 Ref: 323974-11**

The Insulation to large boiler  
(014/derelict boiler house)  
contains asbestos.

*Removed May 2019*

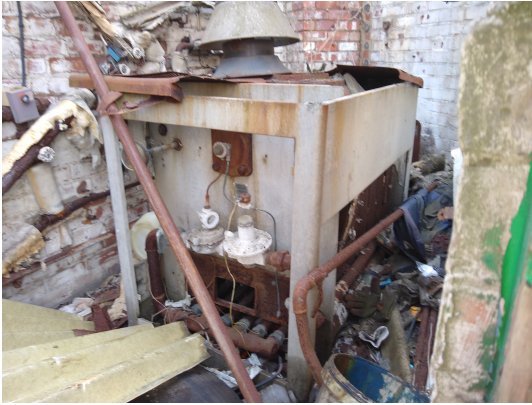
**Item 10 Ref: 323974-12**

The Sealant to large boiler sections (014/derelict boiler house) contain asbestos.

*Removed May 2019*

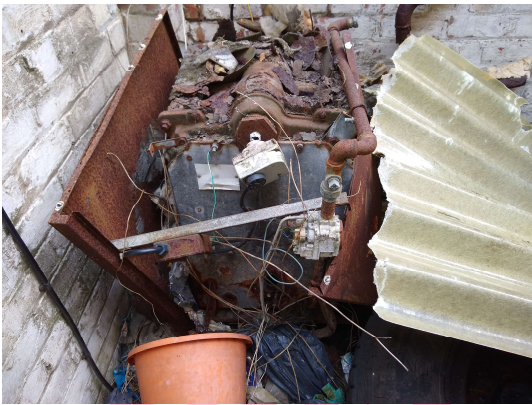
**Item 11 Ref: 323974-13**

The Sealant to sections of small boiler (014/derelict boiler house) contain asbestos.

*Removed May 2019*

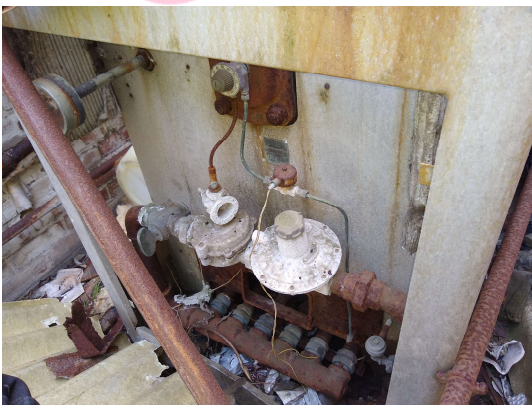
**Item 12 Ref: 323974-14**

The Gasket to gas regulator (014/derelict boiler house) contains asbestos.

*Removed May 2019*

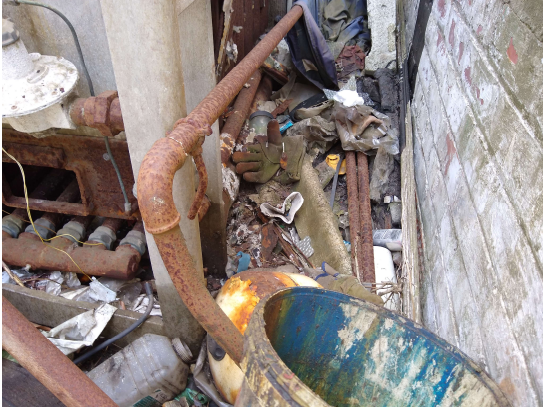
**Item 13 Ref: 323974-15**

The Debris to floor  
(014/derelict boiler house)  
contains asbestos.

*Removed May 2019*

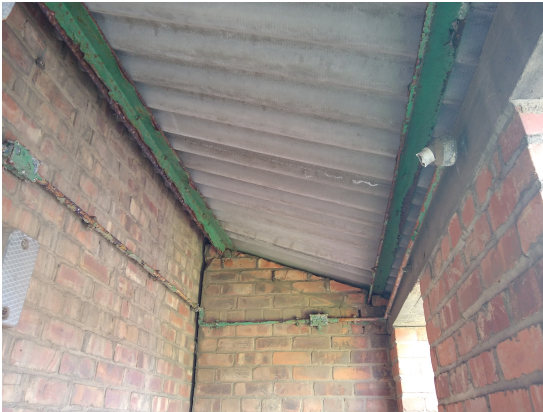
**Item 14 Ref: 323974-4**

The Underside of roof  
(016/smoking shelter) contains  
asbestos.

Any change in appearance  
should be recorded and  
passed to Property Services.

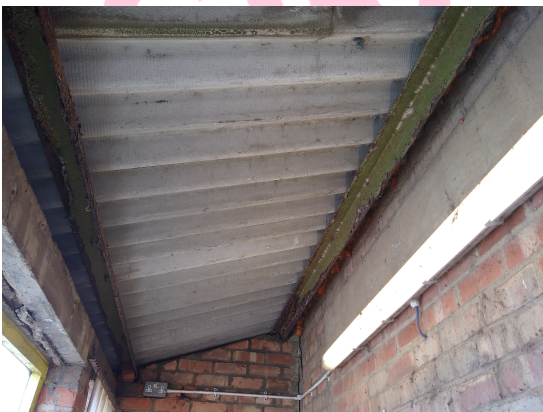
**Item 15 Ref: As 323974-4**

The Underside of roof  
(017/clocking in room)  
contains asbestos.

Any change in appearance  
should be recorded and  
passed to Property Services.

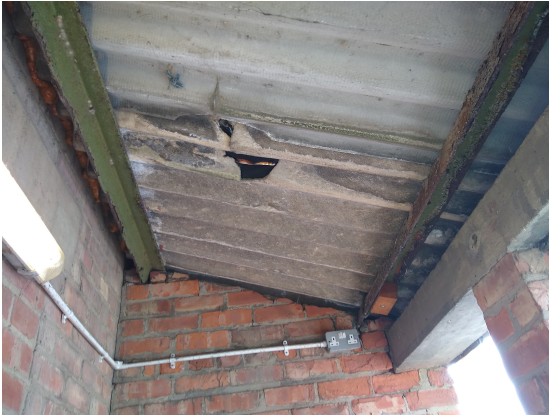
### **Item 16 Ref: 323974-5**

The Underside of roof  
(017/clocking in room)  
contains asbestos.

Any change in appearance  
should be recorded and  
passed to Property Services.

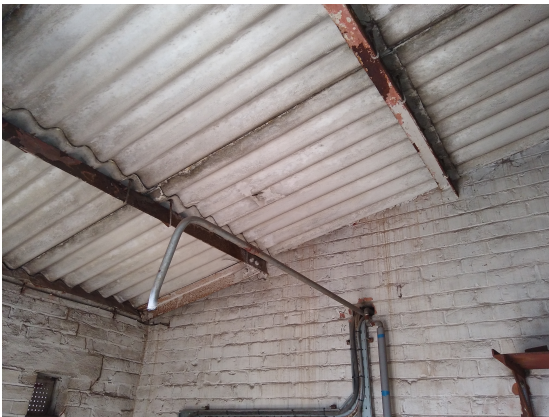
### **Item 17 Ref: 323974-6**

The Underside of roof  
(018/external store) contains  
asbestos.

Any change in appearance  
should be recorded and  
passed to Property Services.

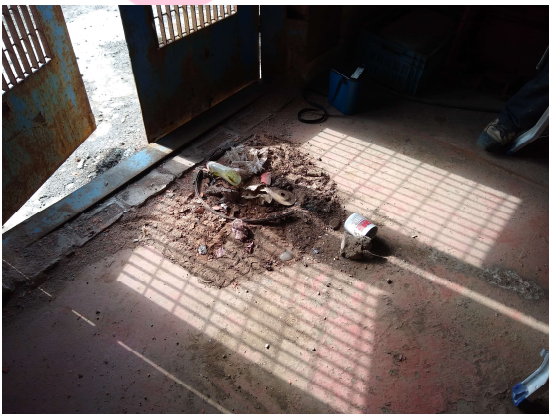
### **Item 18 Ref: 323974-7**

The General debris to floor  
(018/external store) contains  
asbestos.

*Removed May 2019*

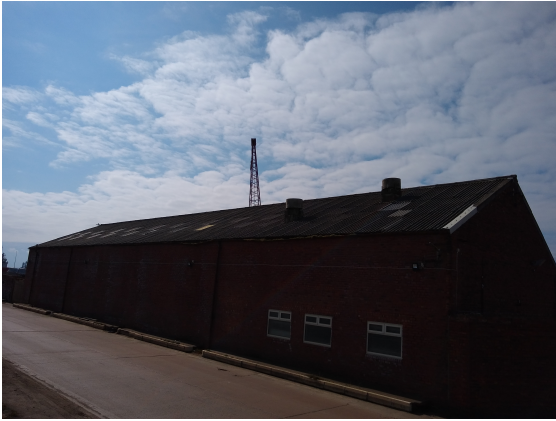
### **Item 19 Ref: As 323974-2**

The Roof (999/externals) contains asbestos.

Any change in appearance should be recorded and passed to Property Services.

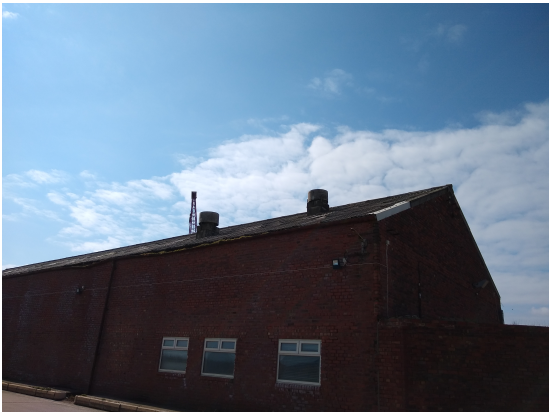
### **Item 20 Ref: Presumed**

The Roof vents (999/externals) contain asbestos.

Any change in appearance should be recorded and passed to Property Services.

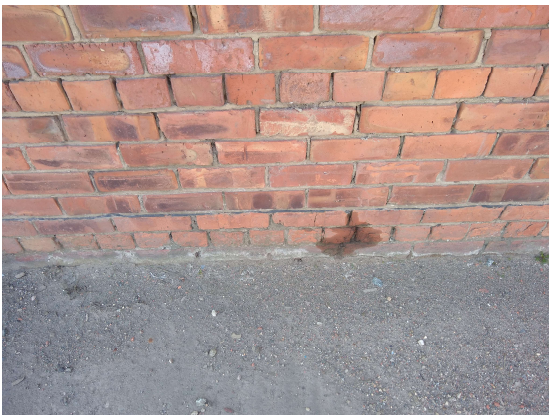
### **Item 21 Ref: 323974-15**

The Damp proof course (999/externals) does not contain asbestos.

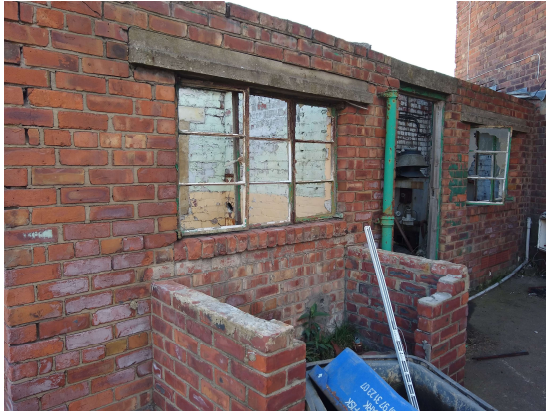
#### **Item 22 Ref: 323974-17**

The Putty to window panes (999/externals) do not contain asbestos.

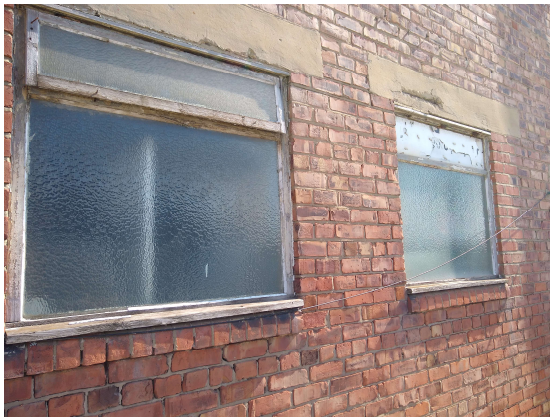
#### **Item 23 Ref: 323974-18**

The Sealant to window frames (999/externals) does not contain asbestos.

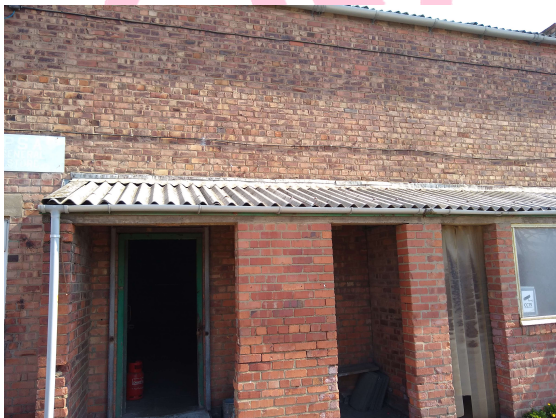
#### **Item 24 Ref: As 323974-4**

The Low level pitched roof covering replacement sheets (999/externals) contain asbestos.

Any change in appearance should be recorded and passed to Property Services.

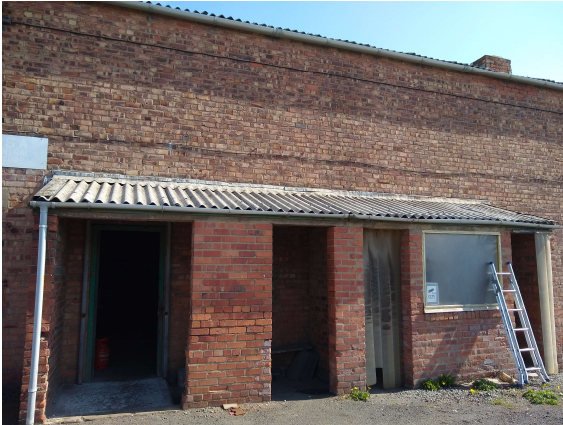
### **Item 25 Ref: As 323974-5**

The Low level pitched roof incl. edge boards (999/externals) contain asbestos.

Any change in appearance should be recorded and passed to Property Services.

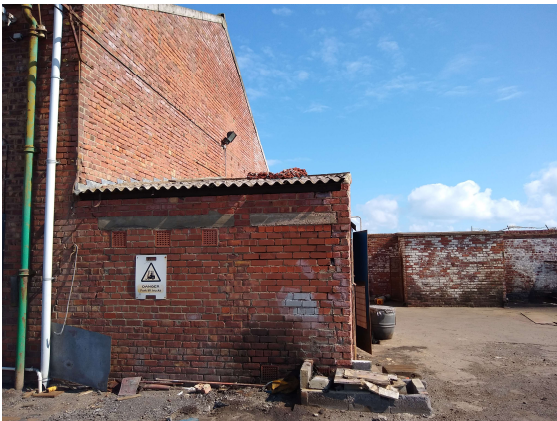
### **Item 26 Ref: As 323974-6**

The Low level flat roof (999/externals) contains asbestos.

Any change in appearance should be recorded and passed to Property Services.

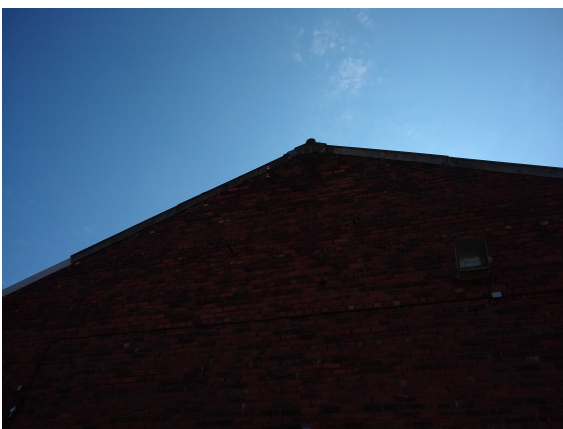
### **Item 27 Ref: Presumed**

The Black telephone insulator to gable end (999/externals) is presumed to contain asbestos.

Any change in appearance should be recorded and passed to Property Services.

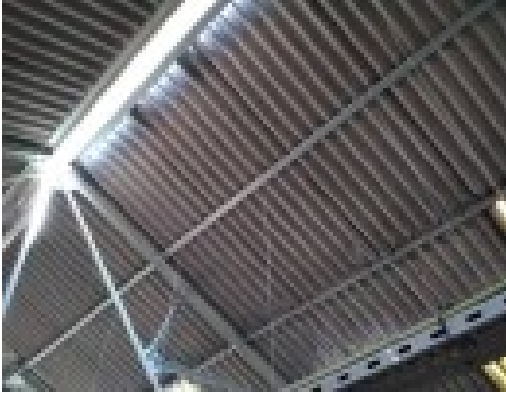
**Item 28 Ref: Presumed**

The ceiling void ceiling above roof in mezzanine (Rm MZ/001) is presumed to contain asbestos.

Refer to item 5 – samples were taken whereas this is just presumed.
