ASBESTOS SURVEY REPORT FOR BISHOPWEARMOUTH CEMETERY LODGES, SUNDERLAND

Asbestos Register for Bishopwearmouth Cemetery Lodges

Premises Manager / Samo: - Tenant Date: 17 July 2024

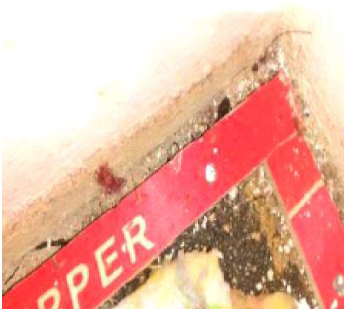
Item 2: As EA003486

The floor screed to the lounge (Room 2) does not contain asbestos.

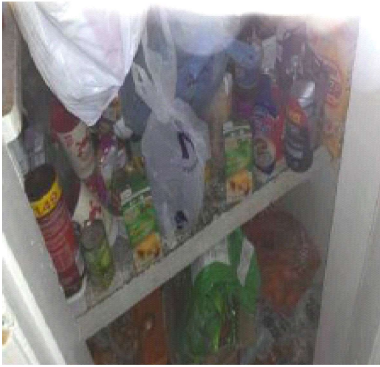
The under stairs cupboard (Room 5) was accessed and no suspect materials were found.

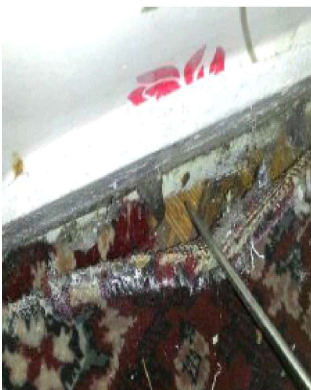
Item 3 – As EA003486

The floor screed to the dining room (Room 6) does not contain asbestos.

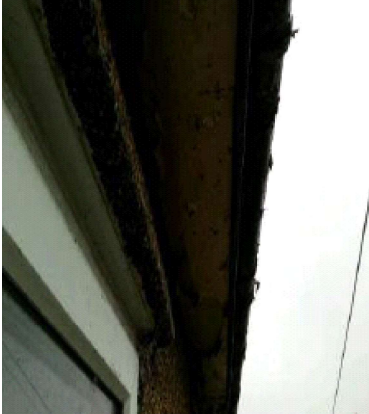
Item 4 – Presumed

The soffits to the external were presumed to contain asbestos.

These were removed in October 2015.

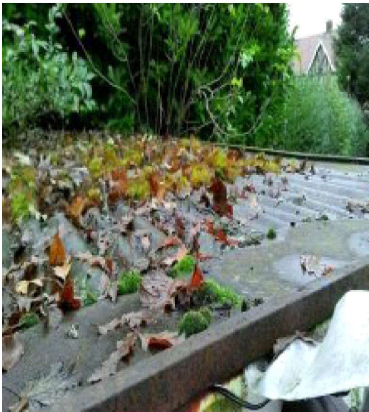
Item 5 Ref: EA003487

The garage roof sheets to the external garage contain asbestos.

There was no access to the garage as it was locked. Therefore further investigation may be required.

Any change in its appearance should be noted and passed to Property Services.

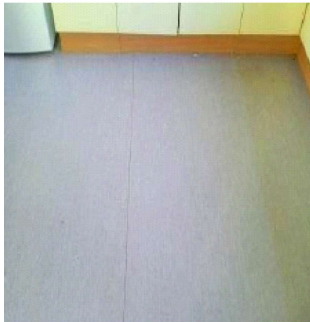
Item 6 Ref: EY000576

The lino to the kitchen (Room 2) does not contain asbestos.

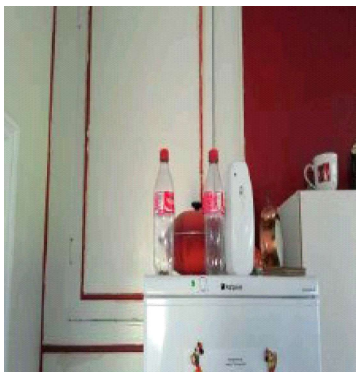
There was no access into the cupboards in the kitchen (Room 2) due to the fridge. Therefore further investigation may be required.

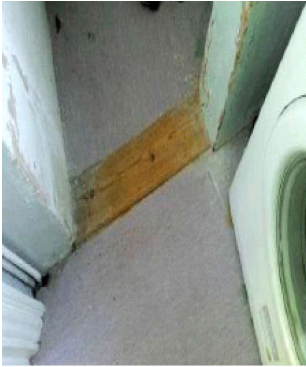
Item 7 As:EY000576

The lino to the kitchen cupboard (Room 3) does not contain asbestos.

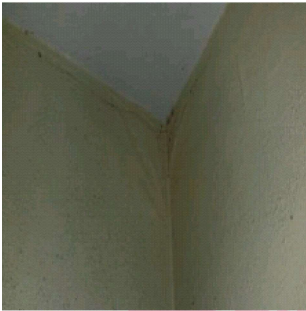
Item 8 – Ref: EY000577

The textured coating to the walls and ceiling in the store room (Room 4) does not contain asbestos.

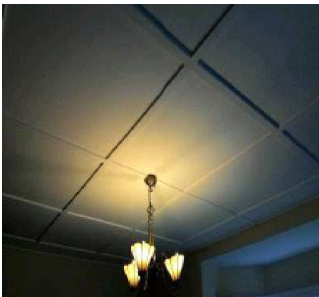
Item 9 – Ref: EY000578

The ceiling to the lounge (Room 5) does not contain asbestos.

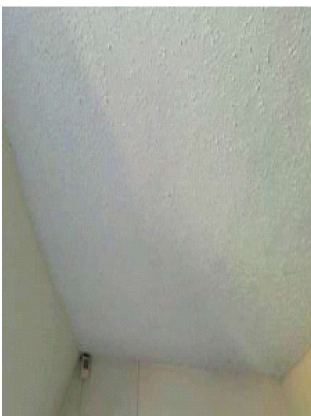
Item 10 – Ref: EY000575

The textured coating to the ceiling in bedroom 2 (Room 2) on the first floor does not contain asbestos.

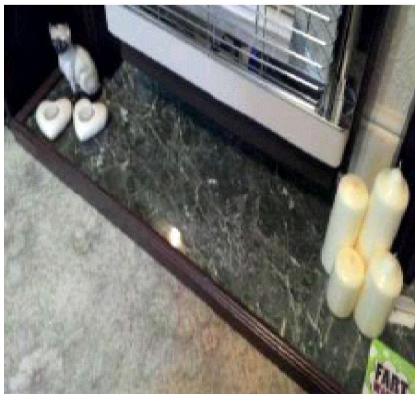
Item 11 – Ref: EA003478

The panel to the underside of the fireplace hearth in the lounge (Room 2) does not contain asbestos.

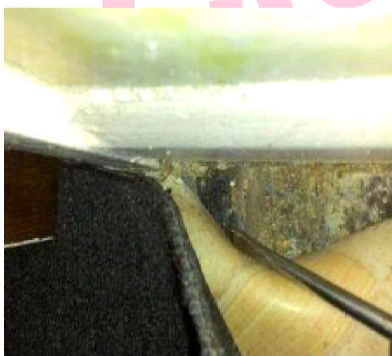
Item 12 – Ref: EA003479

The blue floor tiles to the bathroom (Room 6) contain asbestos.

Item 12	Floor tiles – Room 6	Very Low	12 monthly	03.01.25
Item 13	Adhesive to floor tiles - Room 6	Very Low	12 monthly	03.01.25
Item 14	Floor tiles - Room 9	Very Low	12 monthly	03.01.25

Any change in its appearance should be noted and passed to Property Services.

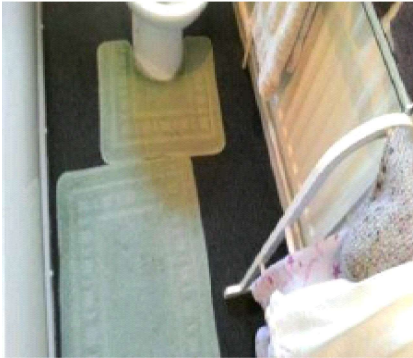
Item 13 – Ref: EA003480

The bitumen adhesive beneath the floor tiles in the bathroom (Room 6) contains asbestos.

Any change in its appearance should be noted and passed to Property Services.

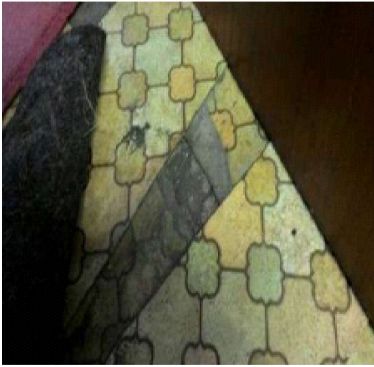
Item 14 As EA003479

The blue floor tiles in the kitchen (Room 9) contain asbestos.

Any change in its appearance should be noted and passed to Property Services.

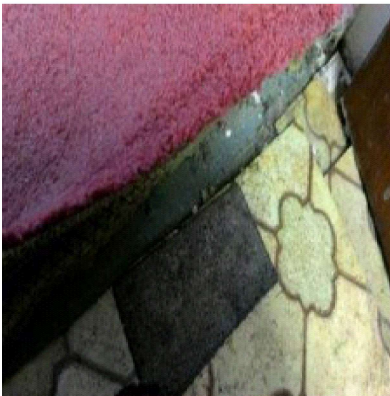
Item 15 As EA003480

The bitumen adhesive beneath the floor tiles in the kitchen (Room 9) contains asbestos.

Item 15	Adhesive to floor tiles – Room 9	Very Low	12 monthly	03.01.25
<i>Item 16</i>	<i>No asbestos</i>	<i>Is present</i>		
Item 17	Textured coating to ceiling - Room 9	Low	6 monthly	03.01.25
<i>Item 18</i>	<i>No asbestos</i>	<i>Is present</i>		
<i>Item 19</i>	<i>No asbestos</i>	<i>Is present</i>		
<i>Item 20</i>	<i>No asbestos</i>	<i>Is present</i>

Any change in its appearance should be noted and passed to Property Services.

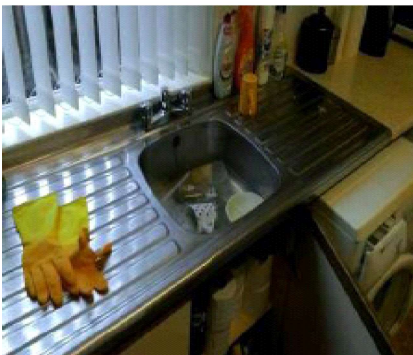
Item 16 Ref: EA003481

The sink pads to the drainer in the kitchen (Room 9) do not contain asbestos.

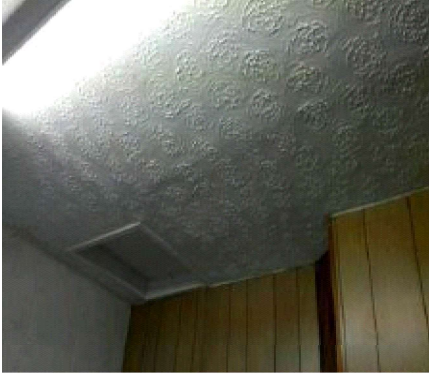
Item 17 Ref: EA003482

The textured coating to the ceiling in the kitchen (Room 9) contains asbestos.

Any change in its appearance should be noted and passed to Property Services.

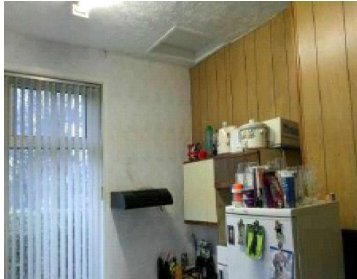
The roof void (Room 1) was inaccessible due to the hatch being above cupboards and cooker hood.

Therefore further investigation may be required.

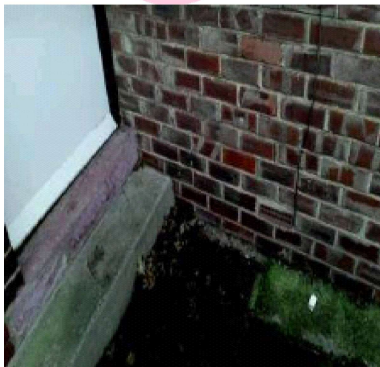
Item 18 Ref: EA003483

The damp proof course to the extension (external) does not contain asbestos.

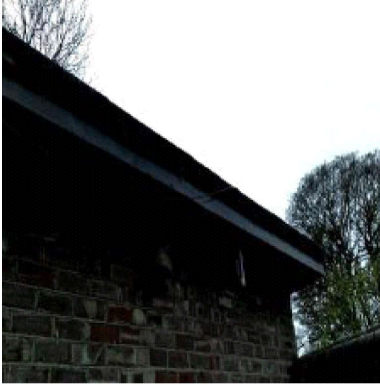
Item 19 Ref: EA003484

The bitumen to the flat roof (external) does not contain asbestos.

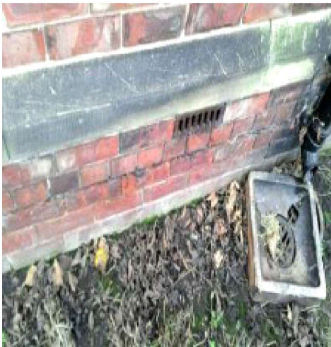
Item 20 Ref: EA003485

The damp proof course (external) to the main building does not contain asbestos.

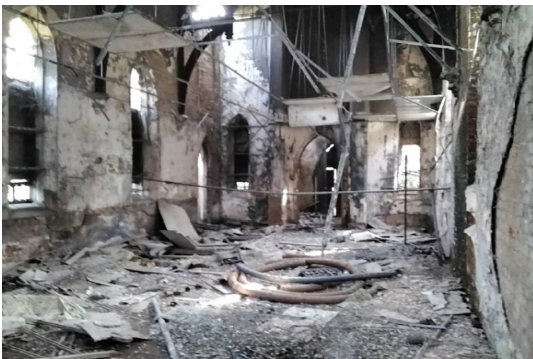
Item 21 Ref: SC005440

The ceiling tile, solid debris to floor and some still suspended in the chapel does not contain asbestos.

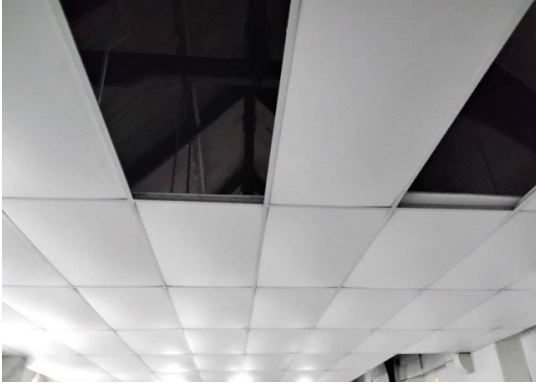
Item 22 Ref: DC003178

The ceiling tile, solid debris to floor and some still suspended in the chapel does not contain asbestos.
