ASBESTOS SURVEY REPORT FOR ASHLEY PRIMARY ACADEMY, TEMPLE PARK ROAD, SOUTH SHIELDS, NE33 0QA

Asbestos Register for ASHLEY PRIMARY ACADEMY, TEMPLE PARK ROAD

Date: 13 February 2025

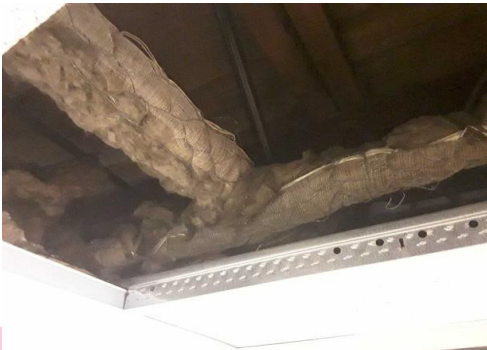
Item 2 Ref: 22-53098-1

The pipes – string to mmmf lagged metal pipes - Ground Floor, Room 1, Entrance Hall - do not contain asbestos

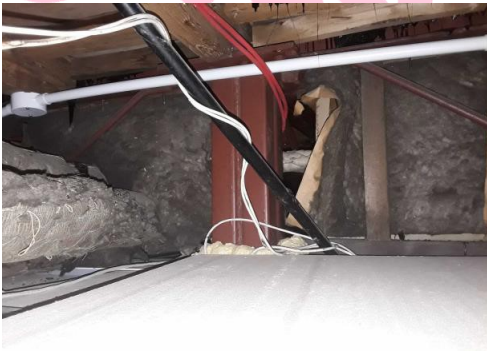
Item 3 Ref: Presumed

The walls – lining inside clasp columns - Ground Floor, Room 1, Entrance Hall - are presumed to contain asbestos.

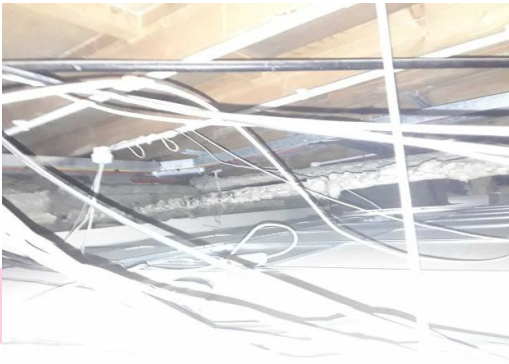
Item 5 Ref: 22-53098-1

The pipes – string to mmmf lagged metal pipes - Ground Floor, Room 3, Staff Room - do not contain asbestos

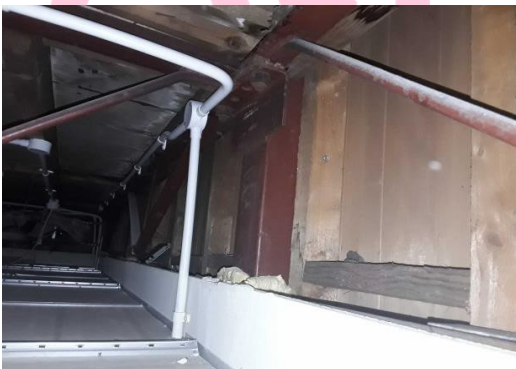
Item 6 Ref: Presumed

The walls – lining inside clasp columns - Ground Floor, Room 3, Staff Room - are presumed to contain asbestos.

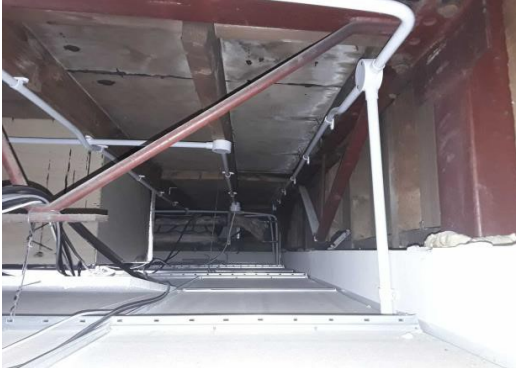
Item 7 Ref: 22-53098-1

The pipes – string to mmmf lagged metal pipes - Ground Floor, Room 4, Reception - do not contain asbestos

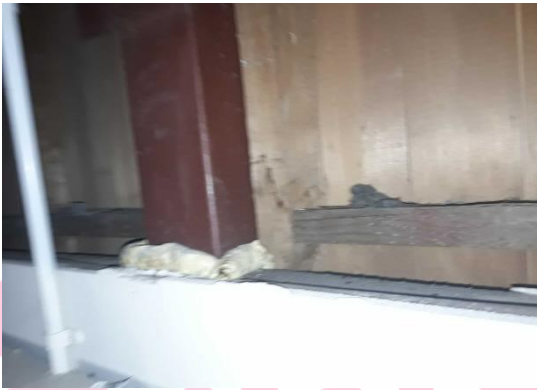
Item 8 Ref: Presumed

The walls – lining inside clasp columns - Ground Floor, Room 4, Reception - are presumed to contain asbestos.

Any change in its appearance should be recorded and passed to Property Services.

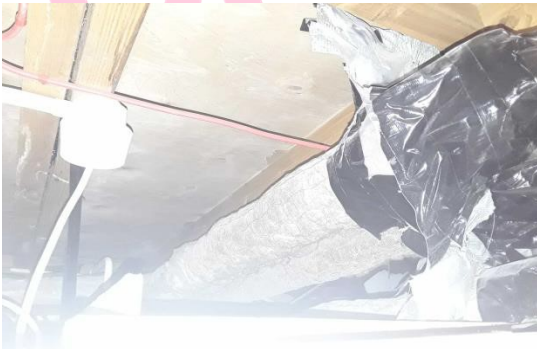
Item 9 Ref: 22-53098-1

The pipes – string to mmmf lagged metal pipes - Ground Floor, Room 5, Ladies Toilets - do not contain asbestos

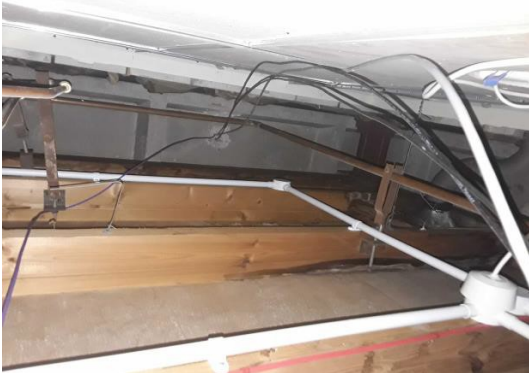
Item 10 Ref: Presumed

The walls – lining inside clasp columns - Ground Floor, Room 5, Ladies Toilets - are presumed to contain asbestos.

Any change in its appearance should be recorded and passed to Property Services.

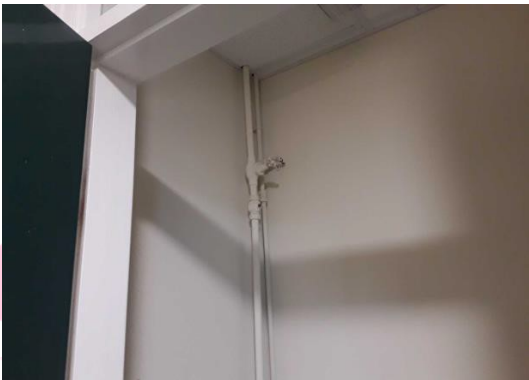
Item 11 Ref: Presumed

The pipes – stop taps (Gaskets) - Ground Floor, Room 5, Ladies Toilets - are presumed to contain asbestos.

Any change in its appearance should be recorded and passed to Property Services.

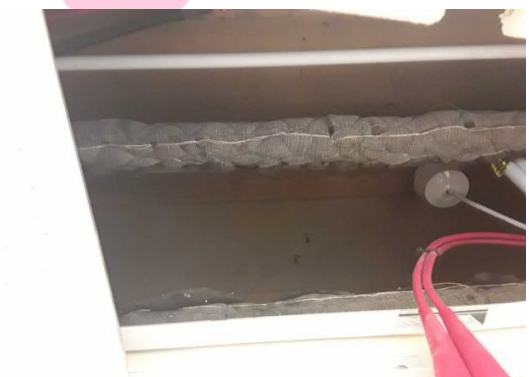
Item 12 Ref: 22-53098-1

The pipes – string to mmf lagged metal pipes - Ground Floor, Room 6, Disabled Toilets - do not contain asbestos

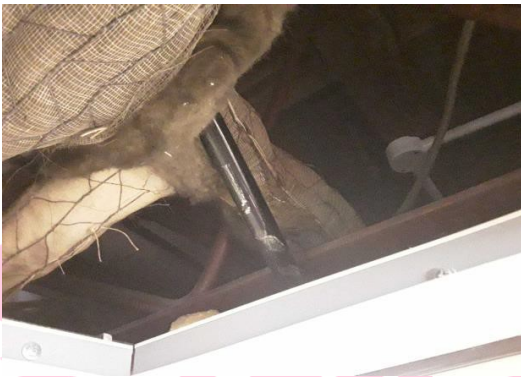
Item 14 Ref: 22-53098-1

The pipes – string to mmmf lagged metal pipes - Ground Floor, Room 7, Head teachers office - do not contain asbestos

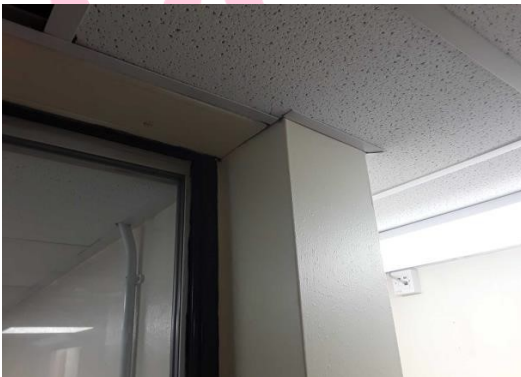
Item 15 Ref: Presumed

The walls – lining inside clasp columns - Ground Floor, Room 7, Head teachers office - are presumed to contain asbestos.

Any change in its appearance should be recorded and passed to Property Services.

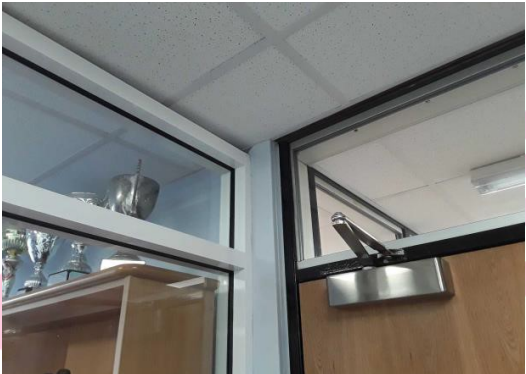
Item 17 Ref: Presumed

The walls – lining inside clasp columns - Ground Floor, Room 8, Hallway - are presumed to contain asbestos.

Any change in its appearance should be recorded and passed to Property Services.

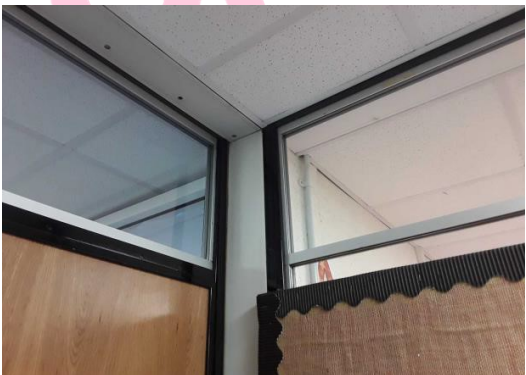
Item 18 Ref: Presumed

The walls – lining inside clasp columns - Ground Floor, Room 9, Corridor - are presumed to contain asbestos.

Any change in its appearance should be recorded and passed to Property Services.

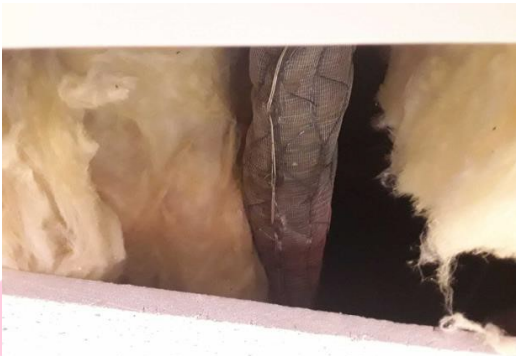
Item 20 Ref: 22-53098-1

The pipes – string to mmmf lagged metal pipes - Ground Floor, Room 10, Classroom - do not contain asbestos

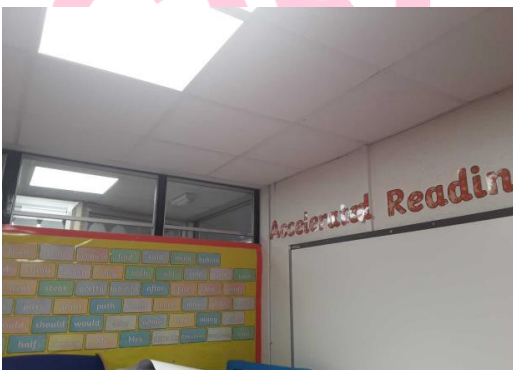
Item 21 Ref: Presumed

The walls – lining inside clasp columns - Ground Floor, Room 10, Classroom - are presumed to contain asbestos.

Any change in its appearance should be recorded and passed to Property Services.

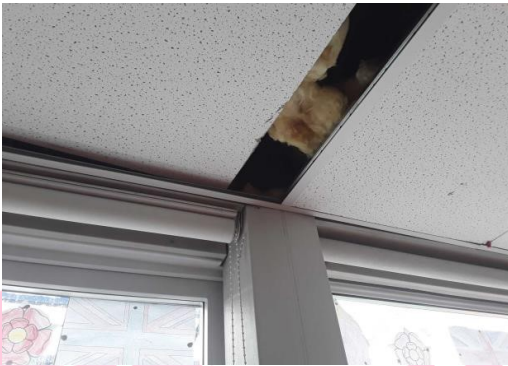
Item 23 Ref: Presumed

The walls – lining inside clasp columns - Ground Floor, Room 11, Classroom - are presumed to contain asbestos.

Any change in its appearance should be recorded and passed to Property Services.

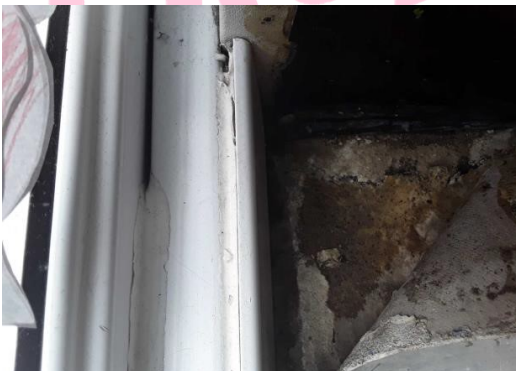
Item 24 Ref: 22-53098-3

The floor – residual adhesive beneath floor screed - Ground Floor, Room 11, Classroom - contains asbestos.

Any change in its appearance should be recorded and passed to Property Services.

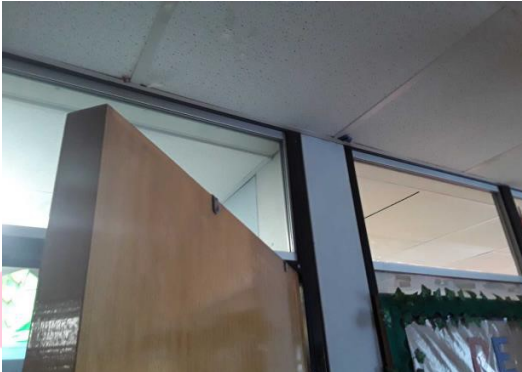
Item 26 Ref: Presumed

The walls – lining inside clasp columns - Ground Floor, Room 12, Classroom store cupboard - are presumed to contain asbestos.

Any change in its appearance should be recorded and passed to Property Services.

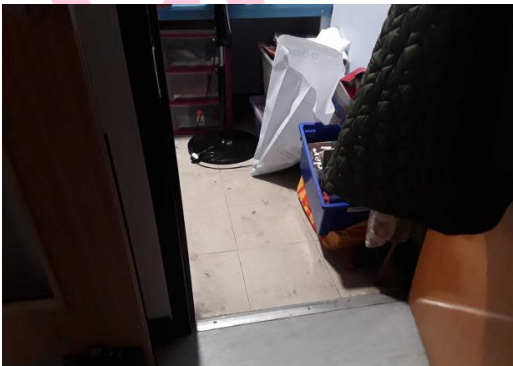
Item 27 Ref: 22-53098-3

The floor – residual adhesive beneath floor screed - Ground Floor, Room 12, Classroom store cupboard - contains asbestos.

Any change in its appearance should be recorded and passed to Property Services.

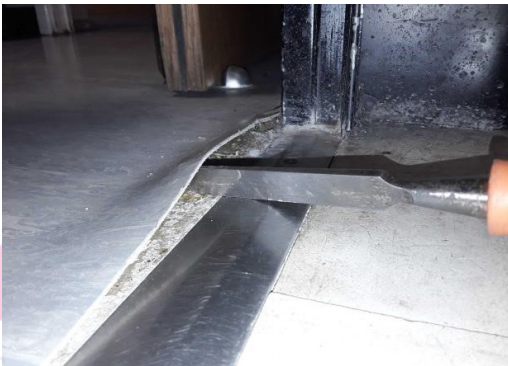
Item 29 Ref: 22-53098-3

The floor – residual adhesive beneath floor screed - Ground Floor, Room 13, Classroom - contains asbestos.

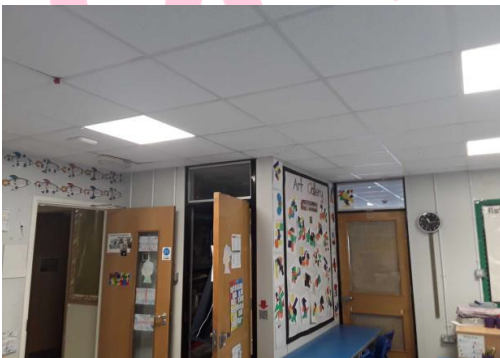
Item 30 Ref: Presumed

The walls – lining inside clasp columns - Ground Floor, Room 14, Classroom – are presumed to contain asbestos.

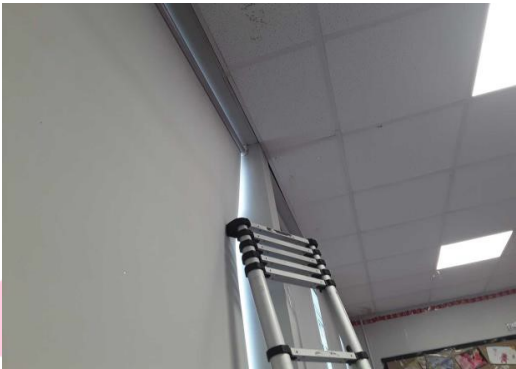
Item 32 Ref: Presumed

The walls – lining inside clasp columns - Ground Floor, Room 15, Classroom – are presumed to contain asbestos.

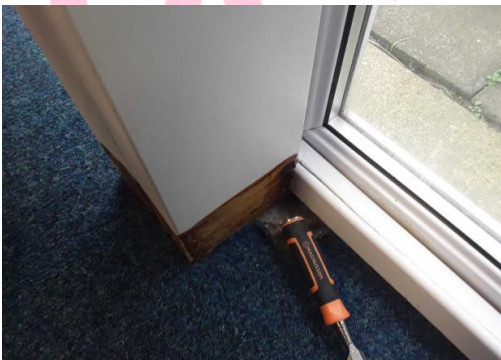
Item 33 Ref: 22-53098-3

The floor – residual adhesive beneath floor screed - Ground Floor, Room 15, Classroom - contains asbestos.

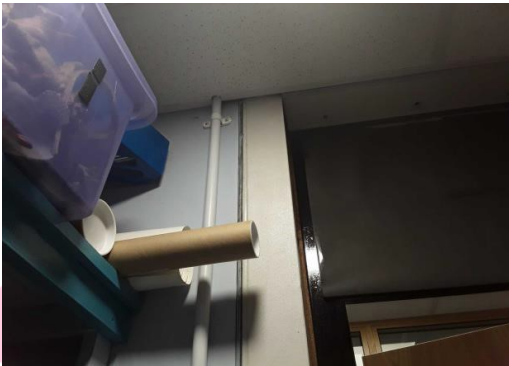
Item 35 Ref: Presumed

The walls – lining inside clasp columns - Ground Floor, Room 16, Corridor Store Cupboard – are presumed to contain asbestos.

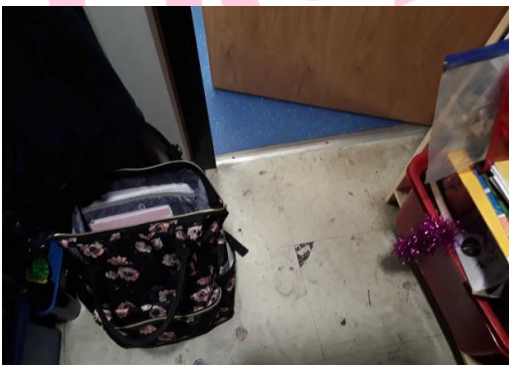
Item 36 Ref: 22-53098-4

The floor – tiles and adhesive - Ground Floor, Room 16, Corridor Store Cupboard - contains asbestos.

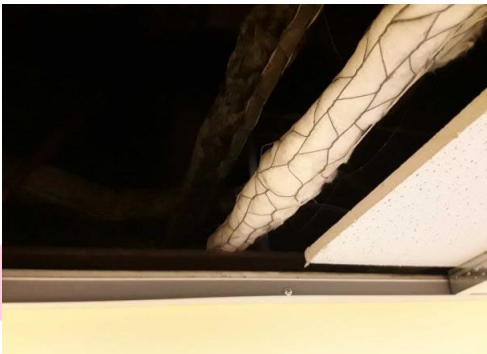
Item 41 Ref: 22-53098-1

The pipes – string to mmmf lagged metal pipes - Ground Floor, Room 19, Fire exit hallway and cloak rooms - do not contain asbestos

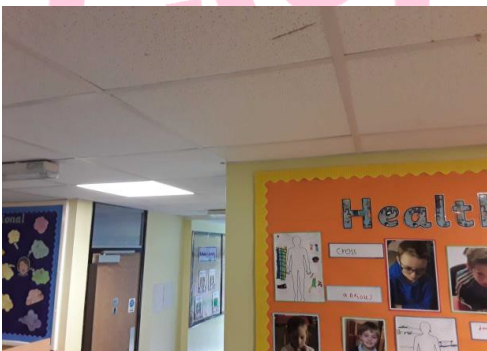
Item 42 Ref: Presumed

The walls – lining inside clasp columns - Ground Floor, Room 19, Fire exit hallway and cloak rooms – are presumed to contain asbestos.

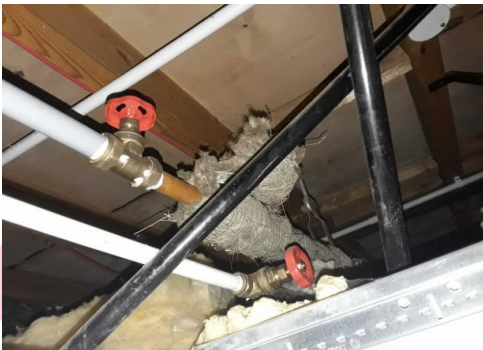
Item 44 Ref: 22-53098-1

The pipes – string to mmmf lagged metal pipes - Ground Floor, Room 20, Boys Toilet - do not contain asbestos

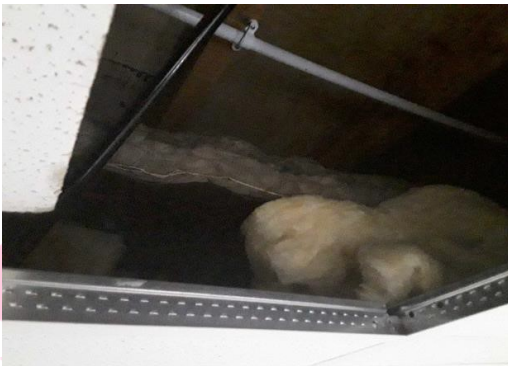
Item 47 Ref: 22-53098-1

The pipes – string to mmf lagged metal pipes - Ground Floor, Room 21, Girls Toilet - do not contain asbestos

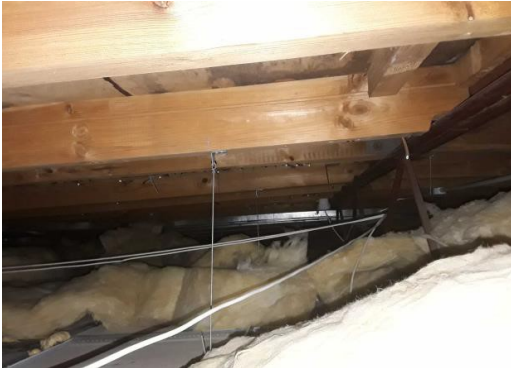
Item 52 Ref: 22-53098-1

The pipes – string to mmmf lagged metal pipes - Ground Floor, Room 22, Classroom - do not contain asbestos

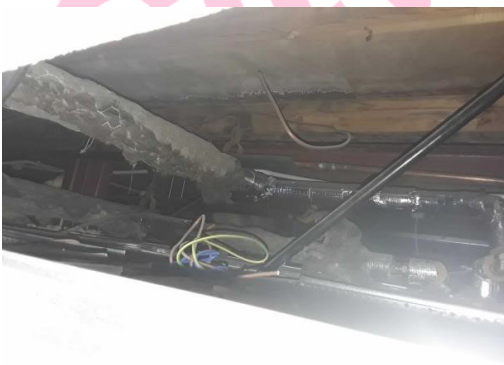
Item 54 Ref: Presumed

The walls – lining inside clasp columns - Ground Floor, Room 25, Classroom store cupboard – are presumed to contain asbestos.

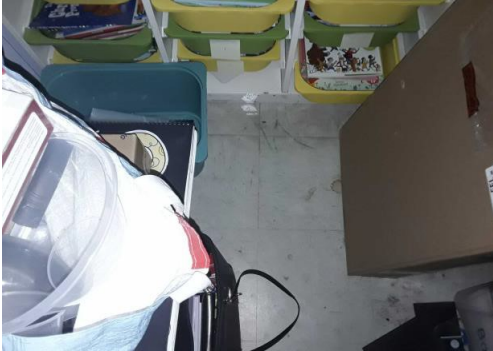
Item 55 Ref: 22-53098-4

The floor – tiles and adhesive
- Ground Floor, Room 25,
Classroom store cupboard -
contains asbestos.

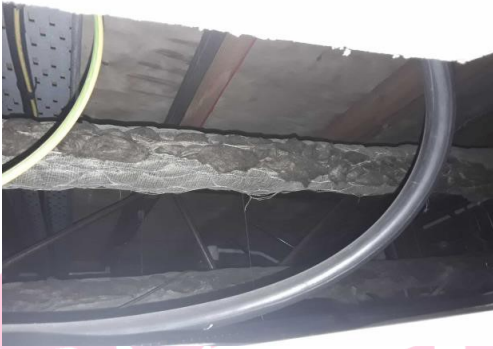
Item 56 Ref: 22-53098-1

The pipes – string to mmmf
lagged metal pipes - Ground
Floor, Room 26, Classroom
store cupboard - do not
contain asbestos

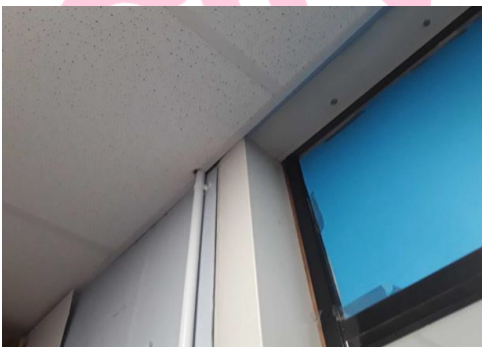
Item 57 Ref: Presumed

The walls – lining inside clasp
columns - Ground Floor,
Room 26, Classroom store
cupboard – are presumed to
contain asbestos.

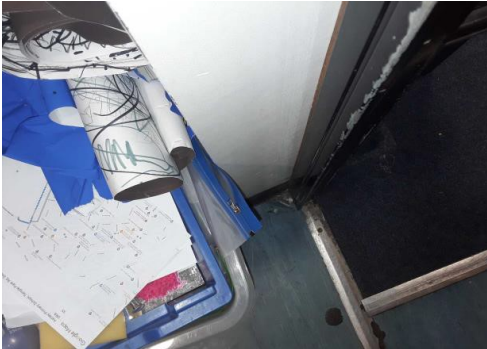
Item 58 Ref: 22-53098-4

The floor – tiles and adhesive
- Ground Floor, Room 26,
Classroom store cupboard -
contains asbestos.

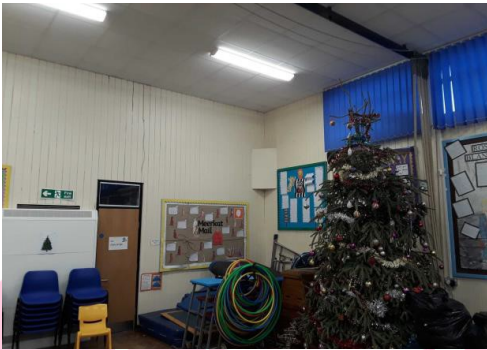
Item 59 Ref: Presumed

The walls – firebreak behind
wood cladding between hall
and boiler room - Ground
Floor, Room 28, Main School
Hall – are presumed to
contain asbestos.

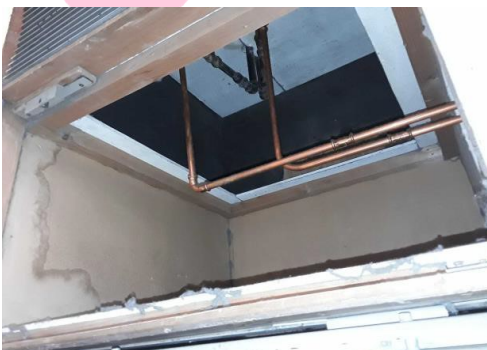
Item 60 Ref: 22-53098-29

The vessels – lining inside
area of old heating unit -
Ground Floor, Room 28, Main
School Hall – does not contain
asbestos.

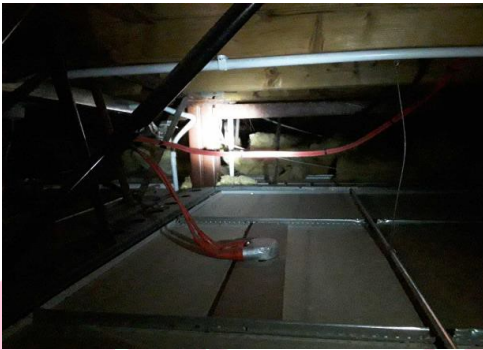
Item 89 Ref: Presumed

The walls – lining inside clasp
columns - Ground Floor,
Room 39, Store Cupboard –
are presumed to contain
asbestos.

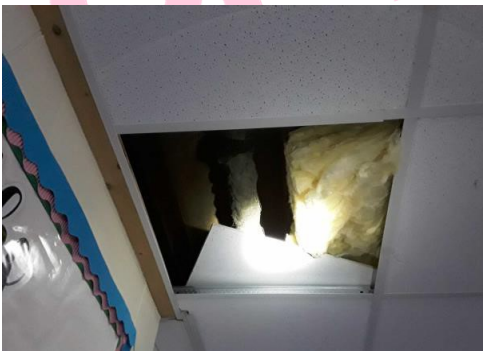
Item 90 Ref: 22-53098-1

The pipes – string to mmmf
lagged metal pipes - Ground
Floor, Room 40, Classroom -
do not contain asbestos

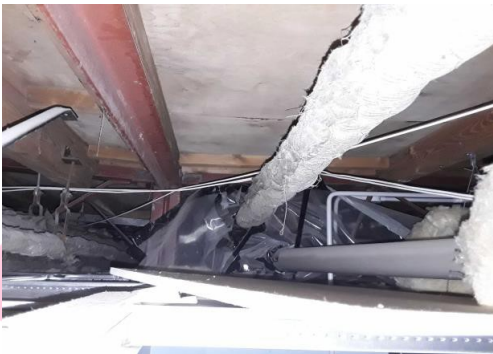
Item 92 Ref: 22-53098-1

The pipes – string to mmmf lagged metal pipes - Ground Floor, Room 41, Classroom Cupboard - do not contain asbestos

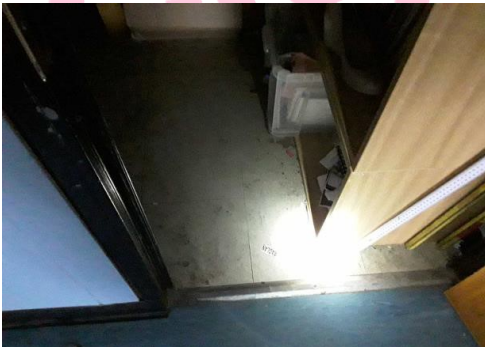
Item 93 Ref: 22-53098-10

The floor – tiles and adhesive - Ground Floor, Room 41, Classroom Cupboard - contains asbestos.

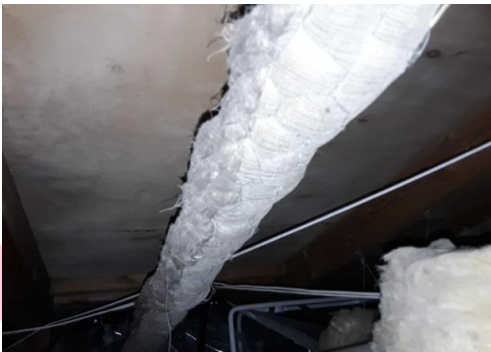
Item 95 Ref: 22-53098-1

The pipes – string to mmmf lagged metal pipes - Ground Floor, Room 42, Classroom Cupboard - do not contain asbestos

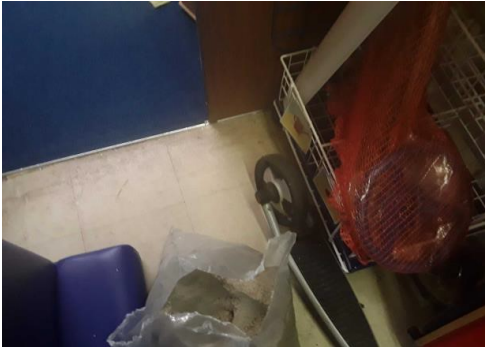
Item 163 Ref: 22-53098-20

The floor – tiles and adhesive
- Ground Floor, Room 89
Nursery area 2 Store
cupboard 1- contains
asbestos.

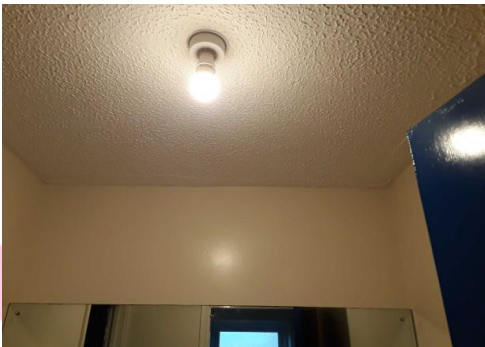
Item 164 Ref: 22-53098-13

The ceiling – textured coating
- Ground Floor, Room 90 Staff
Toilets Nursery - contains
asbestos.

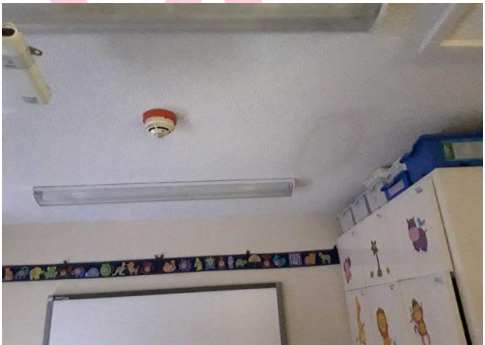
Item 165 Ref: 22-53098-13

The ceiling – textured coating
- Ground Floor, Room 91
Interview Room Nursery -
contains asbestos.

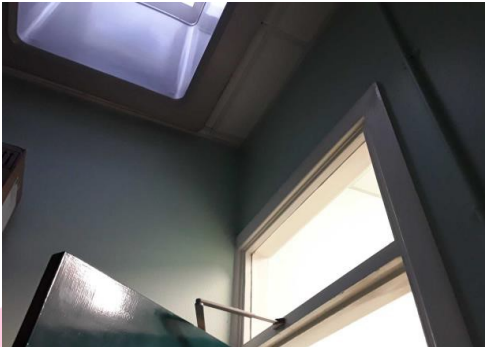
Item 194 Ref: Presumed

The walls – lining inside clasp columns - Ground Floor, Room 110 Kitchen Staff Toilet - are presumed to contain asbestos.

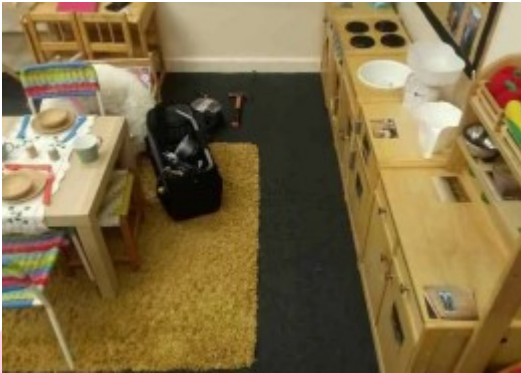
Item 200 Ref: TL000402

The Floor – screed composite sample from opposite ends of room Ground Floor, Rm G/001 Main Nursery Area – does not contain asbestos.

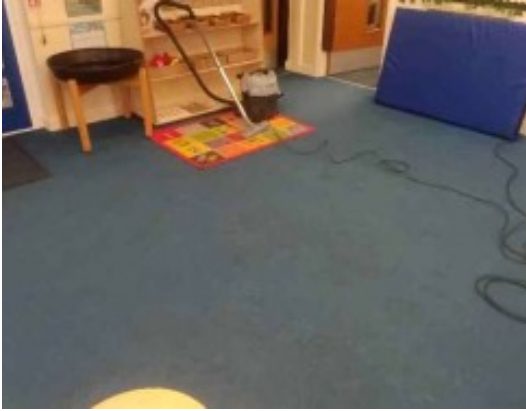
Item 202 Ref: As TL000302

The Floor – screed composite sample from opposite ends of room
Ground Floor, Rm G/002
Main Nursery Area – does not contain asbestos.

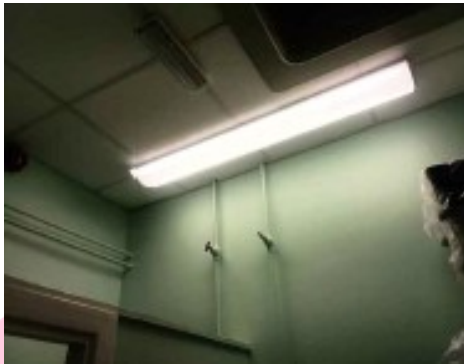
Item 206 Ref: Presumed

The Ceiling Void - Insulating Board, Ground Floor, Rm 109 Toilet(s) is presumed to contain asbestos.
