### ASBESTOS SURVEY REPORT FOR OXCLOSE SCHOOL, CARETAKERS HOUSE No 1, WASHINGTON

**CARETAKERS HOUSE 1, OXCLOSE ACADEMY,  
WASHINGTON (DLC CENTRE)**

### **Plan of Building and Samples Location – CT House 1 – (DLC Centre)**

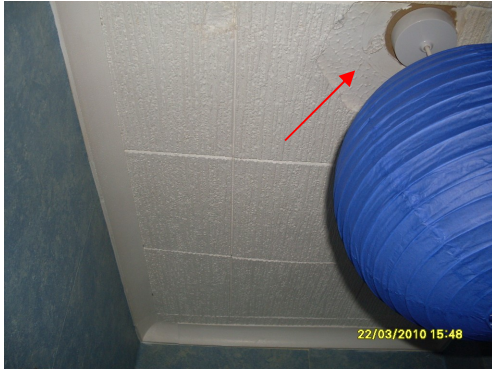
### **Various Ref: ME1380/10**

The textured coating to the ceiling above the ceiling tiles in the toilet (Rm 0/01) contains asbestos. Any change in its appearance should be recorded, and passed to Property Services.

Similar textured coating is located on ceilings in rooms 0/02, 0/03, 0/04, 0/05, 1/01, 1/02, 1/03 and 1/06.

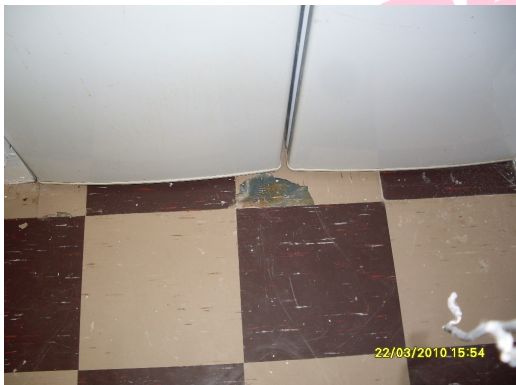
### **Item 3 - Ref:ME1381/10**

The floor tiles to the kitchen (Rm 0/02) do not contain asbestos.

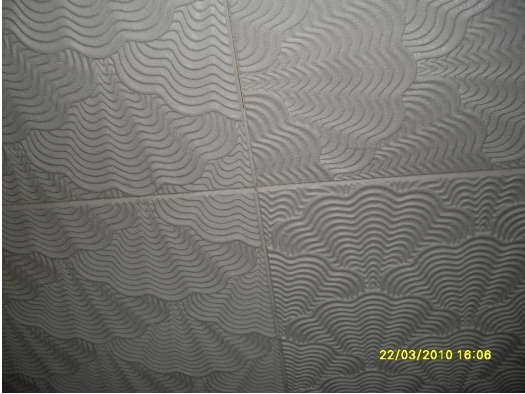
### **Item 10 - Presumed**

The textured coating to the ceiling above the tiles in Bedroom 2 (Rm 1/05) is presumed to contain asbestos.

Any change in its appearance should be recorded, and passed to Property Services.

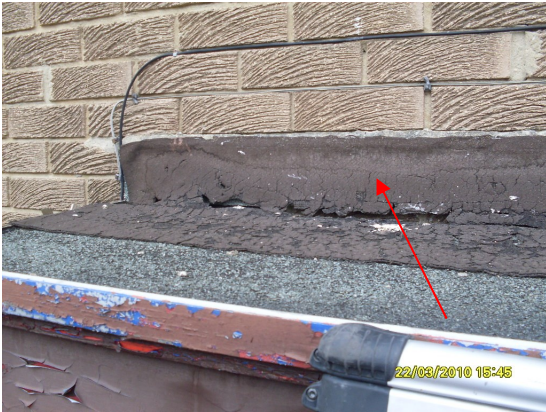
**Item 12 - Ref: ME1379/10**

The roof flashing to the external of the house does not contain asbestos.

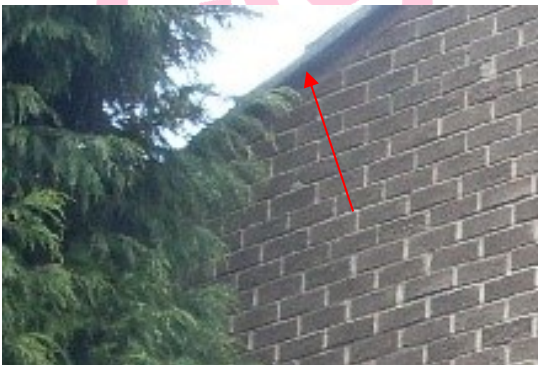
**Item 13 – Presumed**

The undercloaking to the house is presumed to contain asbestos.

*This was removed February 2020.*

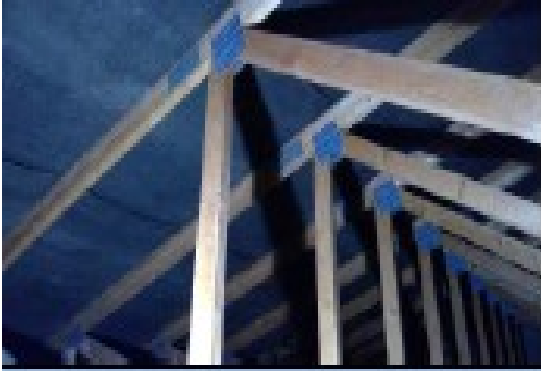
**Item 14 – AN004141**

The roof felt in the roof void does not contain asbestos.
