ASBESTOS SURVEY REPORT FOR OXCLOSE ACADEMY CARETAKERS HOUSE No. 2, WASHINGTON

OXCLOSE ACADEMY 2 CARETAKERS HOUSE, WASHINGTON

Premises Manager / Samo: - Tenant Date: 22 August 2024

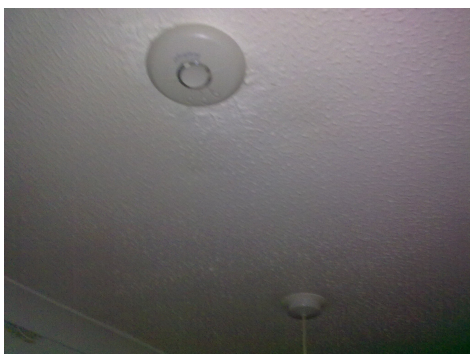
Item 1 Ref: DC2070/10

The coating to the ceiling in the stairs/hall/landing (Rm 0/01) contains asbestos.

Removed February 2020.

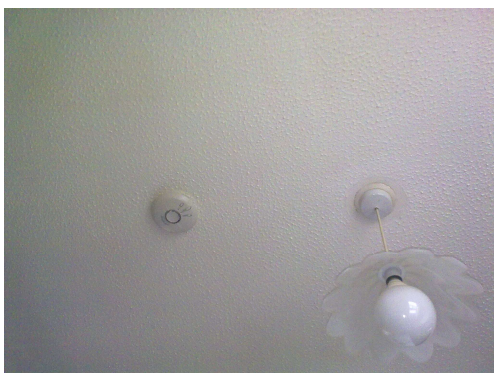
Item 2 – Ref: DC2071/10

The coating to the ceiling in the toilet (Rm 0/02) contains asbestos.

Removed February 2020.

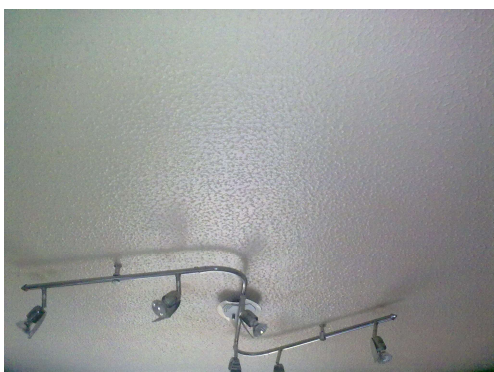
Item 3 – As DC2071/10

The coating to the ceiling in the kitchen (Rm 0/03) contains asbestos.

Removed February 2020.

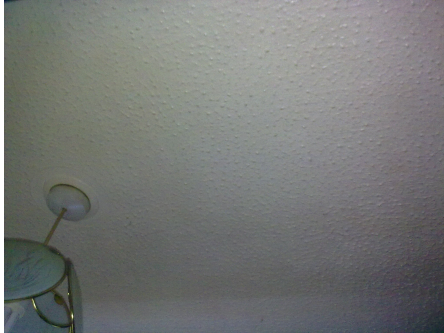
Item 4 - Ref: DC2072/10

The ceiling coating to the lounge (Rm 0/04) contains asbestos.

Removed February 2020.

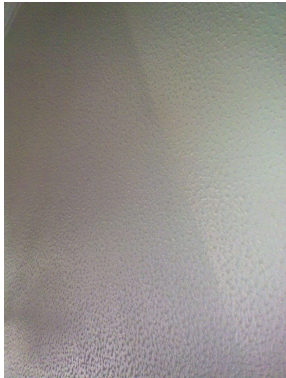
Item 5 – As DC2071/10

The coating to the heating cupboard (Rm 0/06) contains asbestos.

Removed February 2020.

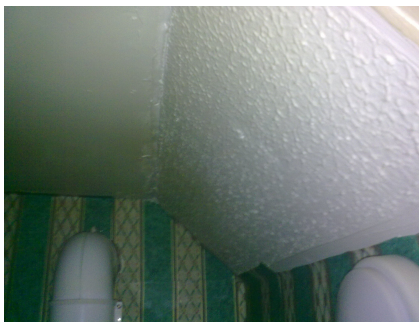
Item 6 – As DC2071/10

The coating to the ceiling in the electrical cupboard (Rm 0/07) contains asbestos.

Removed February 2020.

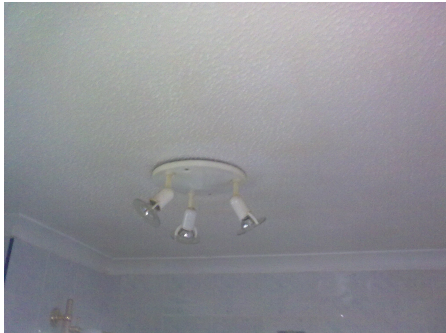
Item 7 - Ref: DC2073/10

The coating to the ceiling in the bathroom (Rm 1/01) contains asbestos.

Removed February 2020.

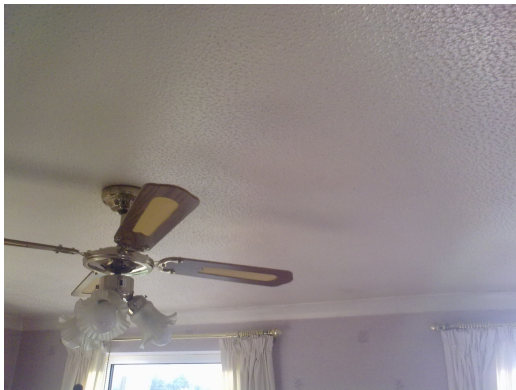
Item 8 – As DC2073/10

The coating to the ceiling in bedroom 1 (Rm 1/02) contains asbestos.

Removed February 2020.

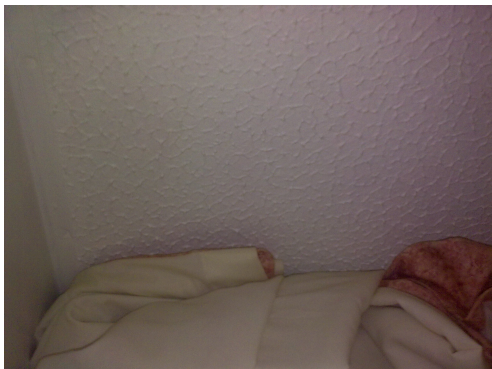
Item 9 – As DC2073/10

The coating to the ceiling in the cupboard to the landing (Rm 1/03) contains asbestos.

Removed February 2020.

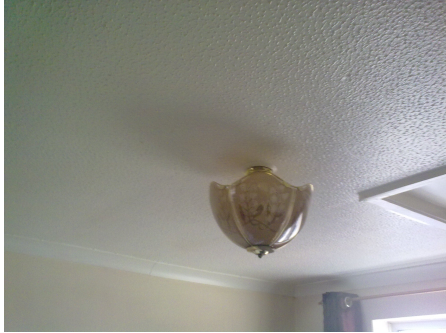
Item 10 – As DC2074/10

The coating to the ceiling in bedroom 2 (Rm 1/04) contains asbestos.

Removed February 2020.

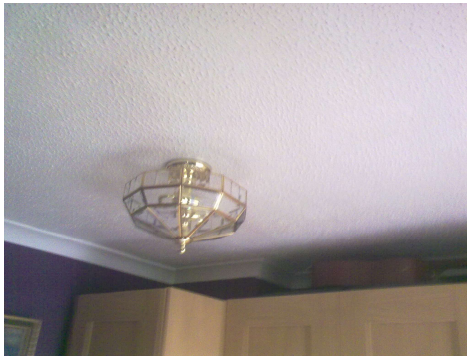
Item 11 – As DC2074/10

The coating to the ceiling in bedroom 3 (Rm 1/05) contains asbestos.

Removed February 2020.

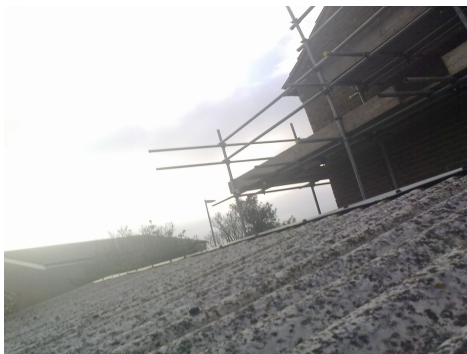
Item 12 – Ref: DC2077/10

The roof to the garage (External) does not contain asbestos.

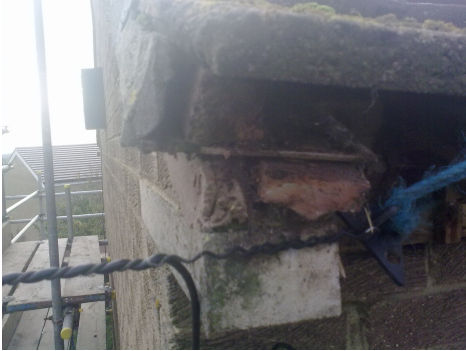
Item 13 – Ref: DC2078/10

The undercloaking to the external of the house contains asbestos. Any change in its appearance should be recorded, and passed to Property Services.

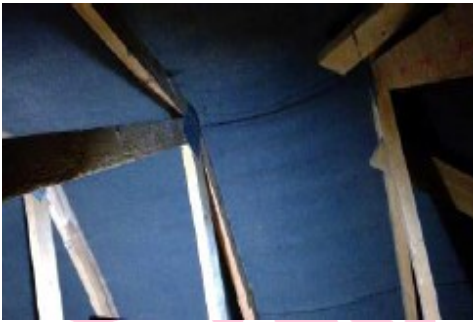
Item 14 – Ref: AN004138

The roof felt in the roof void does not contain asbestos.

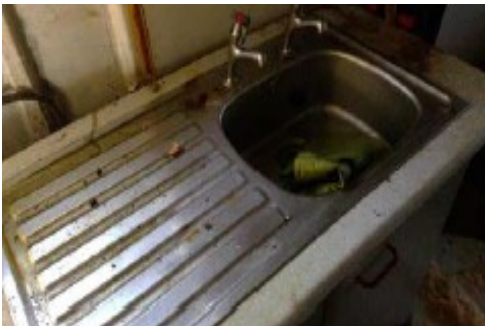
Item 15 – Ref: AN004140

The sink pad in the garage does not contain asbestos.
