### ASBESTOS SURVEY REPORT FOR 24 CHISWICK SQUARE, SUNDERLAND

**24 CHISWICK SQUARE, SUNDERLAND**

**Date: 17 September 2024**

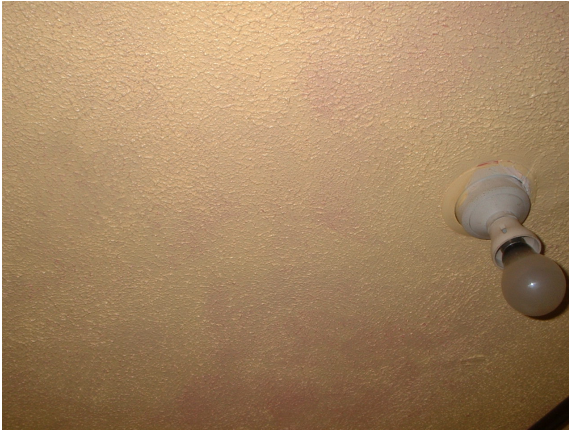
**Item 1 Ref: Sample 01**

The textured coating to the ceiling in the bathroom does not contain asbestos.

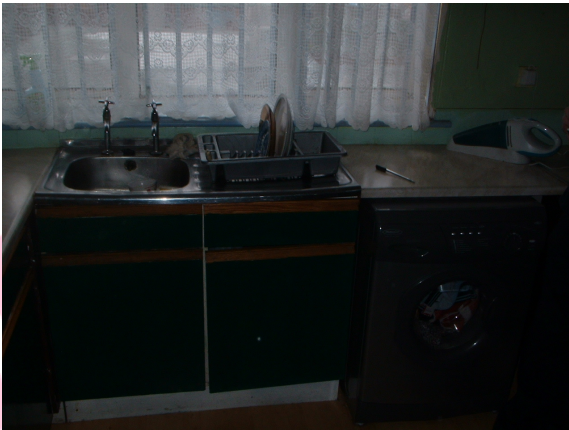
**Item 2 - Ref: Sample 02**

The sink pad to the kitchen does not contain asbestos.

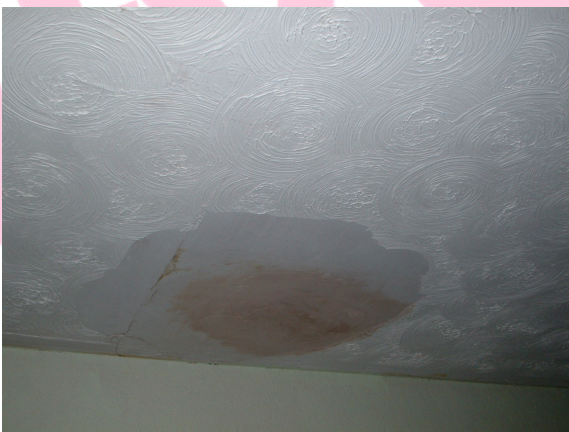
**Item 3 - Ref: Sample 03**

The textured coating to the ceiling in the kitchen does not contain asbestos.

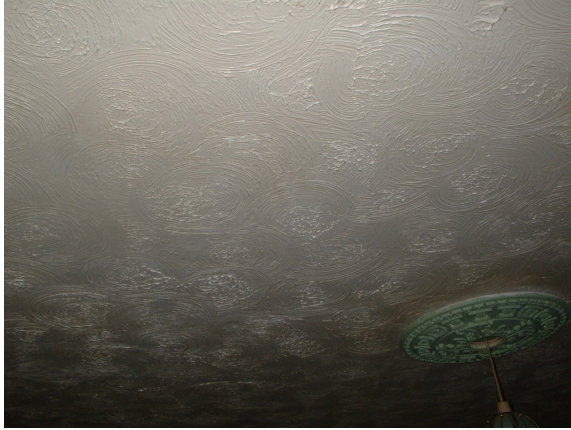
**Item 4 - Ref: Sample 04**

The textured coating to the ceiling in the living room does not contain asbestos.

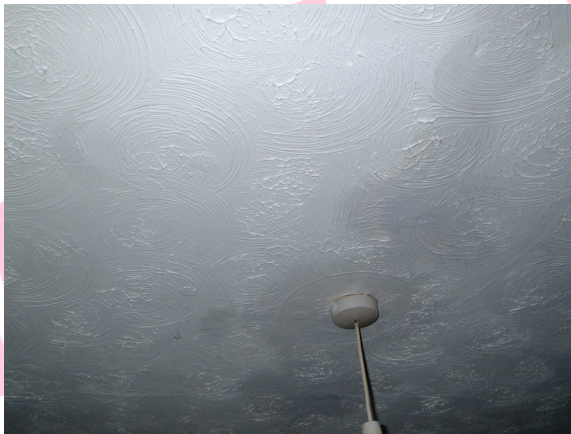
**Item 5 - Ref: Sample 05**

The textured coating to the ceiling in the bedroom does not contain asbestos.

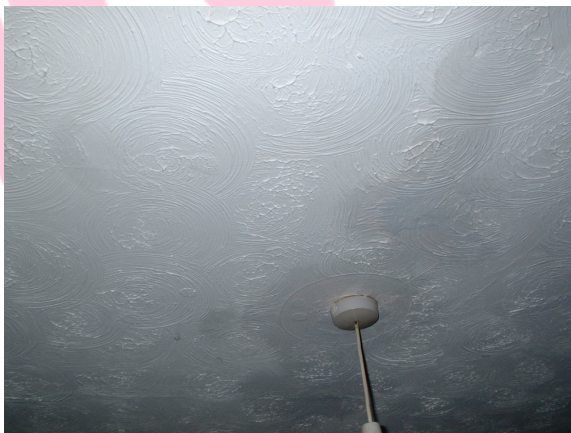
**Item 6 - Ref: Sample 06**

The textured coating to the ceiling in the corridor does not contain asbestos.

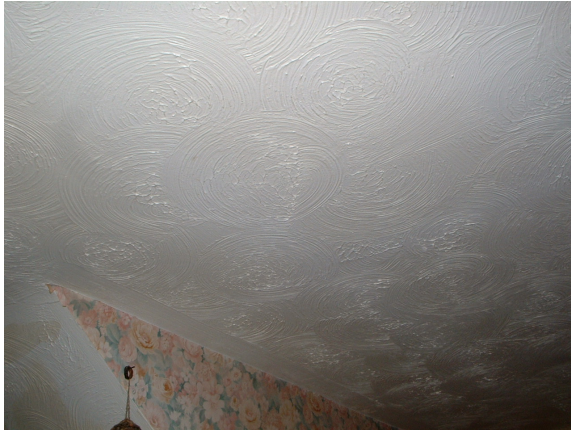
**Item 7 - Ref: Sample 07**

The textured coating to the ceiling in the bedroom does not contain asbestos.

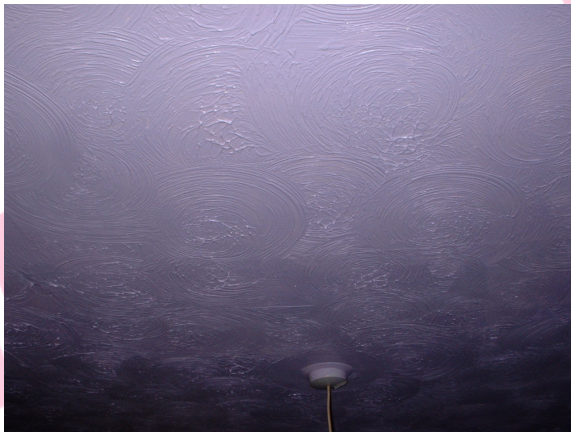
**Item 8 - Ref: Sample 08**

The textured coating to the ceiling in the bedroom does not contain asbestos.

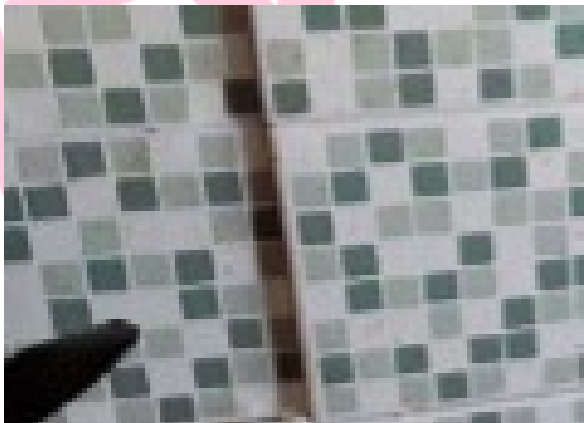
**Item 9 - Ref: 20-27625-2**

The ceramic tile adhesive in the kitchen does not contain asbestos.

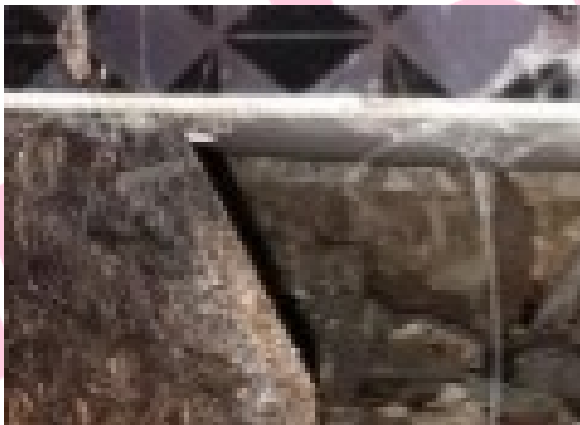
**Item 11 - Ref: 20-27625-4**

The debris under the sink unit does contain asbestos.

Noted as removed on reinspection survey 2024

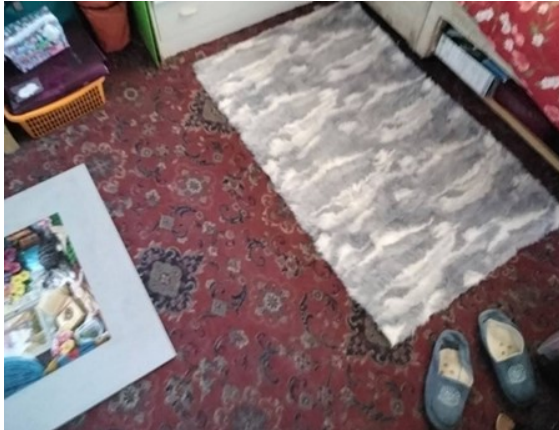
**Item 13 - Ref: SC004900**

The Floor tile under floor covering (Bedroom 3 Rm 2/005) does contain asbestos.

Noted as removed on survey 2023.

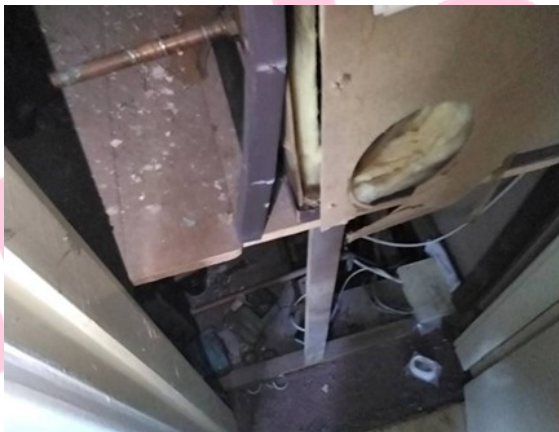
**Item 14 - Ref: SC004897**

The Tank with associated debris to floor (Heating Cupboard Rm 3/005) does not contain asbestos.

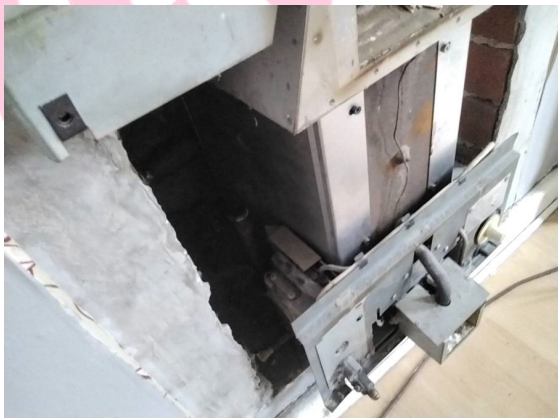
**Item 15 - Ref: SC004975**

The joint/gasket debris (Living Rm/Lounge Rm 1/001) does not contain asbestos.

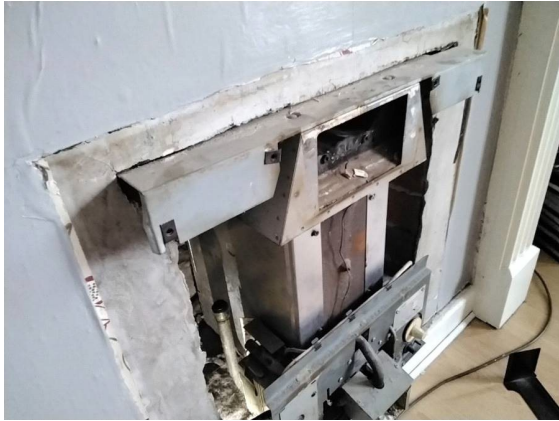
**Item 16 - Ref: SC004976**

The paper/card product debris (Living Rm/Lounge Rm 1/001) does not contain asbestos.

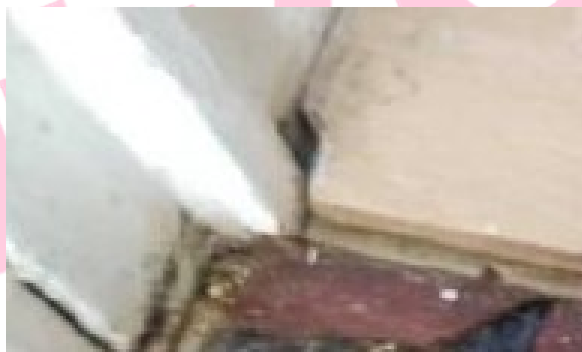
**Item 21 - Ref: 23-62130-3**

The tile and adhesive remnants at doorway in Bedroom 1 (Area 010) does contain asbestos.

Any change in appearance should be reported to Property Services.

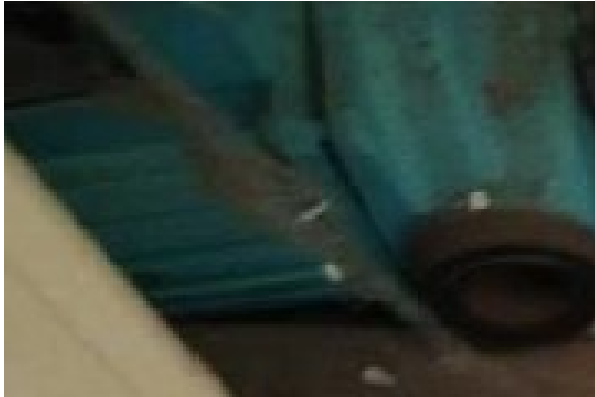
**Item 22 - Ref: 23-62130-8**

The gasket debris to floor in the Boiler/Heating Cupboard (Area 012) does not contain asbestos.

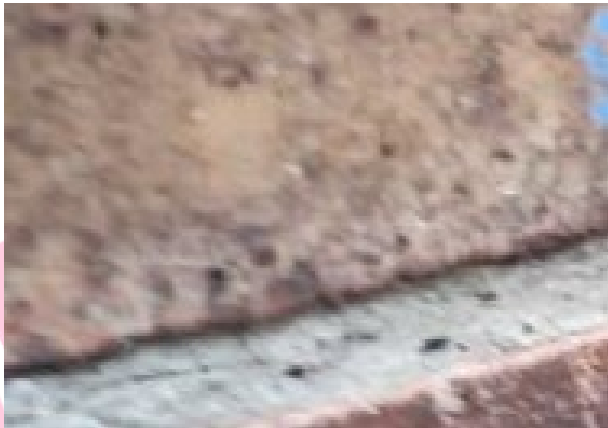
**Item 23 - Ref: 23-62130-10**

The damp proof course to wall External (Area 019) does contain asbestos.

Any change in appearance should be reported to Property Services.

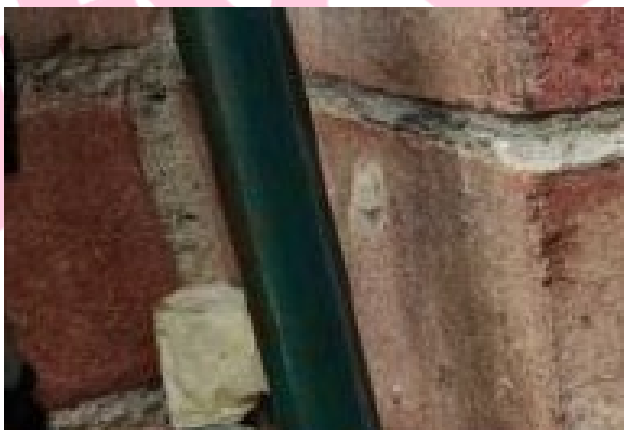
**Item 24 - Ref: 23-62130-9**

The sealant to the door frame External (Area 019) does contain asbestos.

Any change in appearance should be reported to Property Services.
