### ASBESTOS SURVEY REPORT FOR 1 NOOKSIDE, SUNDERLAND, SR4 8PH

**1 Nookside, Sunderland, SR4 8PH**

**Date: 30 May 2024**

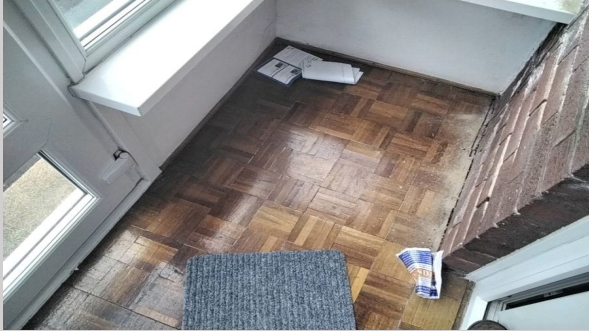
1.	KX001839	Floor adhesive to wooden tiles	Porch (Room G/001)	No Risk

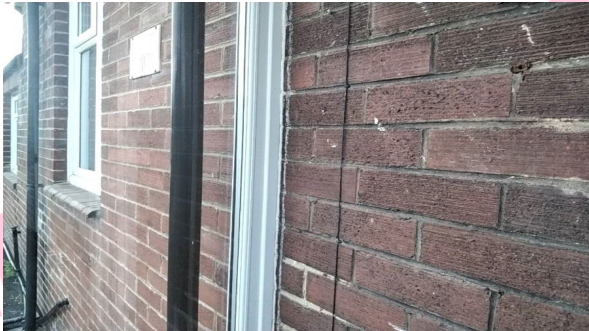
2.	KX001840	Wall sealant remnants from removal of previous windows	Porch (Room G/001)	Removed August 2023

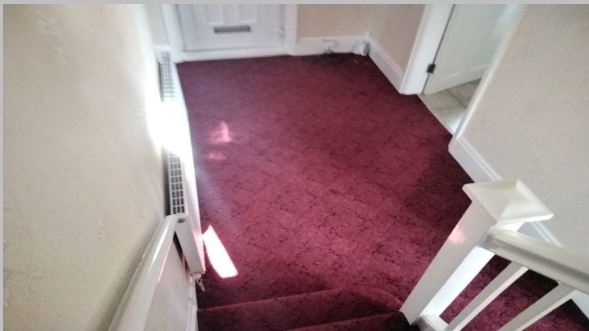
3.	KX001841	Floor covering under carpet	Entrance Hall/Foyer/Lobby including stairs (Room G/002)	No Risk

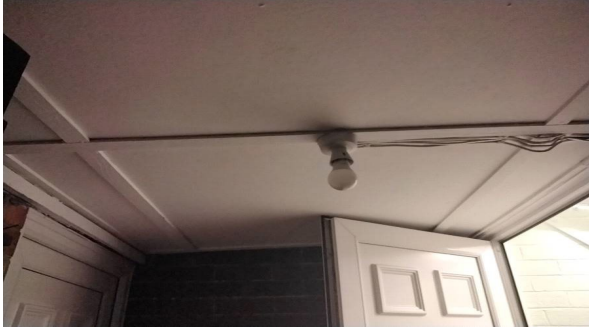
7.	KX001844	Ceiling	Hallway/Passageway (Room G/008)	Removed August 2023

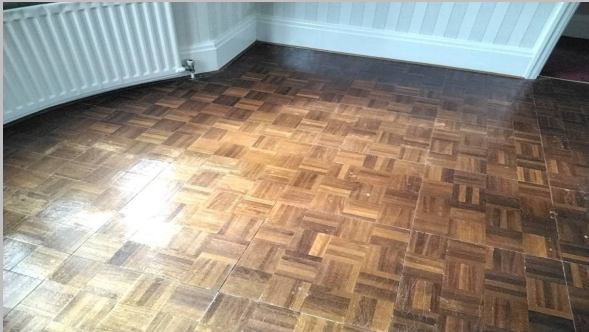
8.	As KX001839	Floor adhesive to wooden tiles	Dining Room (Room G/011)	No Risk

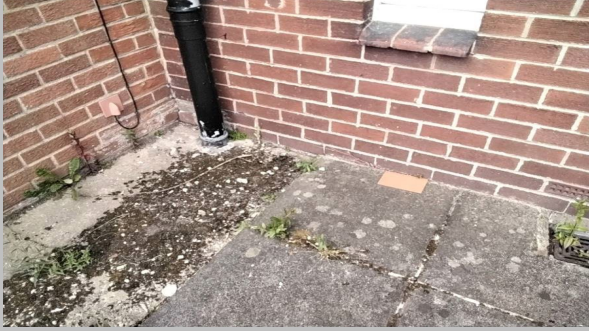
9.	KX001845	Damp Proof Course	External (E/001)	No Risk
