ASBESTOS SURVEY REPORT FOR ELDON GROVE ACADEMY, ELDON GROVE, HARTLEPOOL, TS26 9LY

## **Asbestos Register for Eldon Grove Academy**

**Date: 18 September 2024**

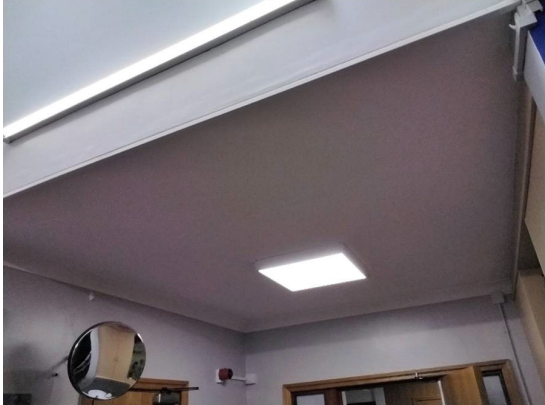
1	SC004854	Ceiling Coating	Main building Ground Floor, Corridor (Room G/002)	Does not contain asbestos.

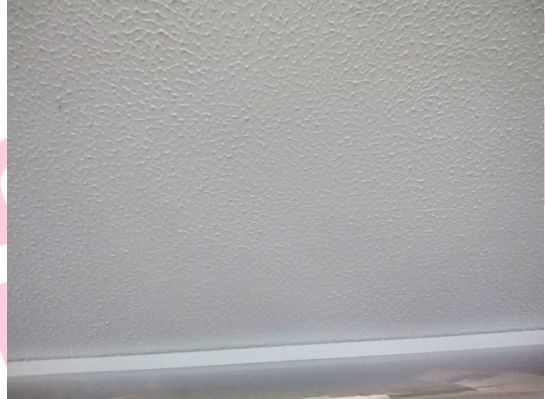
2	SC004856	Ceiling Coating	Main building Ground Floor, Corridor (Room G/004)	Does not contain asbestos.

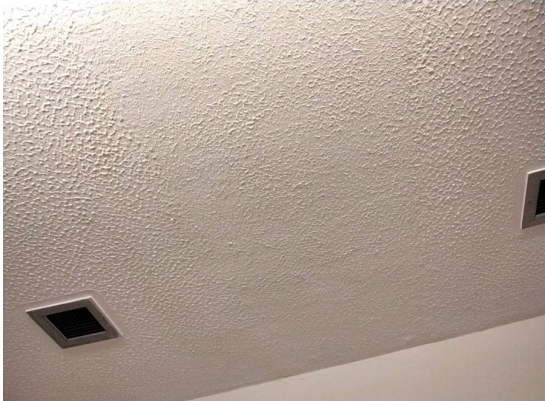
3	As SC004854	Ceiling Coating	Main building Ground Floor, Toilets Disabled (Room G/005)	Does not contain asbestos.

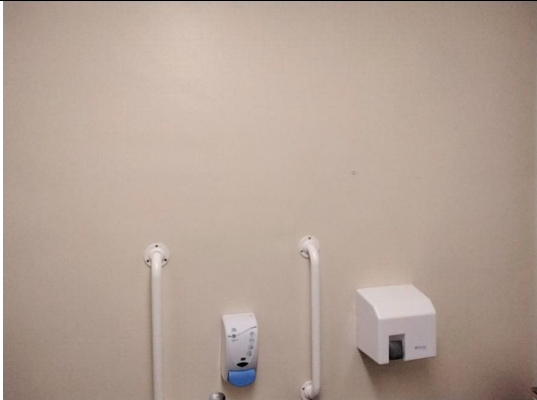
4	SC004855	Wall Coating	Main building Ground Floor, Toilets Disabled (Room G/005)	Does not contain asbestos.

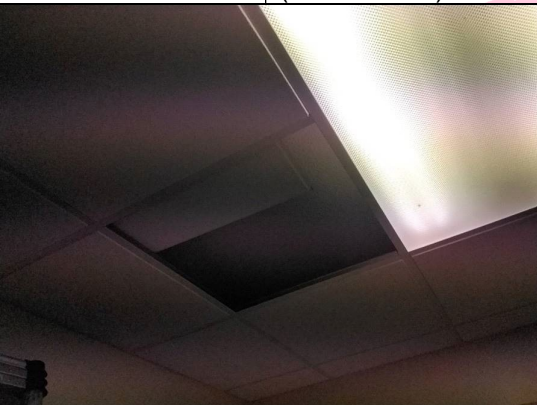
5	As SC004854	Ceiling Coating	Main building Ground Floor, Social Inclusion (Room G/006)	Does not contain asbestos.

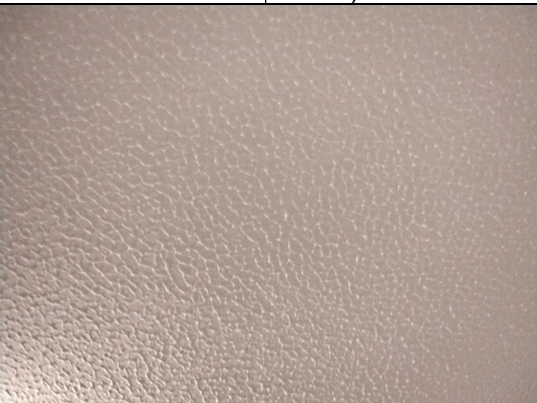
6	As SC004854	Ceiling Coating	Main building Ground Floor, Electrical Cupboard (Room G/009)	Does not contain asbestos.

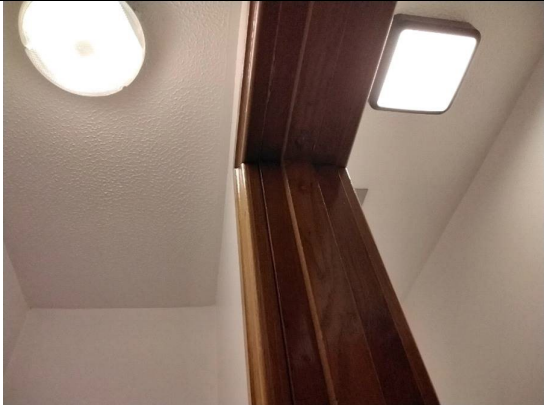
10	As SC004858	Ceiling Coating	Main building Ground Floor, Toilets Staff (Room G/013)	Does not contain asbestos.

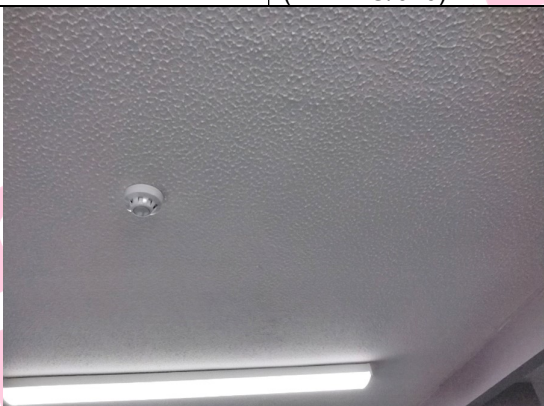
11	SC004859	Ceiling Coating	Main building Ground Floor, Classroom 1 (Room G/016)	Does not contain asbestos.

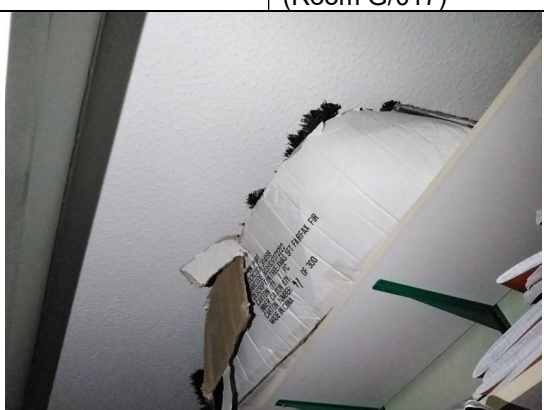
12	As SC004859	Ceiling Coating	Main building Ground Floor, Cupboard (Room G/017)	Does not contain asbestos.

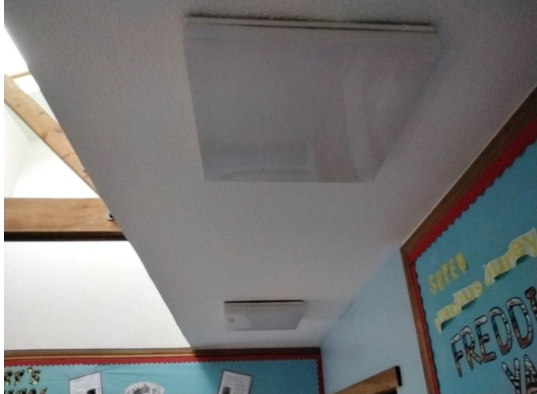
16	As SC004859	Ceiling Coating	Main building Ground Floor, Upper Cloakroom (Room G/022)	Does not contain asbestos.

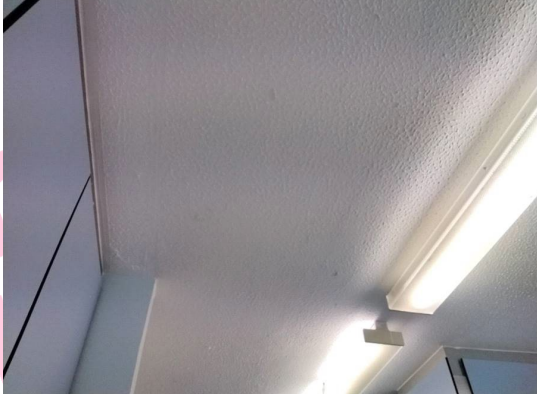
17	SC004860	Ceiling Coating	Main building Ground Floor, Toilets Male (Room G/023)	Does not contain asbestos.

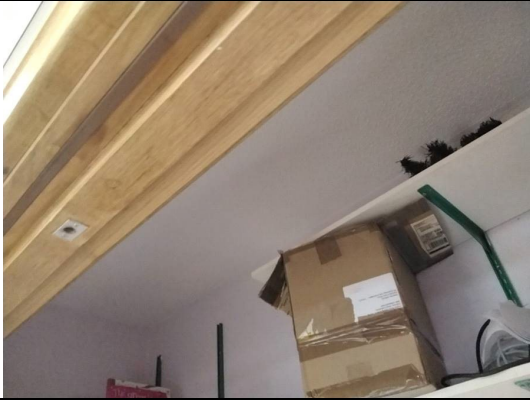
22	As SC004861	Ceiling Coating	Main building Ground Floor, Cupboard (Room G/039)	Does not contain asbestos.

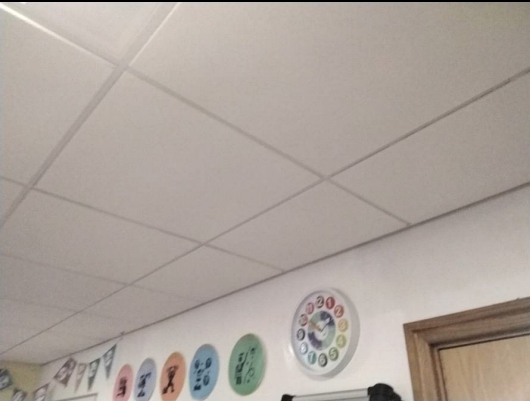
23	As SC004861	Ceiling Coating	Main building Ground Floor, Classroom 8 (Room G/041)	Does not contain asbestos.

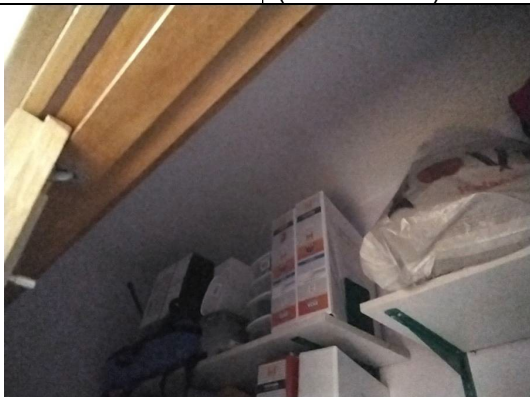
24	As SC004861	Ceiling Coating	Main building Ground Floor, Cupboard (Room G/042)	Does not contain asbestos.

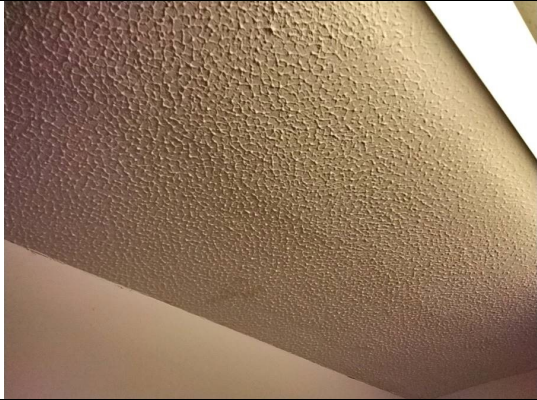
25	SC004862	Ceiling Coating	Main building Ground Floor, Photo copy room (Room G/043)	Does not contain asbestos.

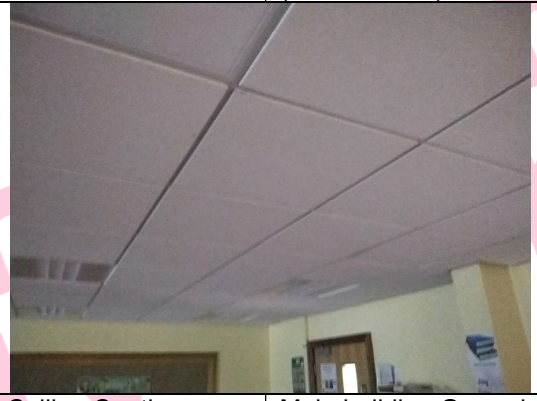
26	As SC004862	Ceiling Coating	Main building Ground Floor, Classroom 9 (Room G/044)	Does not contain asbestos.

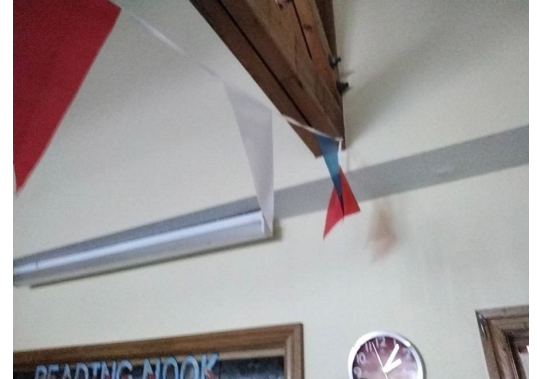
27	As SC004862	Ceiling Coating	Main building Ground Floor, Classroom 10 (Room G/045)	Does not contain asbestos.

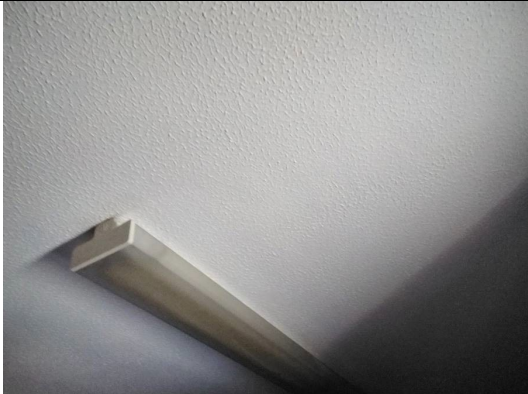
34	As SC004863	Ceiling Coating	Main building Ground Floor, Female Toilets (Room G/050)	Does not contain asbestos.

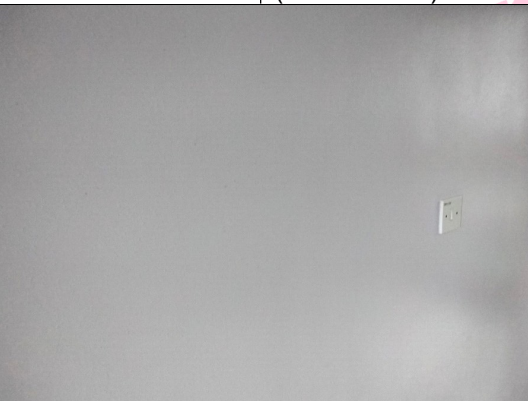
35	As SC004864	Wall Coating	Main building Ground Floor, Female Toilets (Room G/050)	Does not contain asbestos.

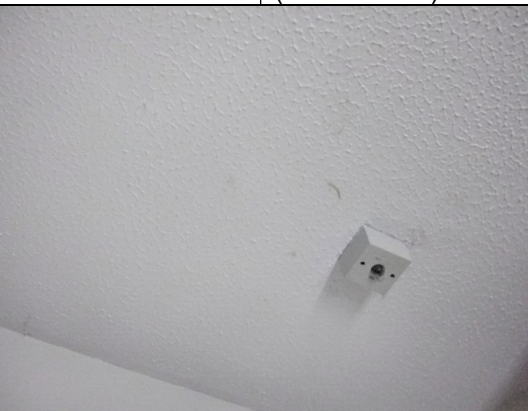
36	As SC004863	Ceiling Coating	Main building Ground Floor, Male Toilets (Room G/051)	Does not contain asbestos.

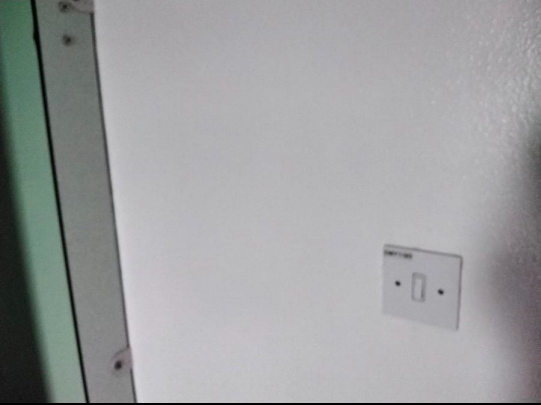
37	As SC004864	Wall Coating	Main building Ground Floor, Male Toilets (Room G/051)	Does not contain asbestos.

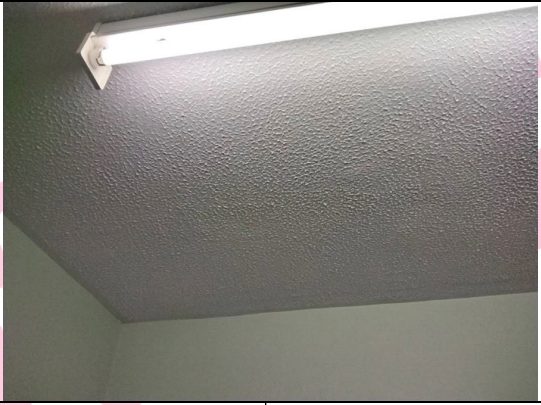
38	As SC004863	Ceiling Coating	Main building Ground Floor, Changing Room (Room G/052)	Does not contain asbestos.

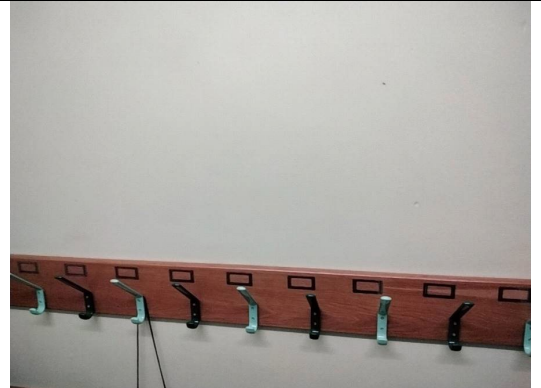
39	As SC004864	Wall Coating	Main building Ground Floor, Changing Room (Room G/052)	Does not contain asbestos.

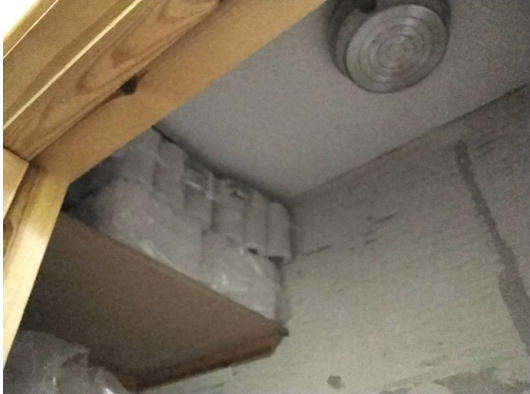
40	As SC004863	Ceiling Coating	Main building Ground Floor, Cleaners Cupboard (Room G/053)	Does not contain asbestos.

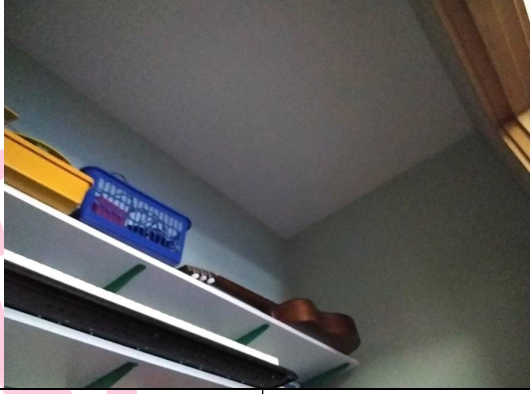
41	As SC004863	Ceiling Coating	Main building Ground Floor, Cupboard (Room G/055)	Does not contain asbestos.

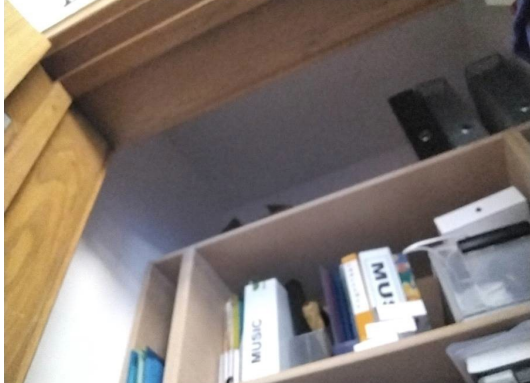
42	As SC004863	Ceiling Coating	Main building Ground Floor, Cupboard (Room G/056)	Does not contain asbestos.

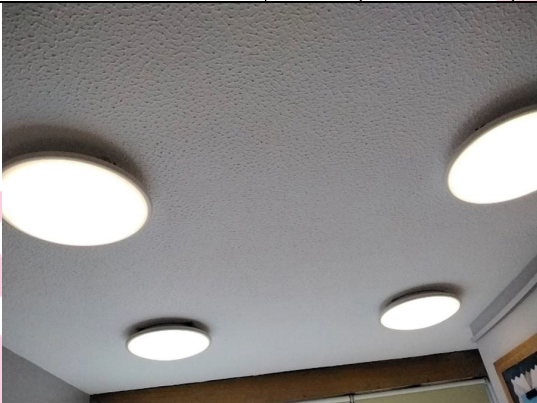
44	As SC004865	Ceiling Coating	Main building Ground Floor, Headteachers Office (Room G/059)	Does not contain asbestos.

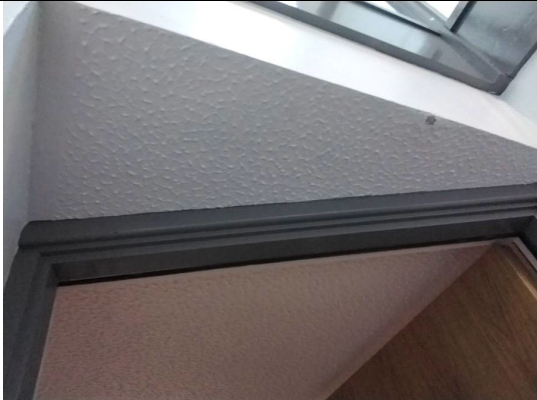
46	As SC004865	Ceiling Coating	Main building Ground Floor, Stairwell (Room G/062)	Does not contain asbestos.

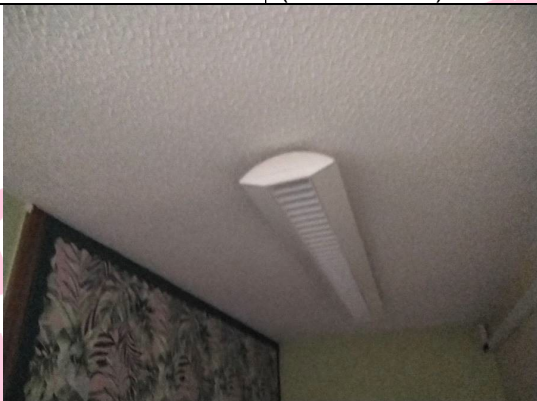
47	As SC004865	Ceiling Coating	Main building Ground Floor, Classroom 12 (Room G/063)	Does not contain asbestos.

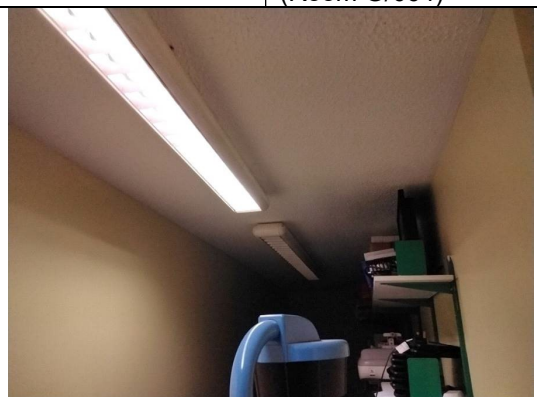
48	As SC004865	Ceiling Coating	Main building Ground Floor, Store Cupboard (Room G/064)	Does not contain asbestos.

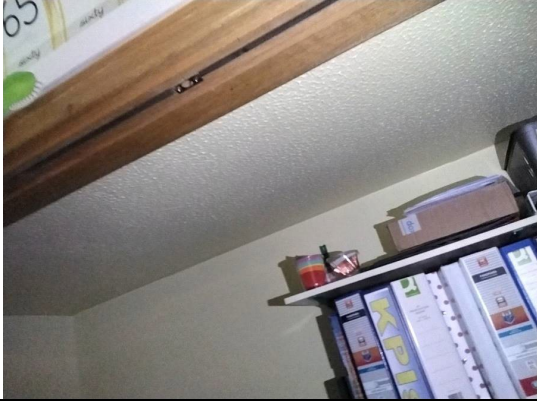
49	As SC004865	Ceiling Coating	Main building Ground Floor, Cupboard (Room G/065)	Does not contain asbestos.

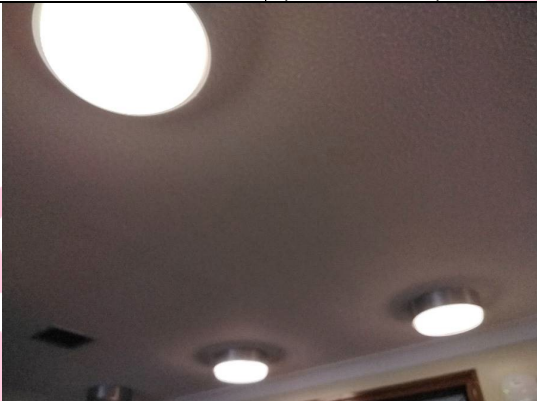
50	SC004866	Ceiling Coating	Main building Ground Floor, Classroom 13 (Room G/066)	Does not contain asbestos.

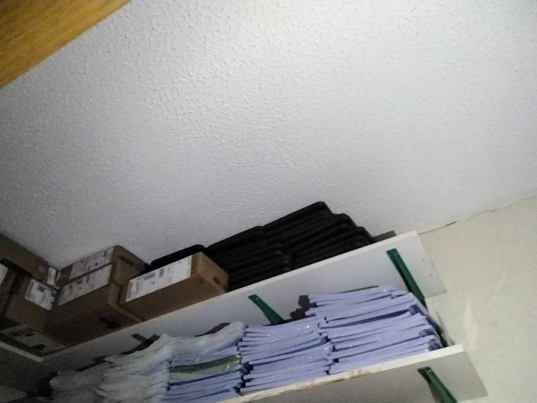
51	As SC004866	Ceiling Coating	Main building Ground Floor, Server Cupboard (Room G/067)	Does not contain asbestos.

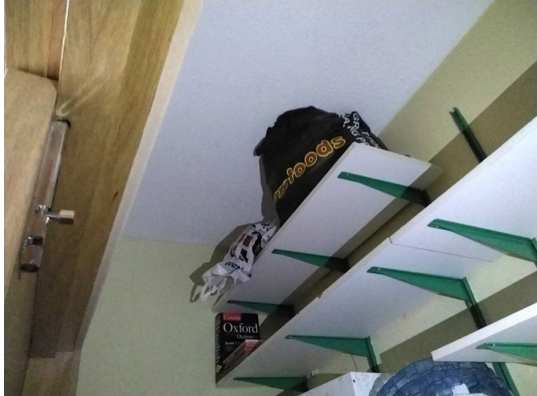
55	As SC004867	Ceiling Coating	Main building Ground Floor, Cupboard (Room G/073)	Does not contain asbestos.

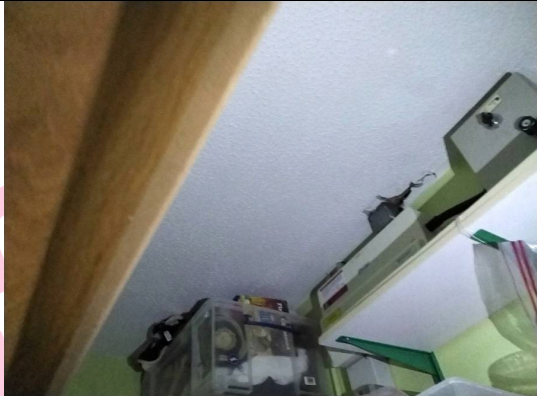
56	As SC004867	Ceiling Coating	Main building Ground Floor, Cupboard (Room G/074)	Does not contain asbestos.

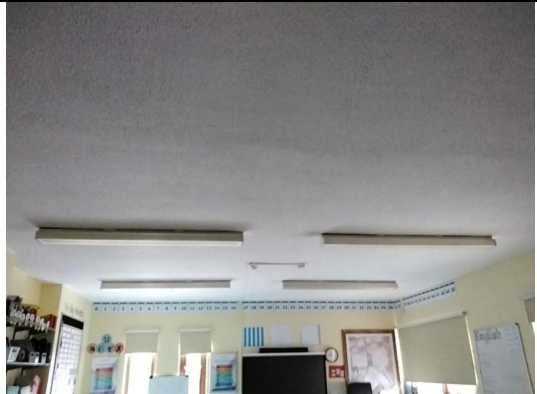
57	SC004868	Ceiling Coating	Main building Ground Floor, Classroom 15 (Room G/076)	Does not contain asbestos.

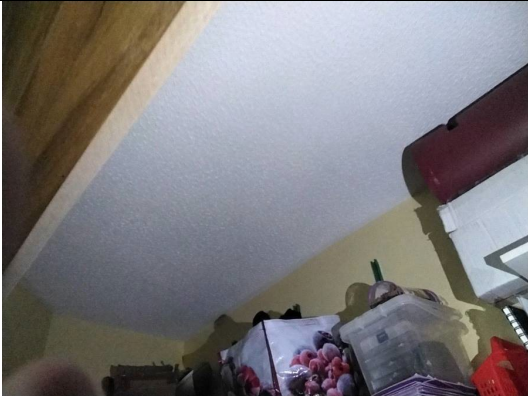
58	As SC004868	Ceiling Coating	Main building Ground Floor, Cupboard (Room G/077)	Does not contain asbestos.

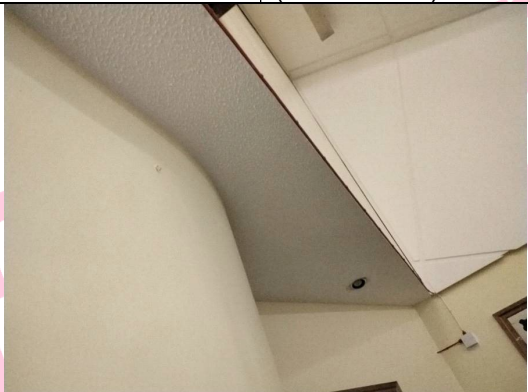
59	As SC004868	Ceiling Coating	Main building Ground Floor, Classroom 16 (Room G/078)	Does not contain asbestos.

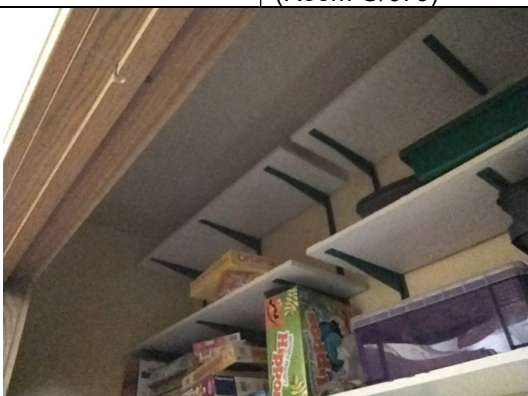
60	As SC004868	Ceiling Coating	Main building Ground Floor, Cupboard (Room G/079)	Does not contain asbestos.

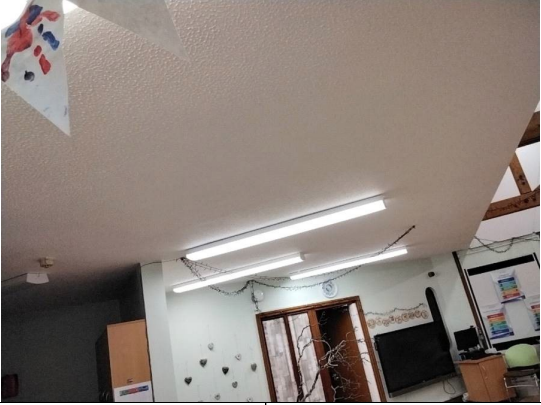
64	As SC004869	Ceiling Coating	Main building Ground Floor, Nursery (Room G/084)	Does not contain asbestos.

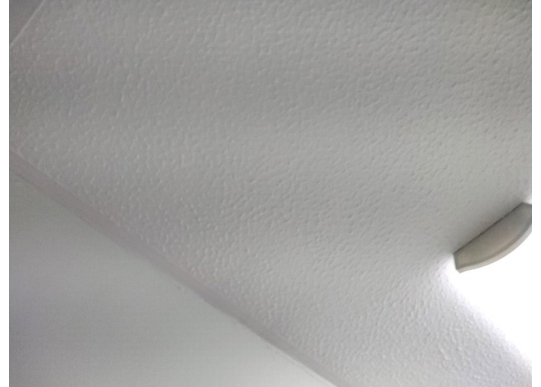
66	SC004870	Ceiling Coating	Main building Ground Floor, Staff WC (Room G/087)	Does not contain asbestos.

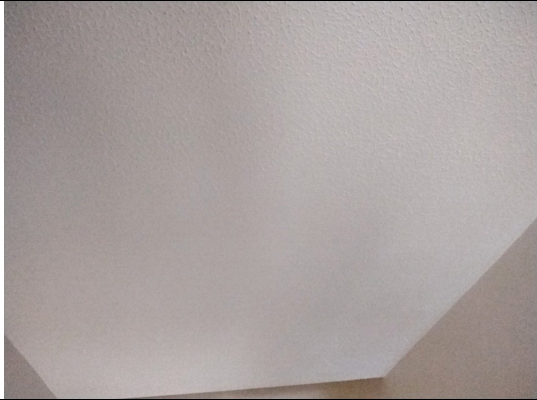
73	SC004873	Ceiling Coating	Main building First Floor Landing (Room 1/006)	Does not contain asbestos.

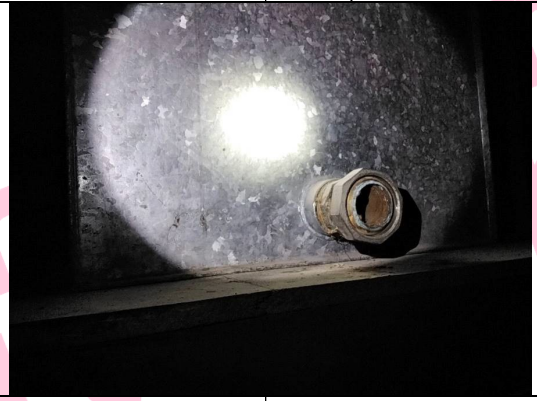
74	SC004887	Tank Pipework Gasket	Main building Roof void Loft space (Room R/001)	Does not contain asbestos.

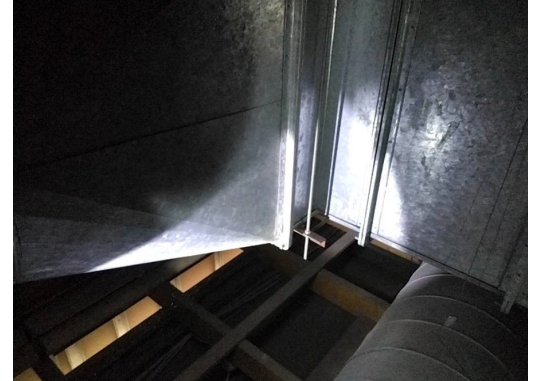
75	SC004888	Ductwork joints	Main building Roof void Loft space (Room R/001)	Does not contain asbestos.

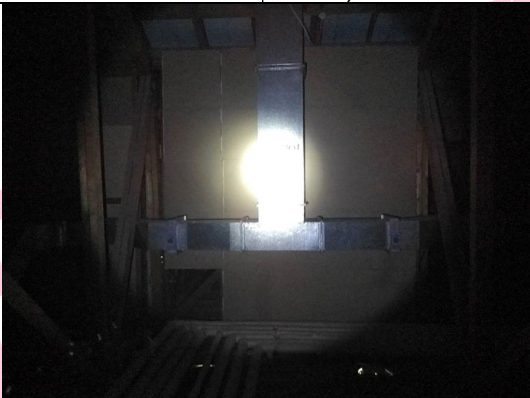
80	As SC004888	Ductwork joints	Main building Roof void Loft space (Room R/006)	Does not contain asbestos.

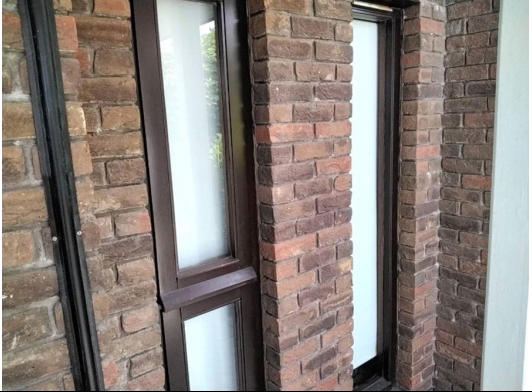
94	As SC004877	Window putty/seal	Main building External (Room E/003)	Does not contain asbestos.

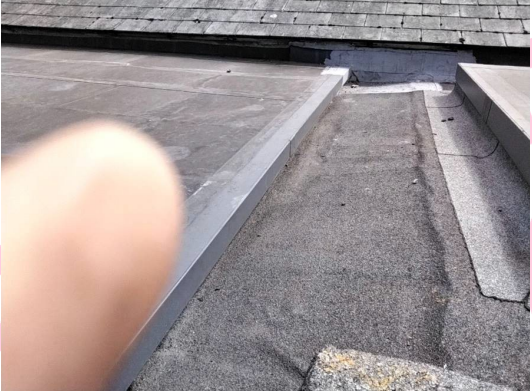
95	SC004878	Roof felt below all rubber coverings	Main building External (Room E/003)	Does not contain asbestos.

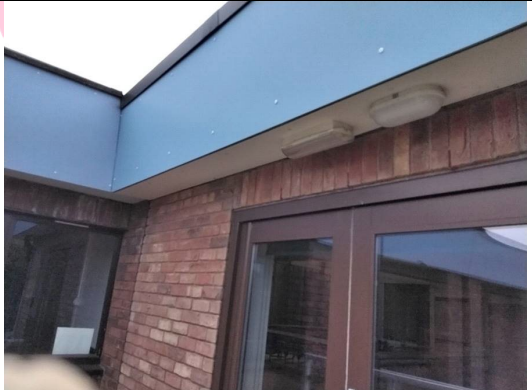
96	SC004879	Soffits to building perimeter	Main building External (Room E/003)	Does not contain asbestos.

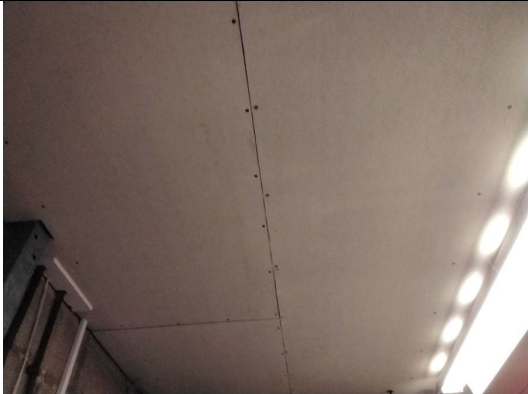
100	SC004882	Ceiling	Main building External Plant Room (Room E/006)	Does not contain asbestos.

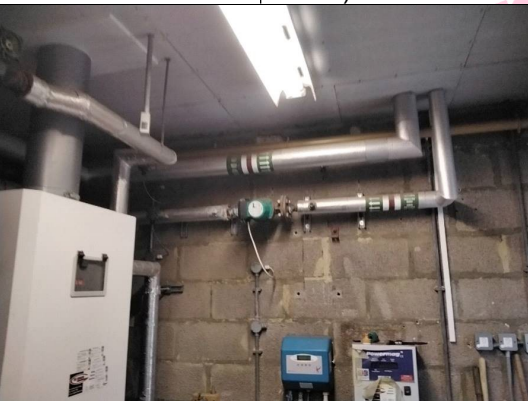
101	SC004883	Pipework Gaskets	Main building External Plant Room (Room E/006)	Does not contain asbestos.

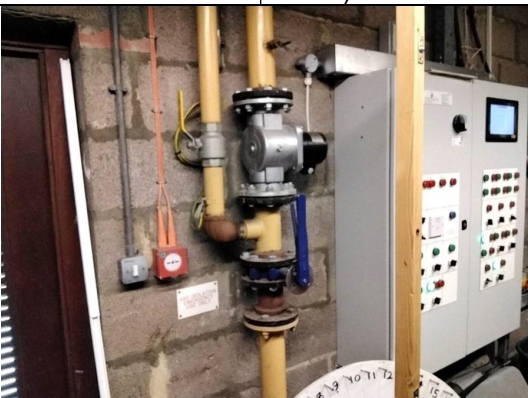
102	SC004884	Pipework Gaskets	Main building External Plant Room (Room E/006)	Does not contain asbestos.

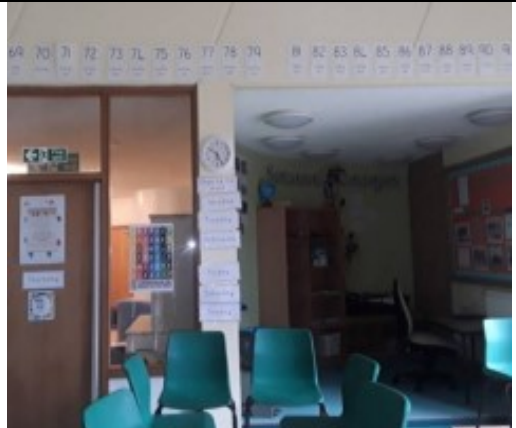
111	As NZ001422	Ceiling – coating to lower ceiling above entrance's and within alcove's	Main building Ground Floor Classroom D (Room G/004)	Does not contain asbestos.
