ASBESTOS SURVEY REPORT FOR ROSSMERE ACADEMY, CATCOTE ROAD, HARTLEPOOL, TS25 3JL.

Rossmere Academy, Hartlepool

Date: 13 February 2025

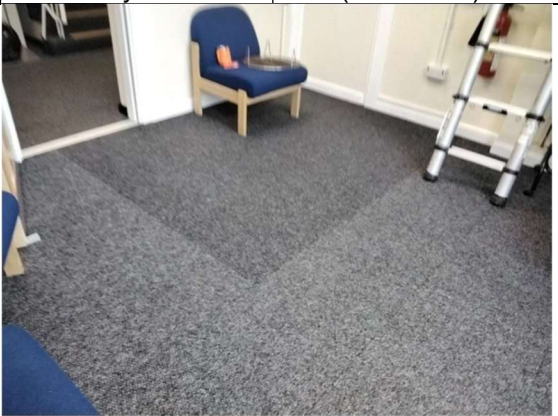
1	KX001572	Floor screed under lino and modern screed layer	Block A Ground Floor Reception Entrance Hall (Room 001)	Does not contain asbestos.

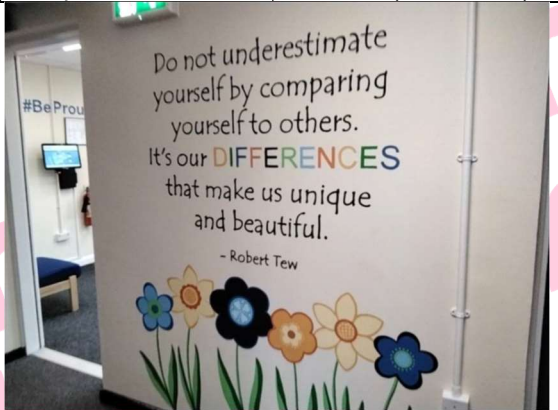
2	KX001573	Wall Coating fire flex paint	Block A Ground Floor Corridor (Room 014)	Does not contain asbestos.

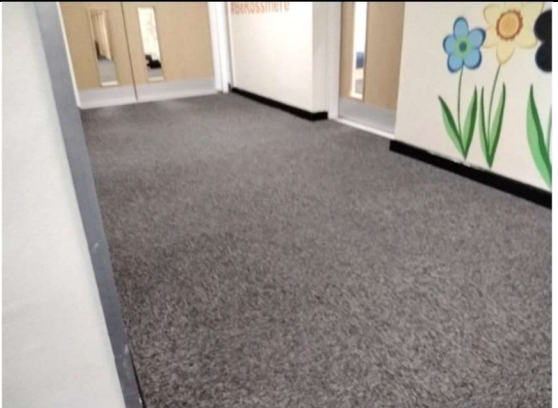
3	As KX001572	Floor screed under carpet and modern screed layer	Block A Ground Floor Corridor (Room 014)	Does not contain asbestos.

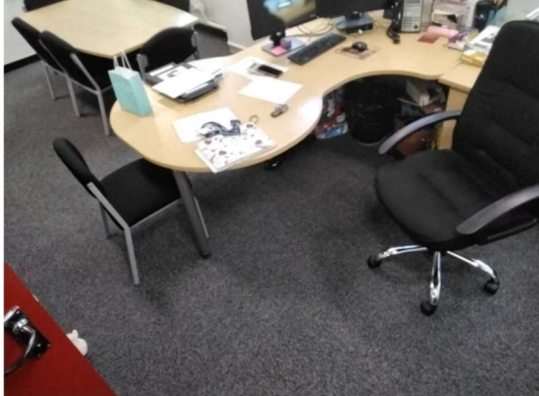
4	As KX001572	Floor screed under carpet and modern screed layer	Block A Ground Floor Office (Room 002)	Does not contain asbestos.

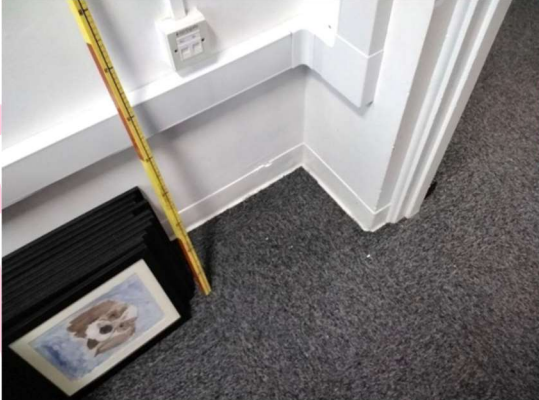
5	KX001574	Wall skirting	Block A Ground Floor Office (Room 002)	Contains asbestos - Any change in appearance should be recorded and passed to Property Services.

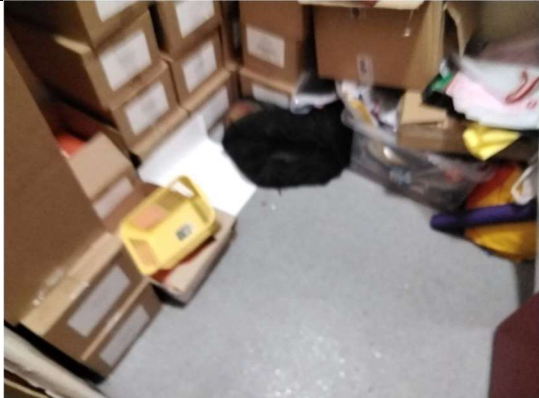
6	As KX001572	Floor screed under lino and modern screed layer	Block A Ground Floor Cupboard Store (Room 003a)	Does not contain asbestos.

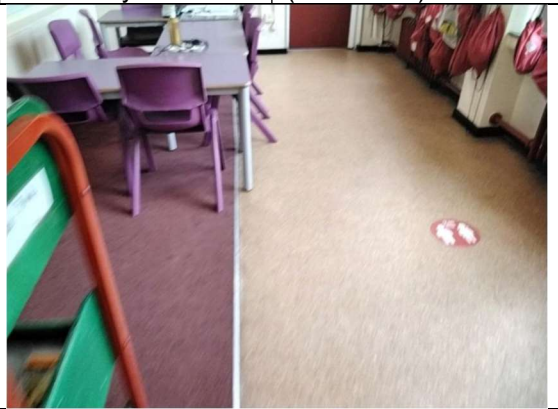
10	As KX001572	Floor screed under carpet and modern screed layer	Block A Ground Floor Hallway Passageway (Room 007)	Does not contain asbestos.

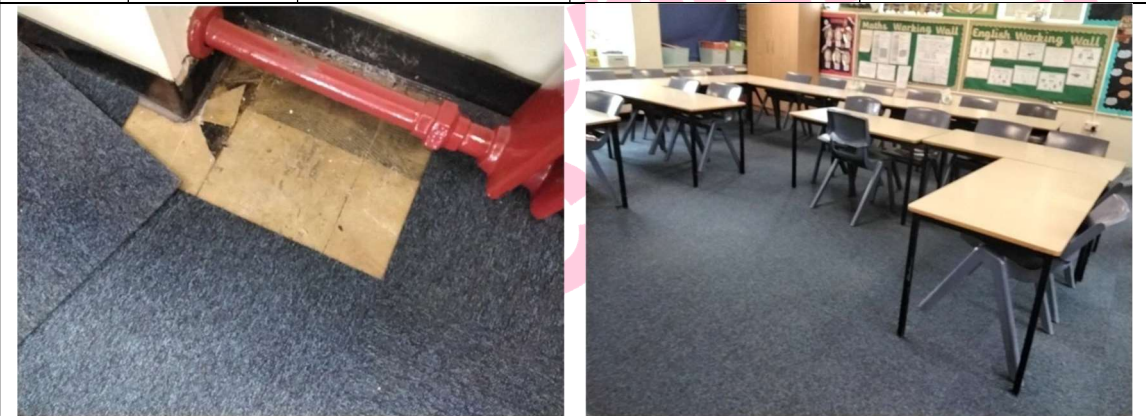
11	KX001576	Floor tile (under floor covering) black and grey below carpet	Block A Ground Floor Classroom (Room 006)	Contains asbestos - Any change in appearance should be recorded and passed to Property Services.

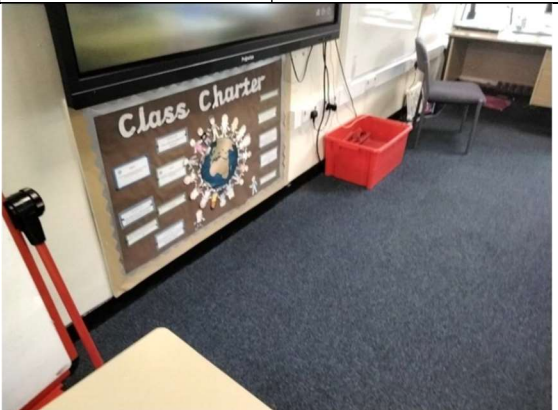
12	KX001577	Wall Skirting	Block A Ground Floor Classroom (Room 006)	Contains asbestos - Any change in appearance should be recorded and passed to Property Services.

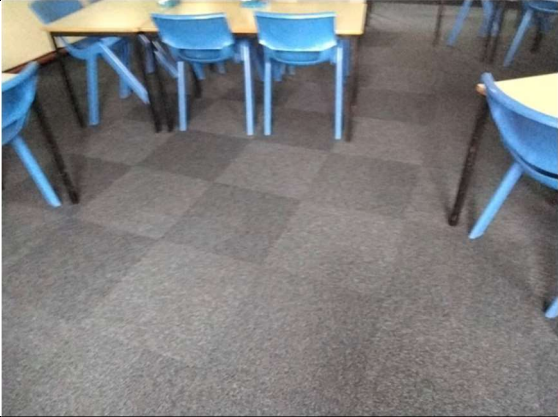
13	As KX001576	Floor tile (under floor covering) black and grey below carpet	Block A Ground Floor Classroom (Room 008)	Contains asbestos - Any change in appearance should be recorded and passed to Property Services.

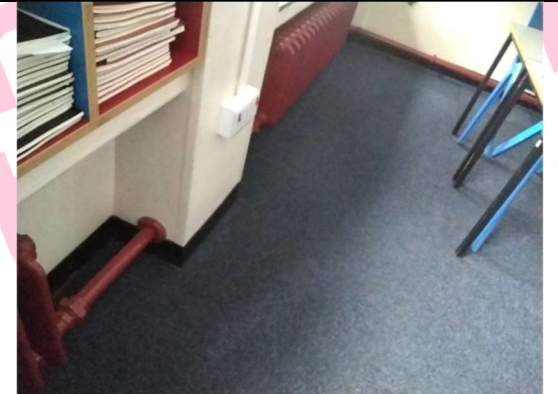
14	As KX001577	Wall Skirting	Block A Ground Floor Classroom (Room 008)	Contains asbestos - Any change in appearance should be recorded and passed to Property Services.

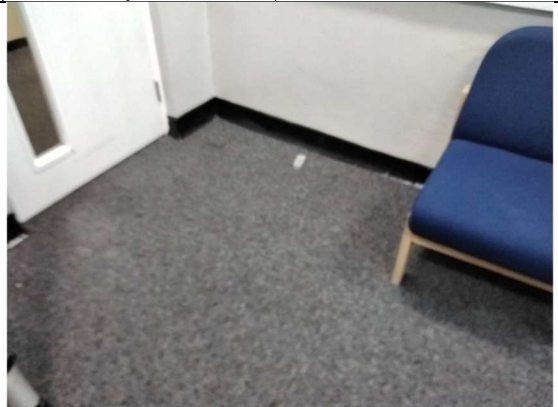
15	As KX001572	Floor screed under lino and modern screed layer	Block A Ground Floor Office (Room 010)	Does not contain asbestos.

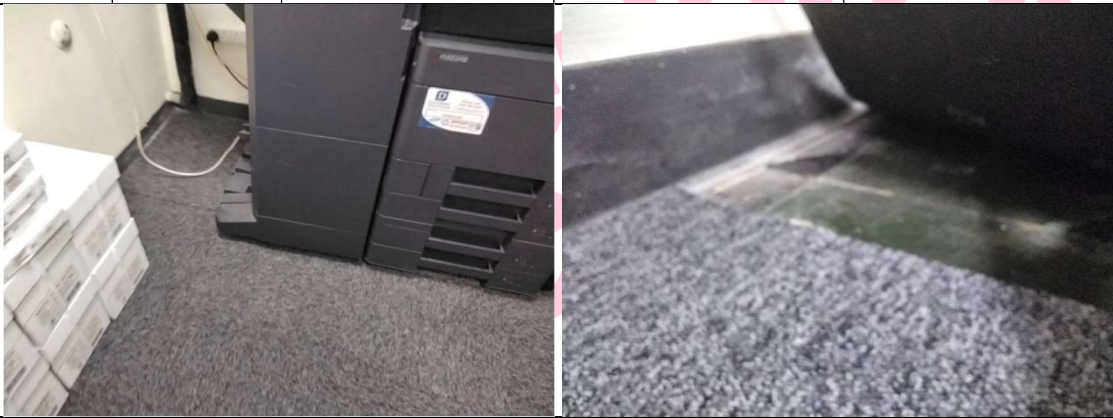
17	KX001579	Floor tile (under floor covering) black, green and grey	Block A Ground Floor Medical/First Aid (Room 015)	Contains asbestos - Any change in appearance should be recorded and passed to Property Services.

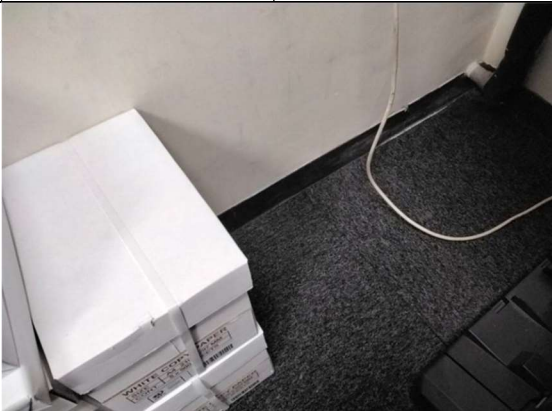
18	KX001580	Wall Skirting	Block A Ground Floor Medical/First Aid (Room 015)	Contains asbestos - Any change in appearance should be recorded and passed to Property Services.

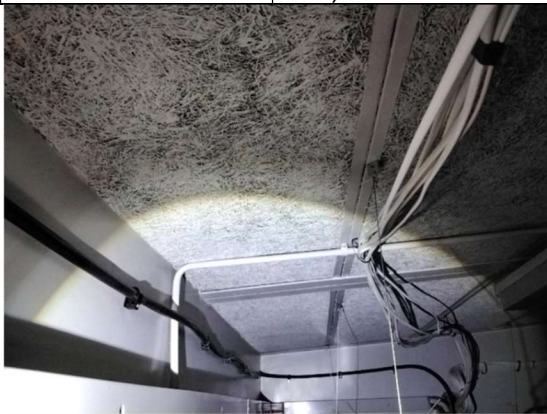
25	KX001584	Ceiling void above ceiling	Block A Ground Floor Store Room (Room 039)	Does not contain asbestos.

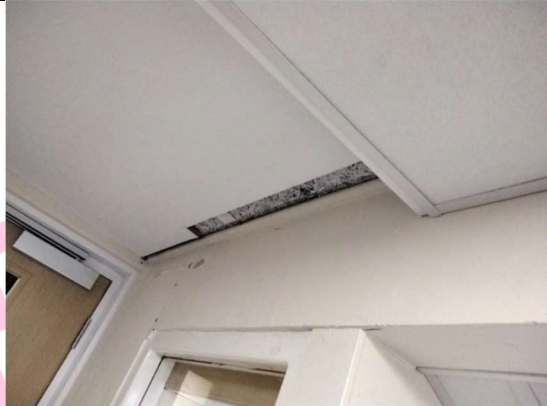
26	As KX001584	Ceiling void above ceiling	Block A Ground Floor Corridor (Room 036)	Does not contain asbestos.

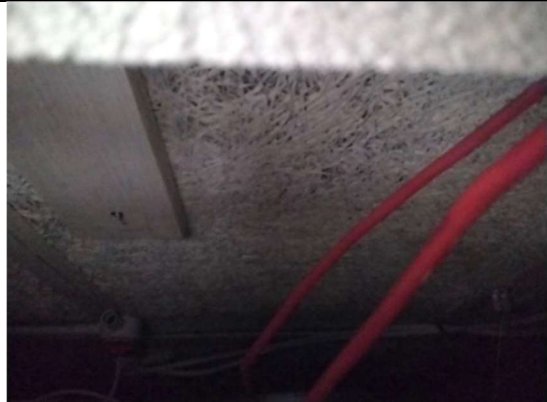
27	As KX001584	Ceiling void above ceiling	Block A Ground Floor Classroom (Room 021)	Does not contain asbestos.

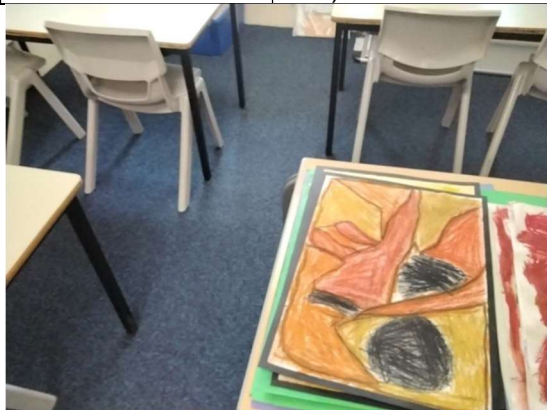
28	KX001586	Floor screed under carpet and screed	Block A Ground Floor Classroom (Room 021)	Does not contain asbestos.

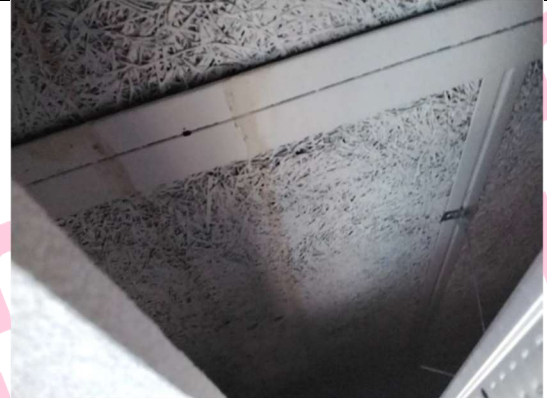
29	As KX001584	Ceiling void above ceiling	Block A Ground Floor Corridor (Room 037)	Does not contain asbestos.

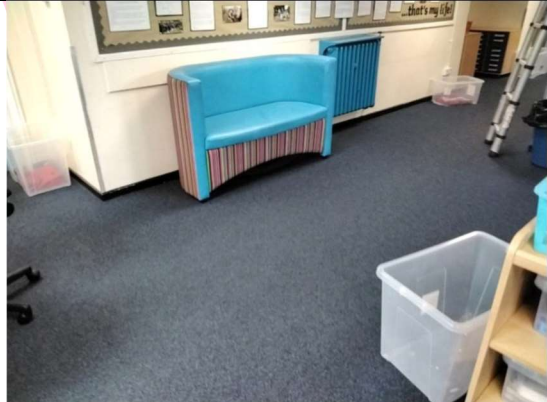
30	KX001586	Floor screed under carpet and screed	Block A Ground Floor Corridor (Room 037)	Does not contain asbestos.

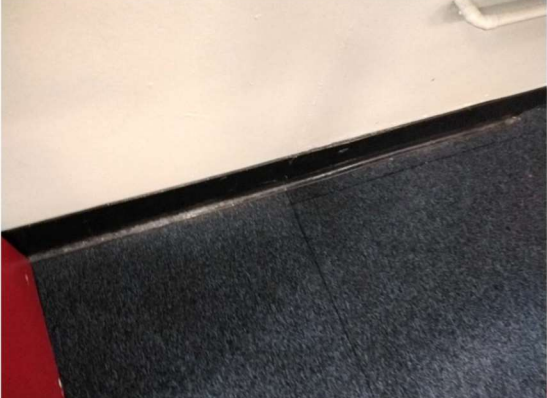
40	As KX001580	Wall Skirting	Block A Ground Floor Classroom (Room 029)	Contains asbestos - Any change in appearance should be recorded and passed to Property Services.

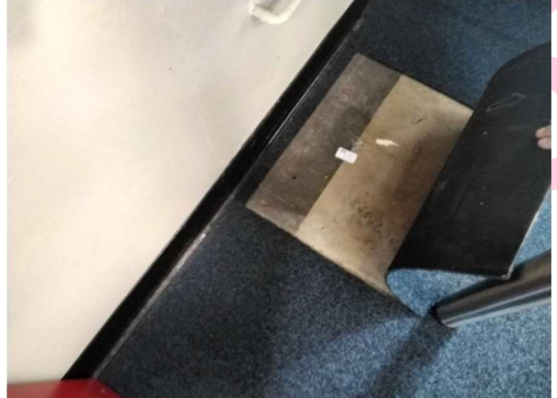
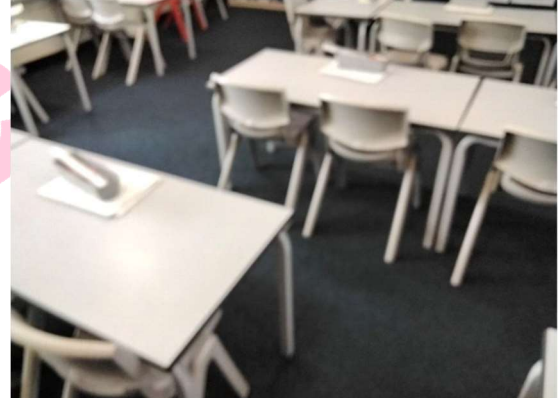
41	KX001588	Floor tile (under floor covering) brown and beige	Block A Ground Floor Classroom (Room 029)	Contains asbestos - Any change in appearance should be recorded and passed to Property Services.

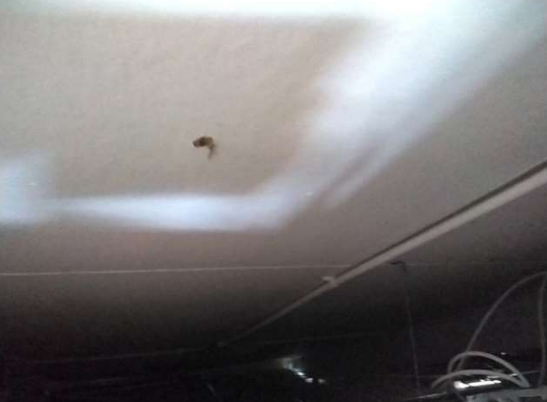
42	KX001589	Ceiling void ceiling above	Block A Ground Floor Classroom (Room 029)	Does not contain asbestos.

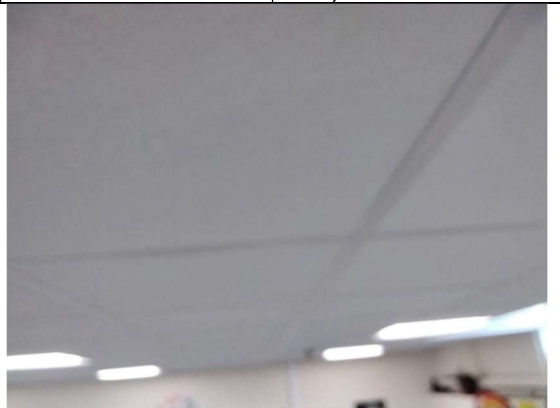
49	As KX001589	Ceiling void ceiling above	Block A Ground Floor Classroom (Room 034)	Does not contain asbestos.

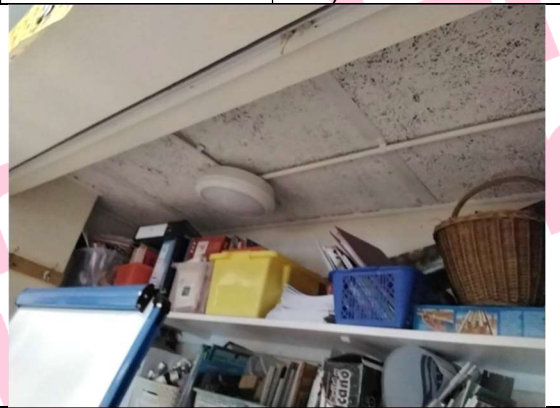
50	As KX001584	Ceiling void above ceiling	Block A Ground Floor Classroom (Room 034)	Does not contain asbestos.

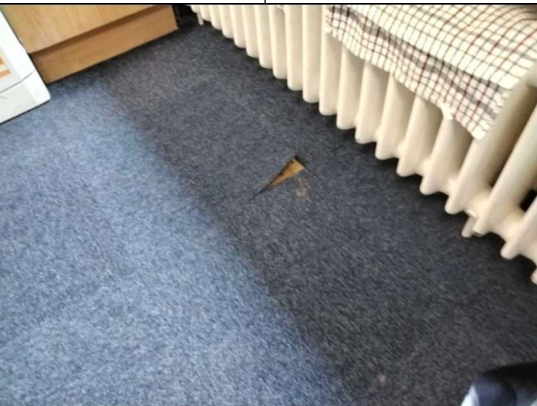
54	KX001590	Floor adhesive residue	Block A Ground Floor Staff Room (Room 041)	Contains asbestos - Any change in appearance should be recorded and passed to Property Services.

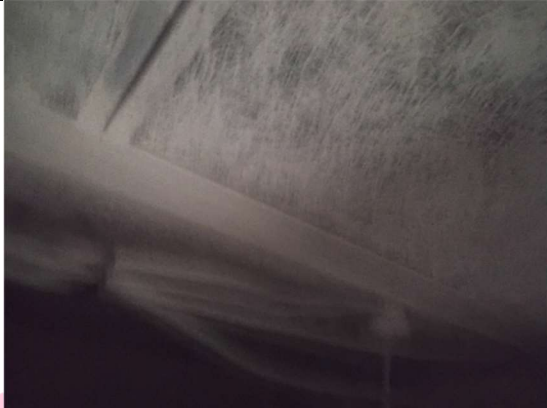
55	As KX001577	Wall Skirting	Block A Ground Floor Staff Room (Room 041)	Contains asbestos - Any change in appearance should be recorded and passed to Property Services.
No Photographic Evidence				
56	KX001591	Ceiling void ceiling above	Block A Ground Floor Corridor (Room 060)	Does not contain asbestos.

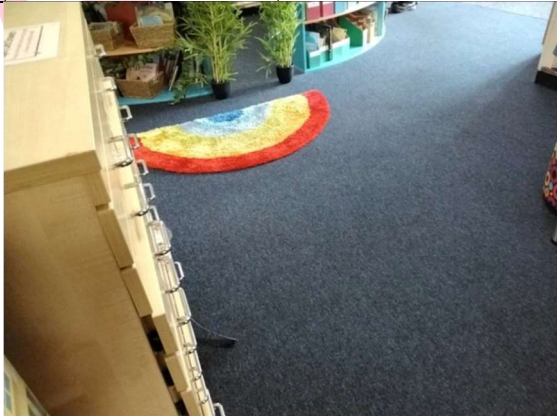
57	As KX001593	Floor tile (under floor covering) grey under screed	Block A Ground Floor Corridor (Room 060)	Contains asbestos - Any change in appearance should be recorded and passed to Property Services.

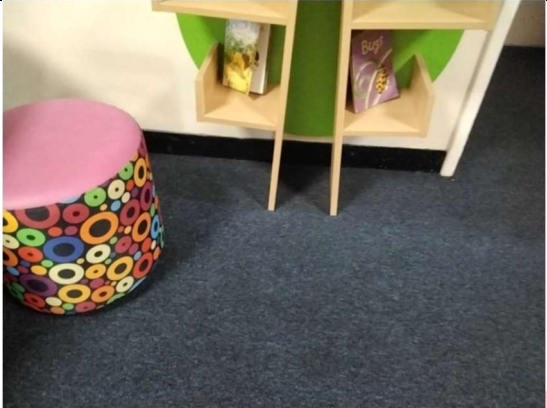
58	As KX001592	Wall skirting	Block A Ground Floor Corridor (Room 060)	Contains asbestos - Any change in appearance should be recorded and passed to Property Services.

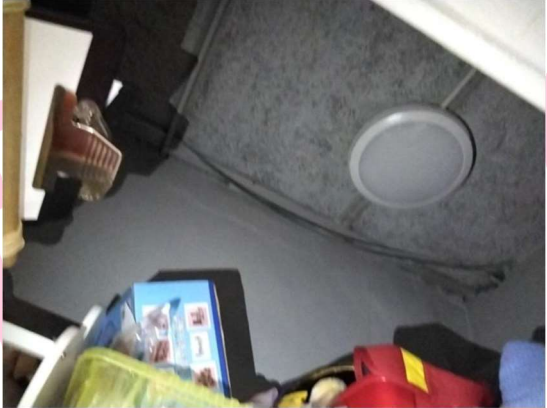
59	As KX001591	Ceiling void ceiling above	Block A Ground Floor Cupboard (Room 057)	Does not contain asbestos.

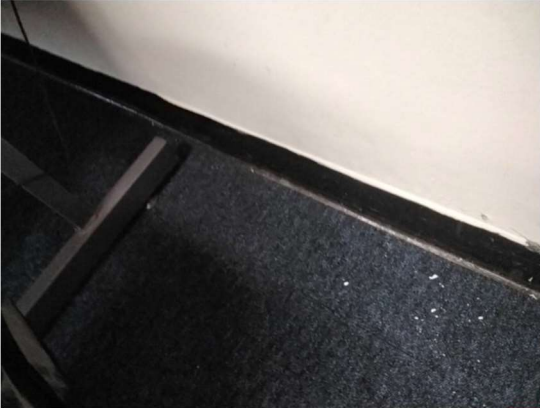
61	As KX001592	Wall skirting	Block A Ground Floor Office (Room 56)	Contains asbestos - Any change in appearance should be recorded and passed to Property Services.

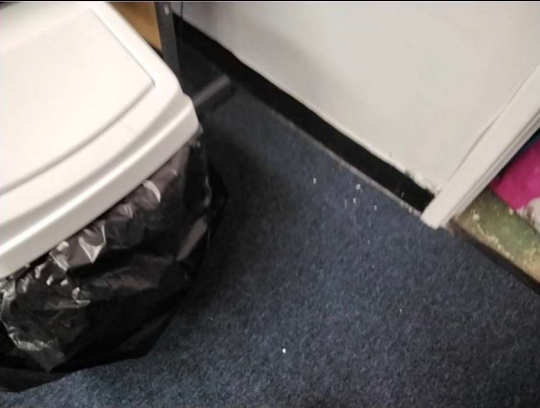
62	As KX001593	Floor tile (under floor covering) grey under screed	Block A Ground Floor Office (Room 56)	Contains asbestos - Any change in appearance should be recorded and passed to Property Services.

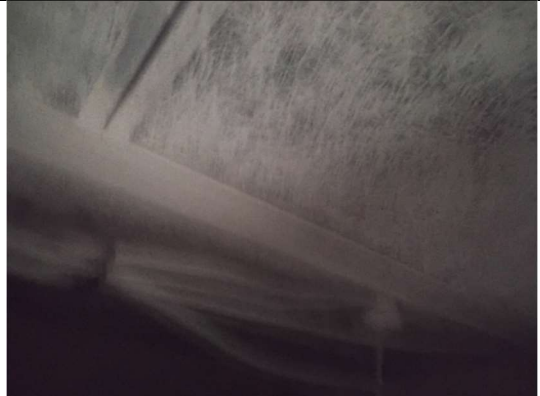
63	As KX001591	Ceiling void ceiling above	Block A Ground Floor Office (Room 059)	Does not contain asbestos.

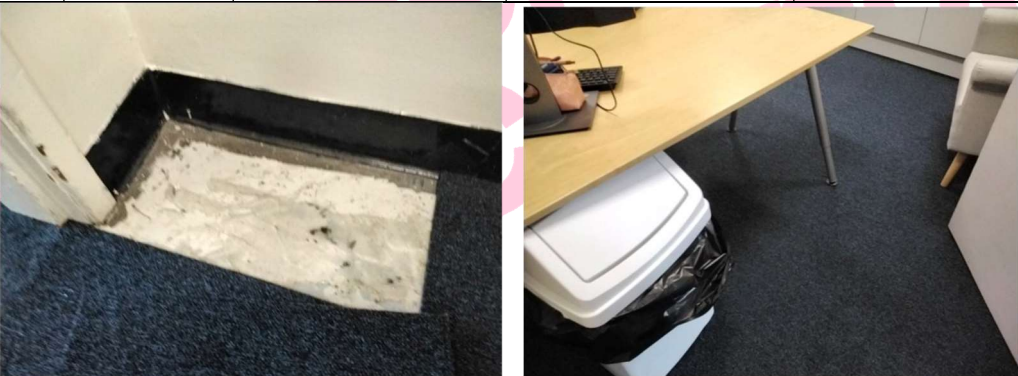
65	As KX001593	Floor tile (under floor covering) grey under screed	Block A Ground Floor Office (Room 59)	Contains asbestos - Any change in appearance should be recorded and passed to Property Services.

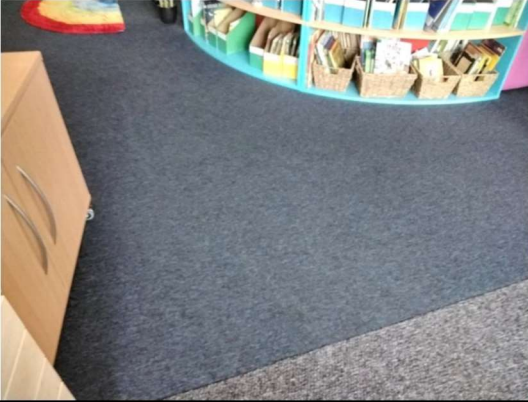
67	As KX001593	Floor tile (under floor covering) grey under screed	Block A Ground Floor Corridor (Room 61)	Contains asbestos - Any change in appearance should be recorded and passed to Property Services.

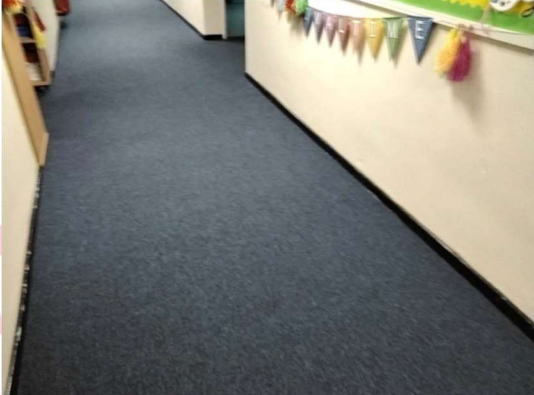
71	As KX001572	Floor screed under carpet and modern screed layer	Block A Ground Floor Corridor (Room 078)	Does not contain asbestos.

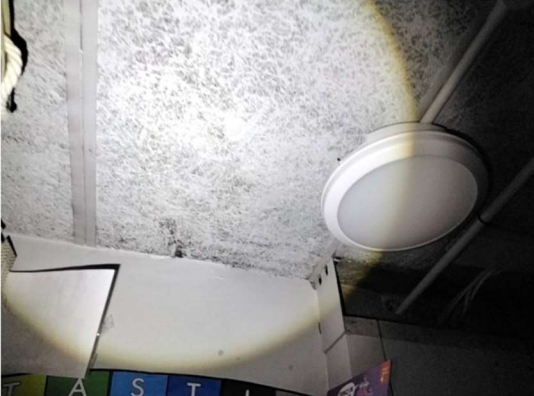
72	As KX001591	Ceiling void ceiling above	Block A Ground Floor Cupboard (Room 064)	Does not contain asbestos.

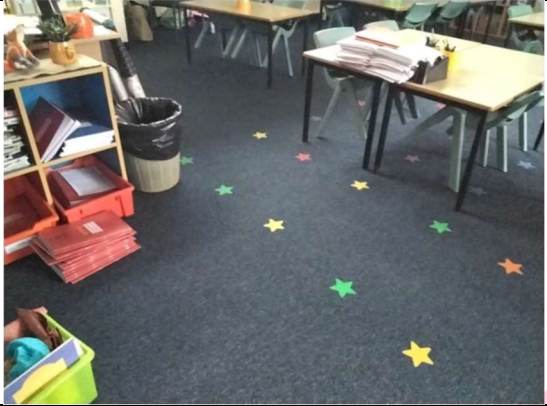
73	KX001594	Floor adhesive residue under carpet and screed	Block A Ground Floor Classroom (Room 065)	Contains asbestos - Any change in appearance should be recorded and passed to Property Services.

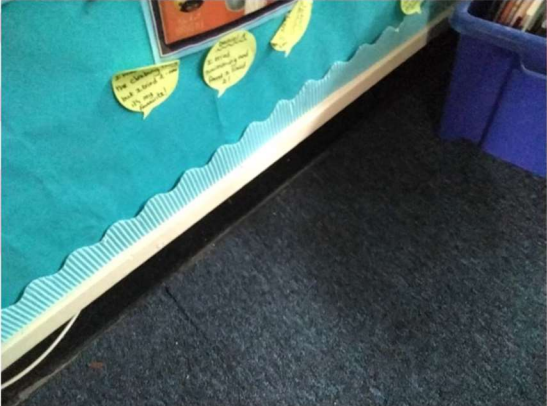
74	As KX001592	Wall skirting	Block A Ground Floor Classroom (Room 065)	Contains asbestos - Any change in appearance should be recorded and passed to Property Services.

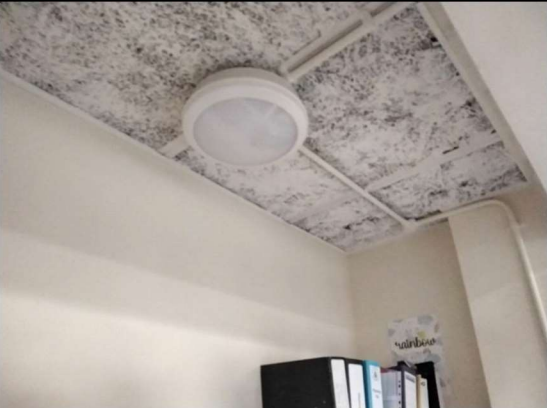
75	As KX001591	Ceiling alcove	Block A Ground Floor Classroom (Room 065)	Does not contain asbestos.

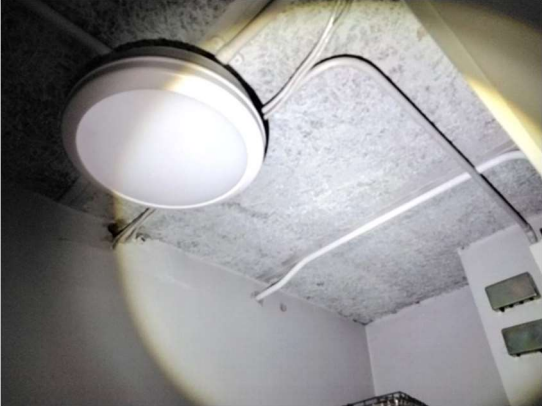
76	As KX001591	Ceiling void ceiling above	Block A Ground Floor Cupboard (Room 068)	Does not contain asbestos.

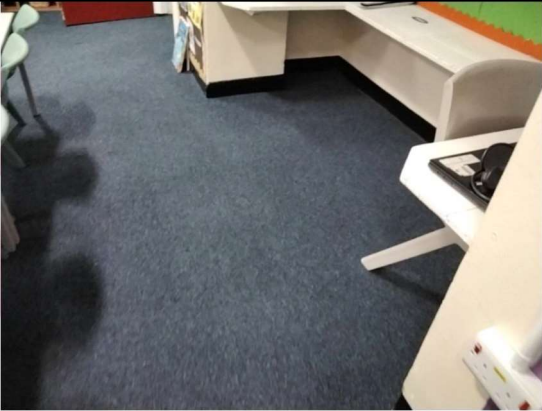
77	As KX001592	Wall skirting	Block A Ground Floor Classroom (Room 069)	Contains asbestos - Any change in appearance should be recorded and passed to Property Services.

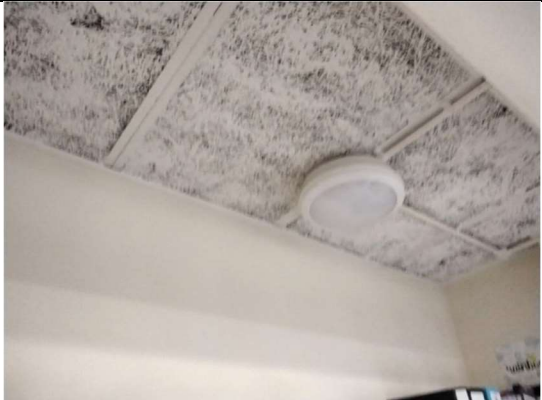
78	As KX001591	Ceiling	Block A Ground Floor Classroom (Room 069)	No Risk

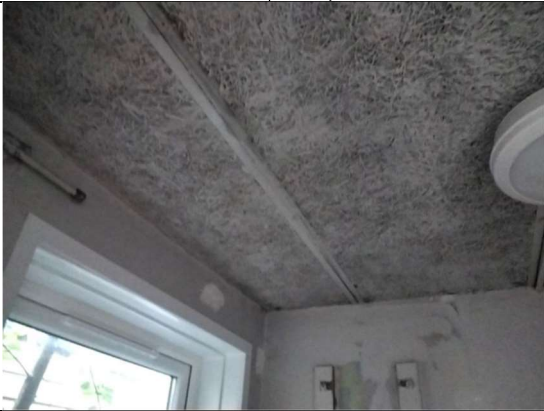
82	As KX001591	Ceiling void ceiling above	Block A Ground Floor Cupboard (Room 070)	Does not contain asbestos.

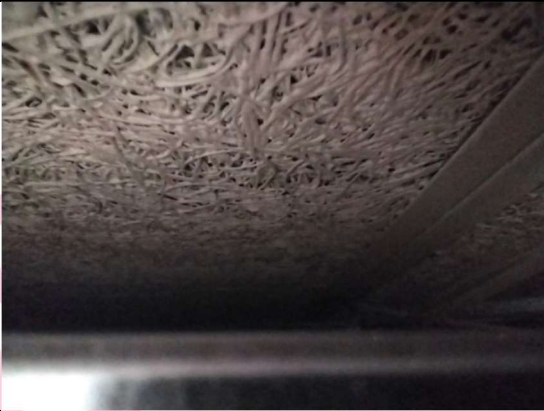
83	As KX001591	Ceiling	Block A Ground Floor Classroom (Room 076)	Does not contain asbestos.

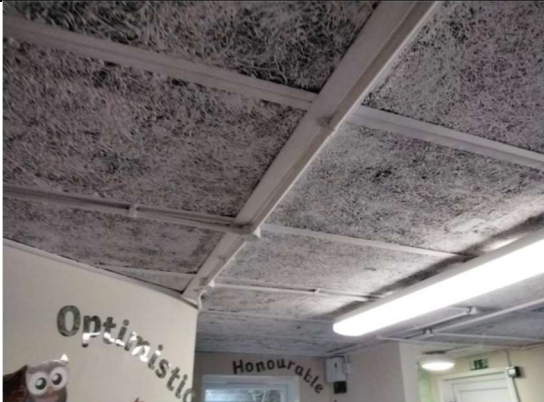
84	As KX001591	Ceiling	Block A Ground Floor Cloakroom (Room 072)	Does not contain asbestos.

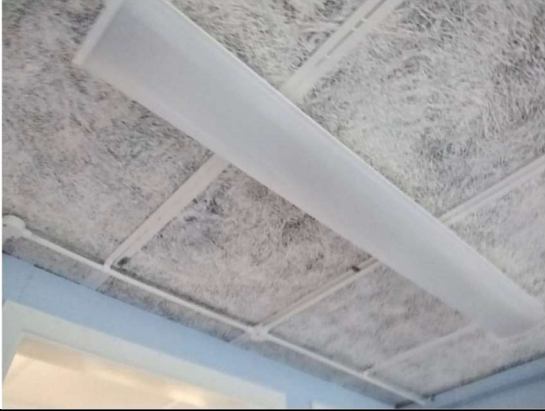
91	As KX001591	Ceiling	Block A Ground Floor Classroom (Room 078b)	Does not contain asbestos.

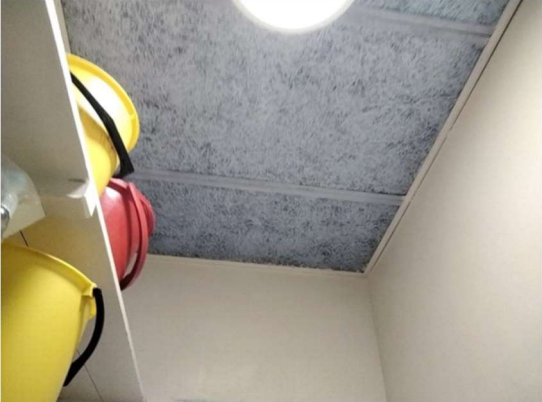
97	As KX001591	Ceiling	Block A Ground Floor Cleaners Cupboard (Room 052)	Does not contain asbestos.

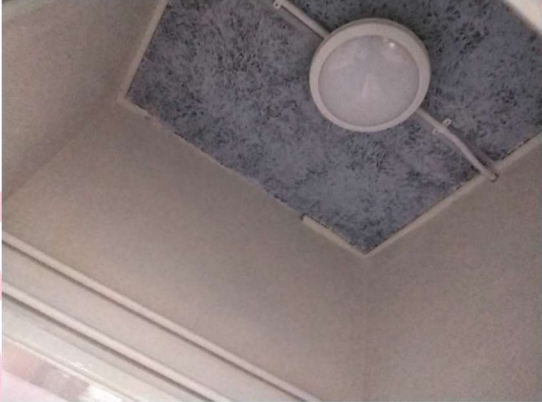
98	As KX001591	Ceiling	Block A Ground Floor Hallway Passageway (Room 062)	Does not contain asbestos.

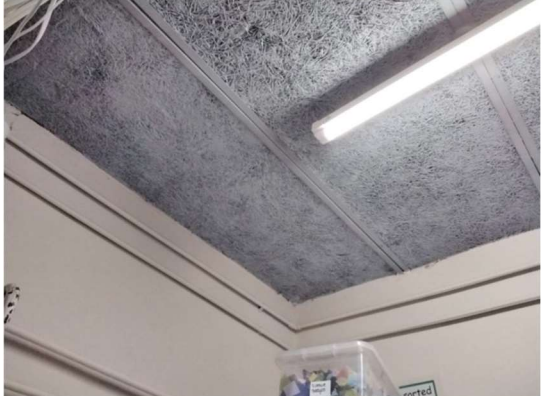
99	As KX001591	Ceiling	Block A Ground Floor Store Room (Room 044)	Does not contain asbestos.

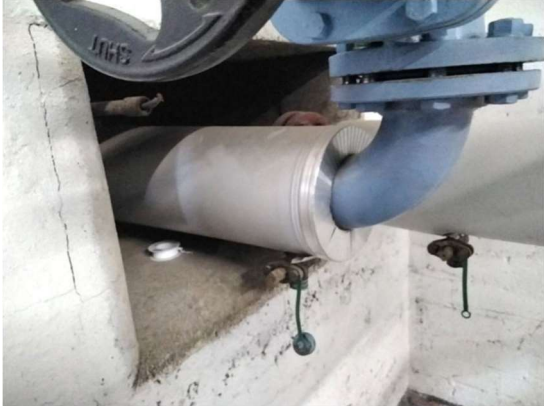
115	KX001603	Debris/Residue unsealed at entrance to floor duct - encapsulated	Block A Ground Floor Boiler Room (Room 089)	Medium Risk

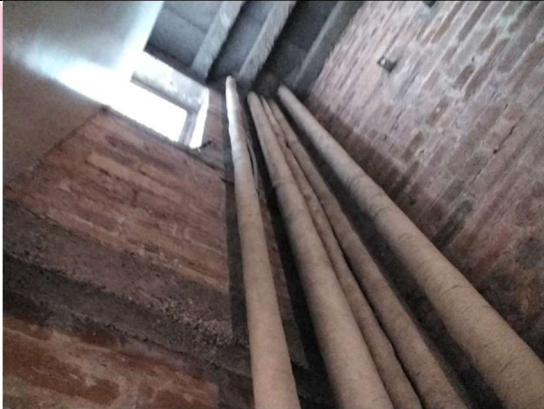
116	KX001583	Electric services cabling/braiding insulation x2	Block A First Floor Storage (Room 018)	Does not contain asbestos.
<p>No Photographic Evidence</p>				
117	As KX001585	Pipework insulation string binding to fibreglass	Block A First Floor Storage (Room 018)	Contains asbestos - Any change in appearance should be recorded and passed to Property Services.

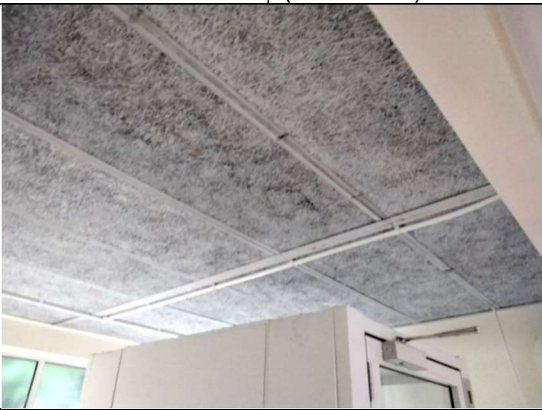
118	As KX001591	Ceiling	Block A First Floor Staircase Stairwell (Room 107)	Does not contain asbestos.

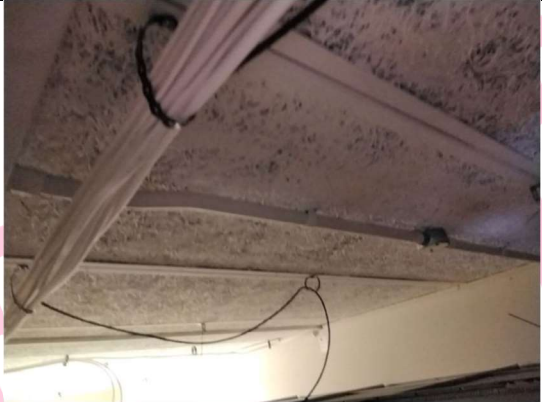
119	As KX001591	Ceiling void ceiling above	Block A First Floor Corridor (Room 106a)	Does not contain asbestos.

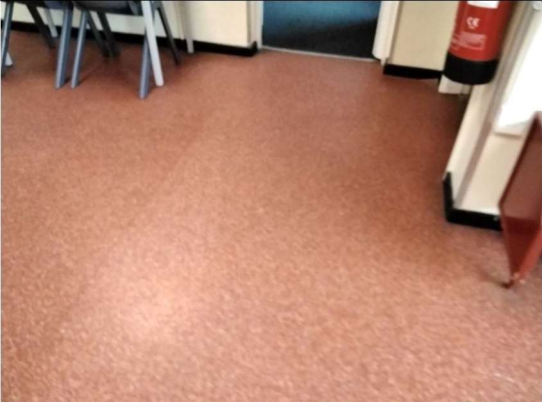
120	KX001604	Floor screed under modern lino and screed	Block A First Floor Corridor (Room 106a)	Does not contain asbestos.

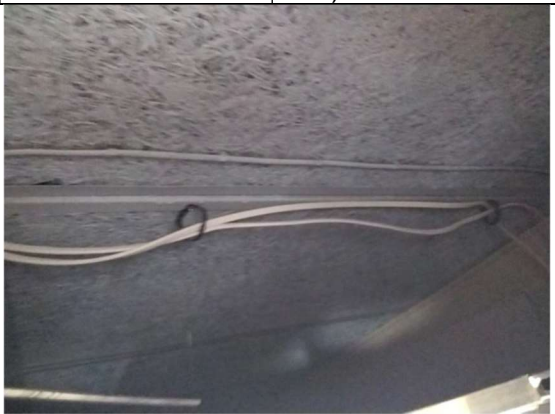
121	As KX001591	Ceiling void ceiling above	Block A First Floor Cloakroom (Room 105)	Does not contain asbestos.

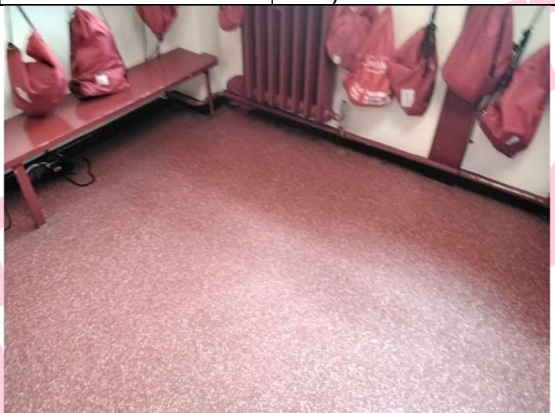
122	KX001604	Floor screed under modern lino and screed	Block A First Floor Cloakroom (Room 105)	Does not contain asbestos.

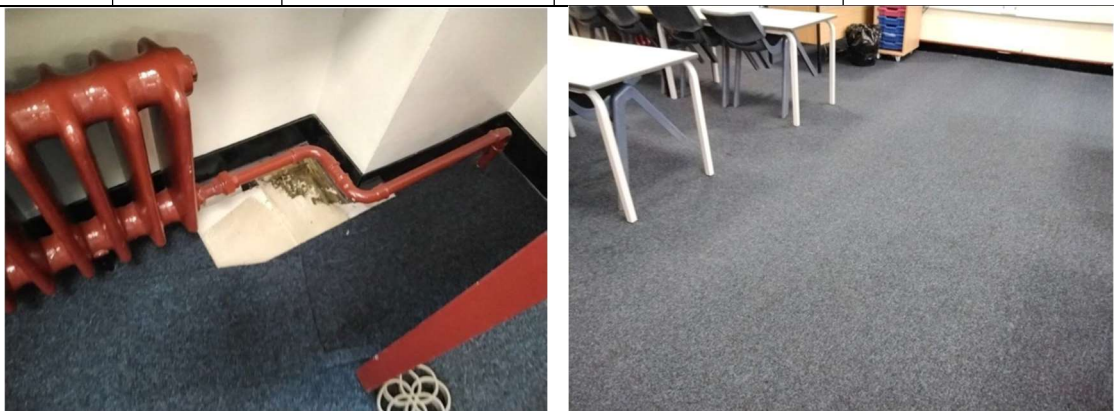
123	KX001605	Floor tile under floor covering	Block A First Floor Classroom (Room 90)	Contains asbestos - Any change in appearance should be recorded and passed to Property Services.

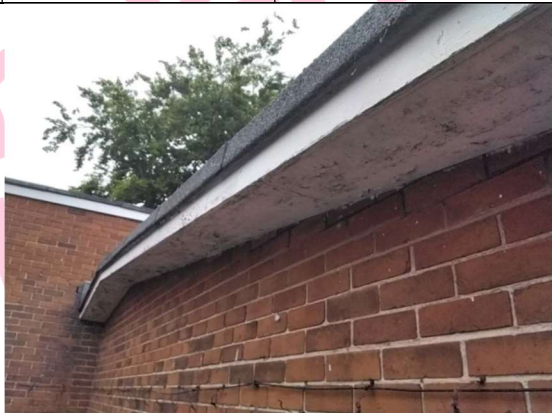
140	KX001608	Soffits Gable ends	Block A External	Contains asbestos - Any change in appearance should be recorded and passed to Property Services.

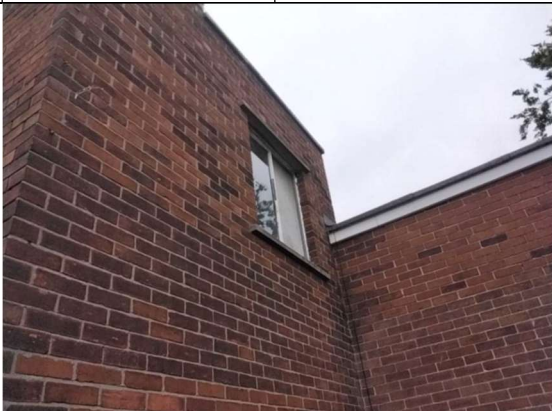
141	KX001609	Window putty seal second floor store window	Block A External	Does not contain asbestos.

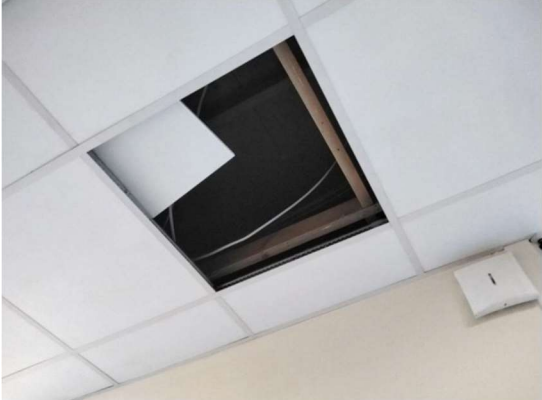
148	KX001619	Ceiling void debris to wooden framework and within nail holes - encapsulated	Block B Ground Floor Kitchen (Room 109)	Medium Risk

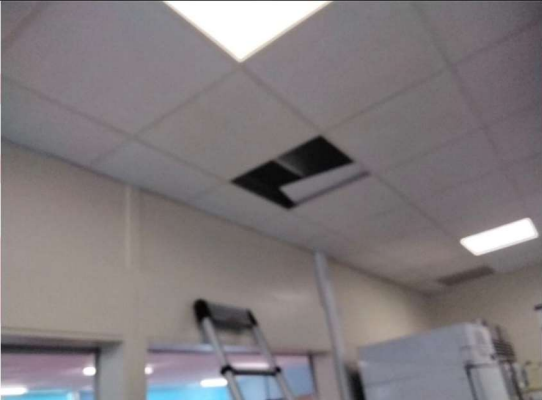
149	KX001620	Ceiling void debris to wooden framework and within nail holes - encapsulated	Block B Ground Floor Kitchen (Room 109)	Medium Risk

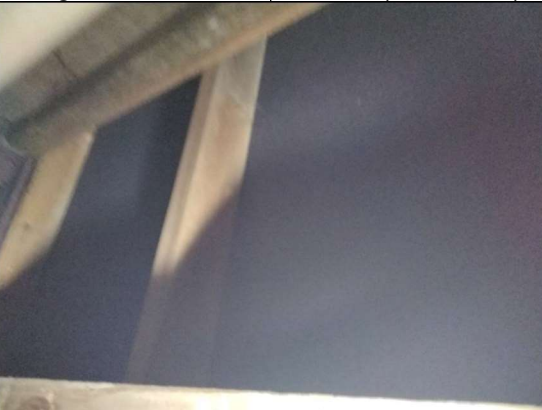
150	As KX001621	Ceiling void wall lining	Block B Ground Floor Kitchen (Room 109)	Does not contain asbestos.

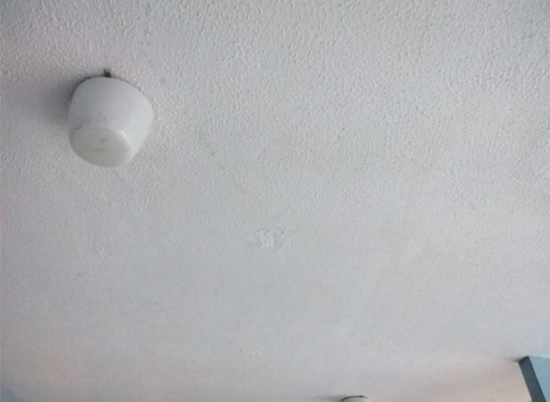
164	KX001626	Ceiling coating	Block B Ground Floor Entrance Hall Foyer Lobby (Room 130)	Contains asbestos - Any change in appearance should be recorded and passed to Property Services.

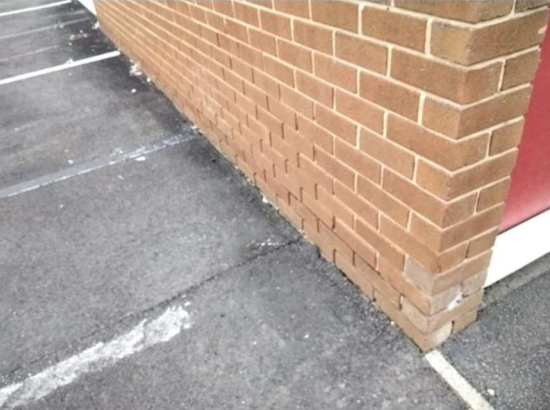
165	KX001614	Damp proof course	Block B External	Does not contain asbestos.
