ASBESTOS SURVEY REPORT FOR FULWELL CA, SUNDERLAND

Asbestos Register for FULWELL CA, SUNDERLAND

Fulwell CA – Last updated 03 October 2024 – Version 2

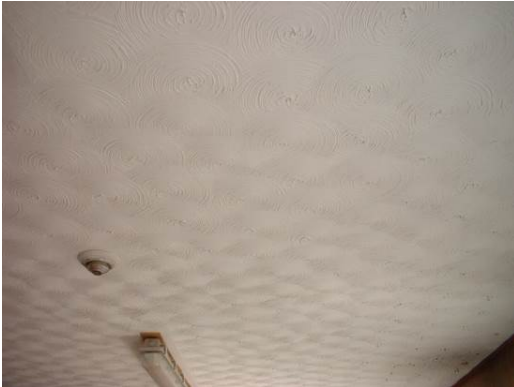
Item 1 Ref: CA02/1

The ceiling to the kitchen (Room 1) contains asbestos.

Any change in its appearance should be recorded and passed to Property Services.

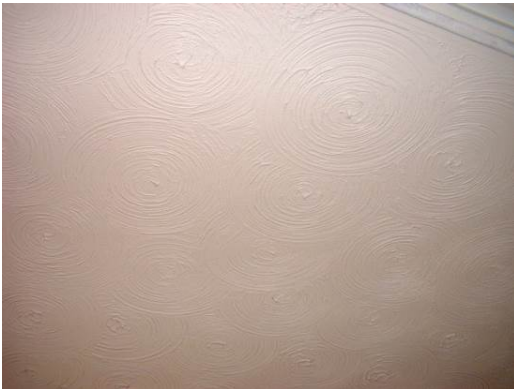
Item 2 - Ref: as CA02/1

The ceiling to Room 3 contains asbestos.

Any change in its appearance should be recorded and passed to Property Services.

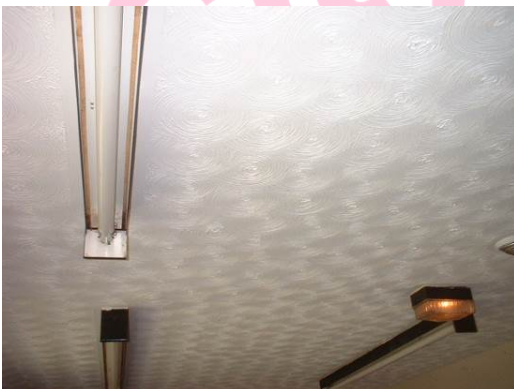
Item 3 - Ref: As CA02/1

The ceiling to Room 11 contains asbestos.

Any change in its appearance should be recorded, and passed to Property Services

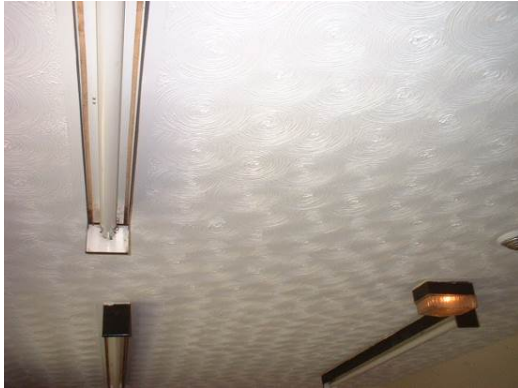
Item 4 - Ref: as CA02/1

The ceiling to Room 12 contains asbestos.

Any change in its appearance should be recorded, and passed to Property Services

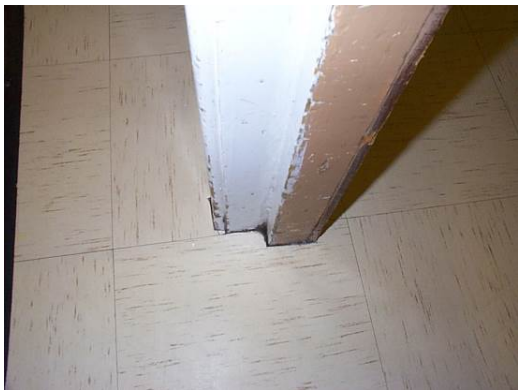
Item 5 - Ref: CA02/2

The flooring to Room 1 does not contain asbestos.

Similar flooring is also located in Room 3 (Item 6).

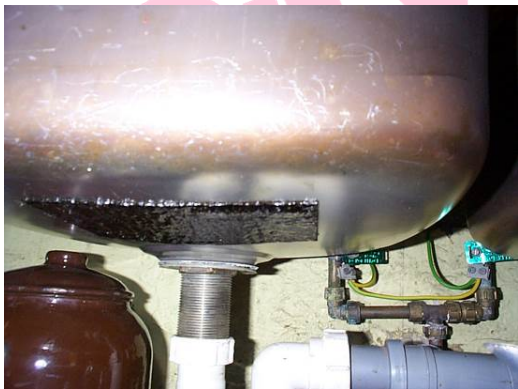
Item 7 - Ref: CA02/3

The sink pad in Room 1 does not contain asbestos.

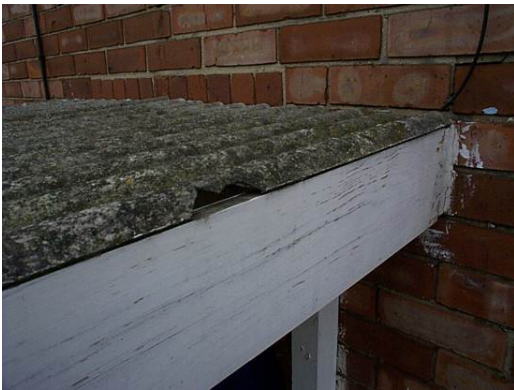
Item 11 Ref: CA02/5

The external canopy (Area 13) contains asbestos.

A similar canopy is also located in area 14 (Item 12).

Any change in its appearance should be recorded, and passed to Property Services

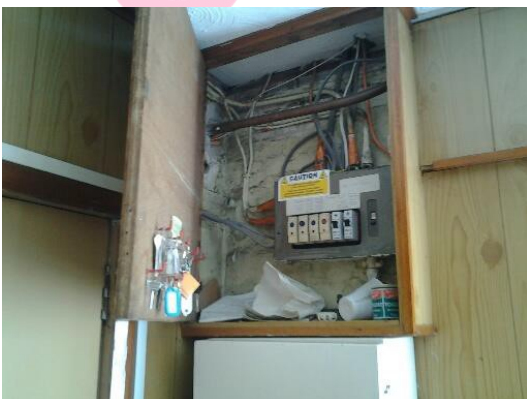
Item 13 Ref: 16-23632-2

The walls behind the wood panels in Room 1 (Kitchen) does not contain asbestos.

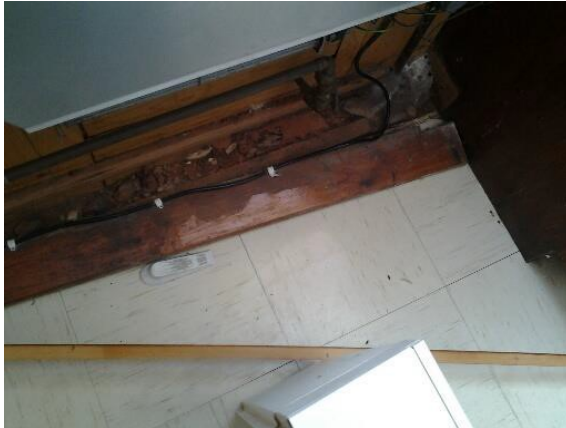
Item 14 - Ref: 16-24632-4

The floor behind the kickboards in Room 1 (Kitchen) does contain asbestos.

Any change in its appearance should be recorded and passed to Property Services.

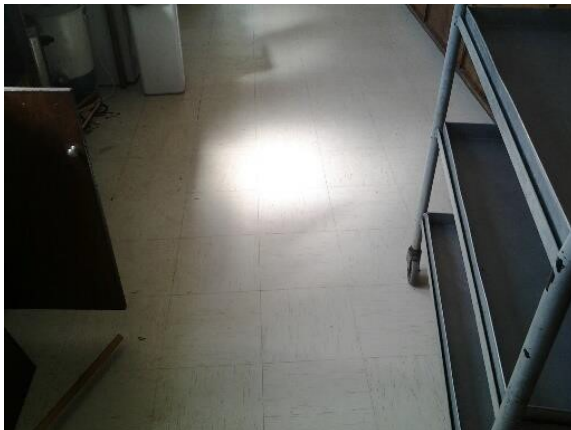
Item 15 Ref: 16-24632-5

The floor under vinyl tiles and screed in Room 1 (Kitchen) does contain asbestos.

Any change in its appearance should be recorded and passed to Property Services.

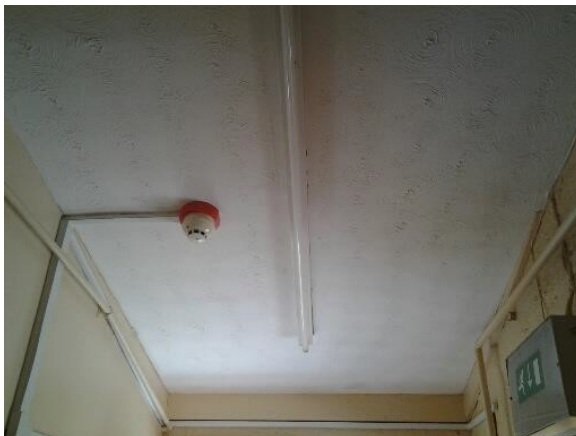
Item 16 Ref: 16-23632-1

The ceiling in the Entrance lobby does contain asbestos.

Any change in its appearance should be recorded and passed to Property Services.

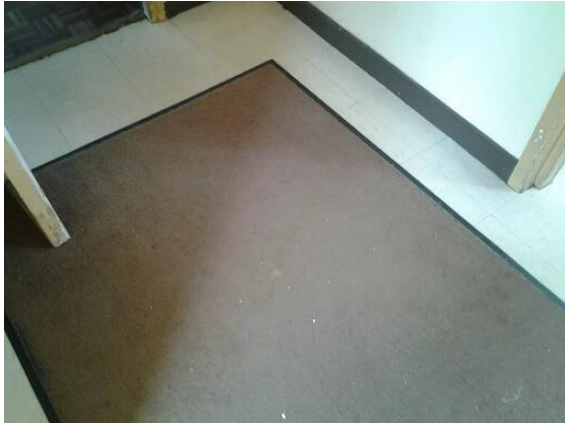
Item 17 - Ref: 16-24632-3

The flooring in the Entrance lobby does not contain asbestos.

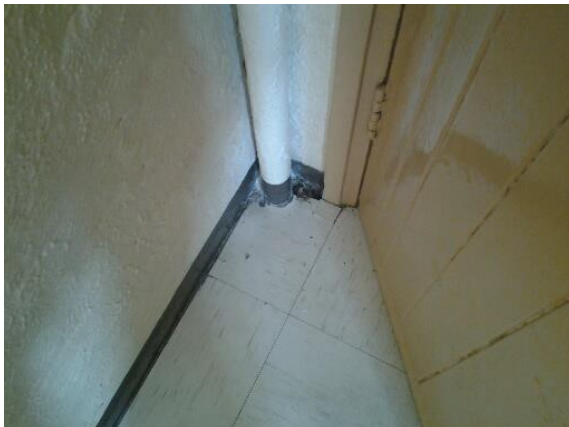
Item 18 Ref: As 16-24632-4

The floor around pipe penetration in the Entrance lobby does contain asbestos.

Any change in its appearance should be recorded and passed to Property Services.

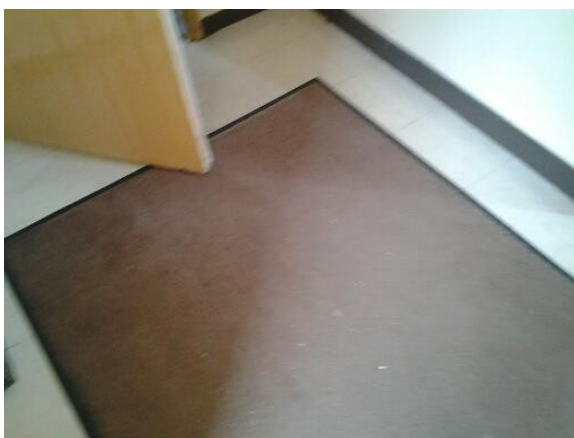
Item 19 Ref: As 16-23632-5

The floor under the vinyl tiles and screed in the Entrance lobby does contain asbestos.

Any change in its appearance should be recorded and passed to Property Services.

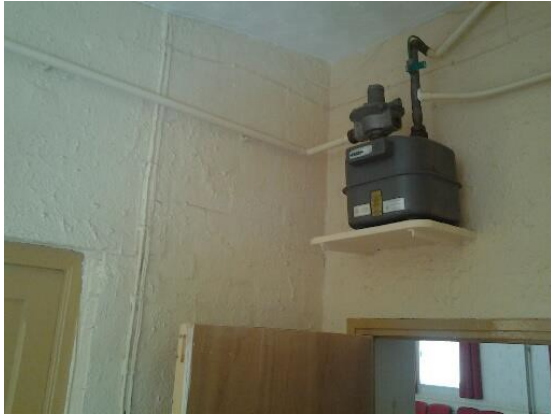
Item 20 - Ref: 16-24632-6

The textured coating in the Entrance lobby does not contain asbestos.

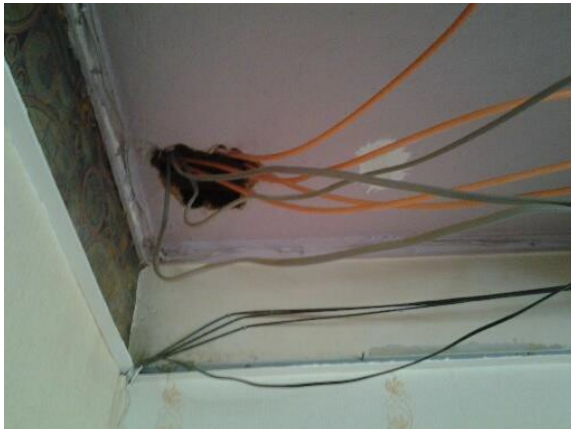
Item 21 Ref: 16-24632-7

The ceiling above the suspended ceiling in the Hall does not contain asbestos.

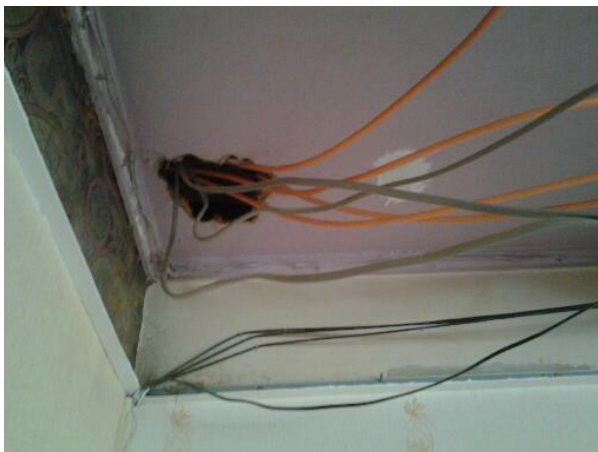
Item 22 Ref: 16-23632-8

The ceiling above the suspended ceiling in the Hall does not contain asbestos.

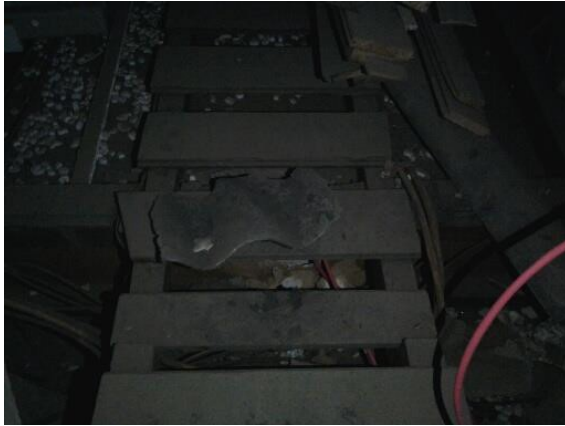
Item 23 - Ref: 16-24632-9

The debris to the ceiling void in the Hall does contain asbestos.

Any change in its appearance should be recorded and passed to Property Services.

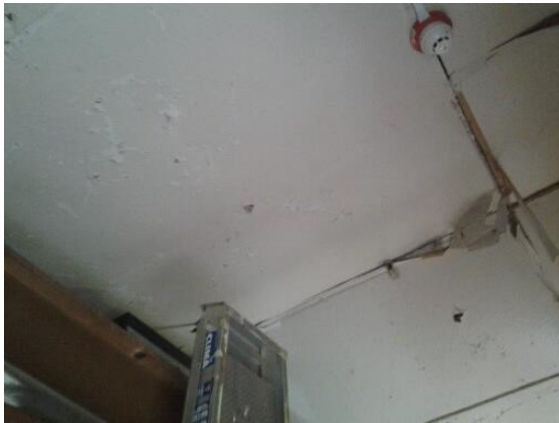
Item 24 Ref: 16-24632-10

The ceiling, soffit and fascia in the Stage does not contain asbestos.

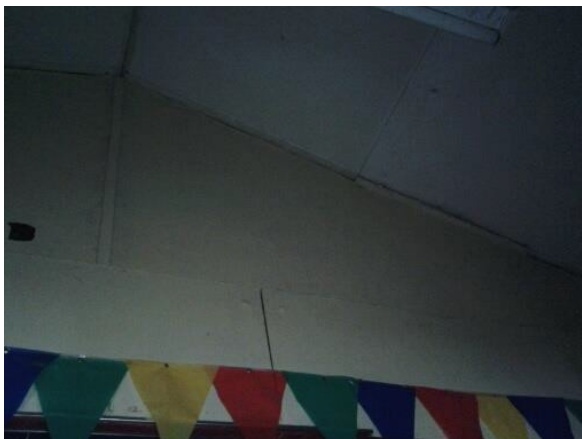
Item 25 Ref: 16-23632-11

The fascia in the Stage does not contain asbestos.

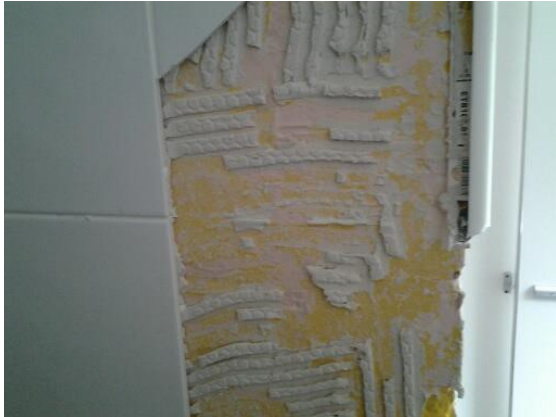
Item 26 - Ref: 16-24632-13

The walls in the Female WC does not contain asbestos.

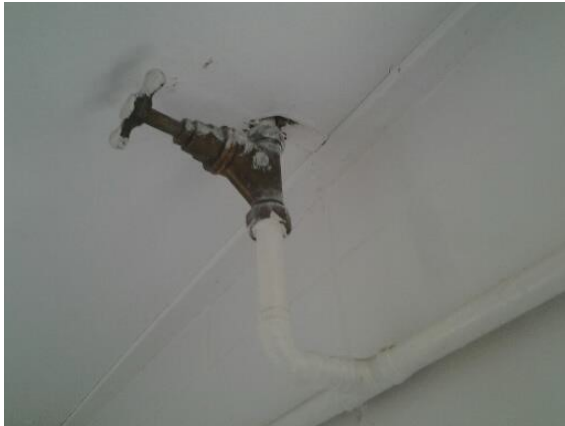
Item 27 Ref: 16-24632-15

The gaskets in the Female WC does not contain asbestos.

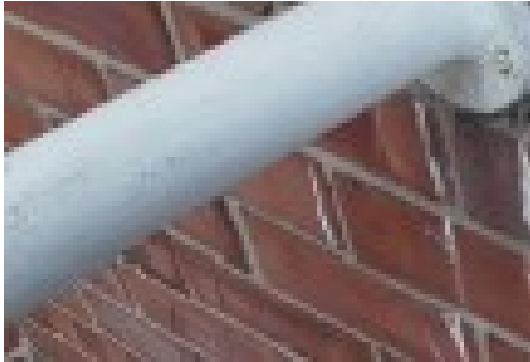
Item 29 - Ref: 21-39178-1

The frame sealant to the door in the Entrance to the Community Centre (Area 1) does not contain asbestos.

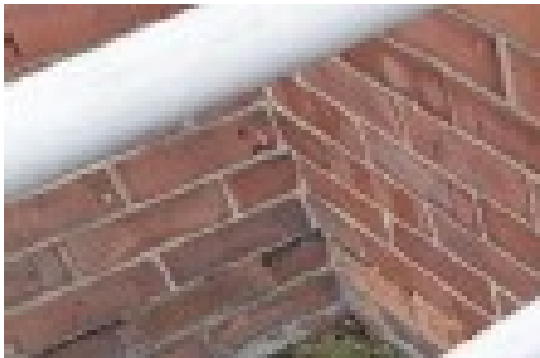
Item 30 Ref: 21-39178-2

The damp proof course to the Entrance door to the Community Centre (Area 1) does not contain asbestos.
