### ASBESTOS SURVEY REPORT FOR BROADWAY YOUTH & COMMUNITY CENTRE (FORMALLY GRINDON CA), CORTINA AVENUE, SUNDERLAND

*Control of Asbestos  
Regulations 2012*

**GRINDON COMMUNITY CENTRE, SUNDERLAND**

**Date: 14<sup>th</sup> June 2023**

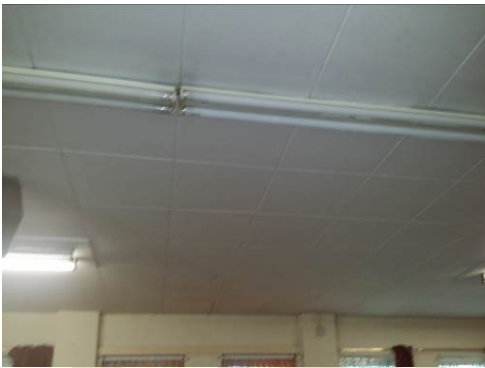
### **Item 8 - Ref: 120755-3**

The ceiling to the hall (Room 007) contains asbestos.

Any change in its appearance should be noted and passed to Property Services.

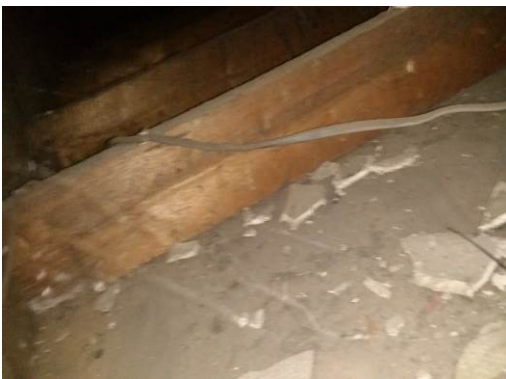
### **Item 11 Ref: 120755-7**

**THERE IS SIGNIFICANT ASBESTOS CEMENT DEBRIS TO THE LOFT AREA AND CEILING VOIDS. THERE IS TO BE NO ACCESS UNTIL AN ENVIRONMENTAL CLEAN IS CARRIED OUT.**

There debris to the ceiling void in the changing room (Room 009) contains asbestos.

There should be **no access** to the area, prior to the area being cleaned.
