ASBESTOS SURVEY REPORT FOR 260-261 HIGH STREET WEST,
SUNDERLAND, STR1 3DH

Asbestos Register for

260-261 High Street West, Sunderland

Date: 27 September 2024

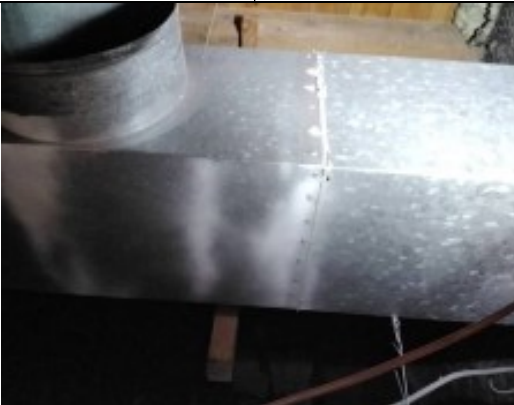
| 4 | SC004716 | Ceiling void - Ductwork | Shop Floor G/001 | Does not contain asbestos |

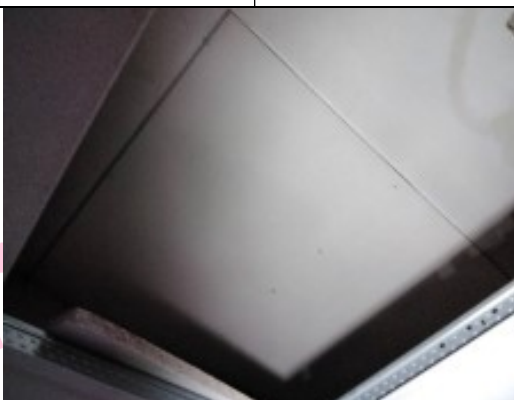
| 5 | SC004717 | Ceiling void – ceiling panel | Shop Floor G/001 | Does not contain asbestos |

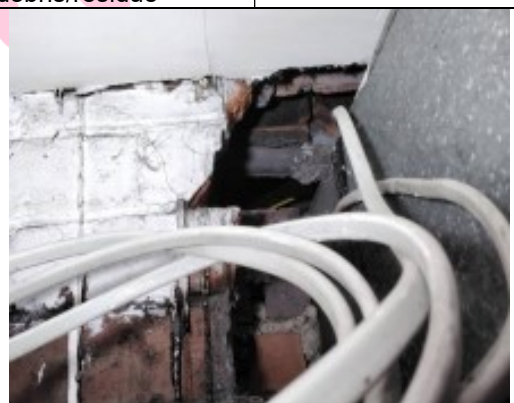
| 6 | SC004718 | Ceiling void – debris/residue | Shop Floor G/001 | Does not contain asbestos |

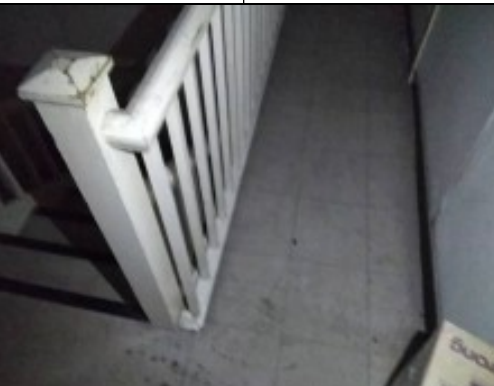
| 9 | As SC004720 | Floor – tile to staircase – composite sample of multiple coloured floor tiles | Landing 1/001 | Does not contain asbestos |
