ASBESTOS SURVEY REPORT FOR 68-71 HIGH STREET WEST,
SUNDERLAND, SR1 3DW

68-71 High Street West, Sunderland

Date: 01 October 2024

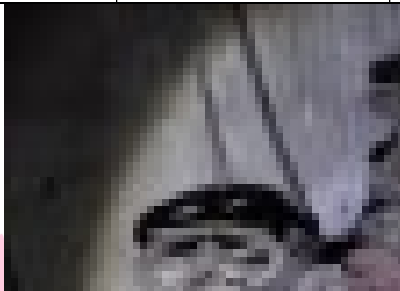
2	QY000271	Pipework Gaskets	Boiler Room Z/001	Contains asbestos - Any change in its appearance should be recorded and passed to Property Services.

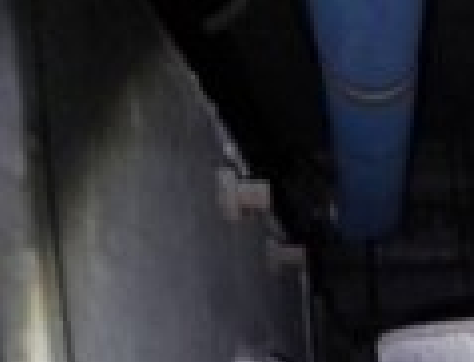
10	QY000279	Ductwork – joints to flue/ductwork hatch	Boiler Room Z/001	Does not contain asbestos

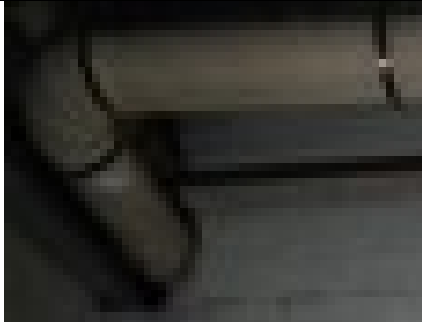
16	QY000283	Damp proof course	Duct Z/002	Contains asbestos - Any change in its appearance should be recorded and passed to Property Services.

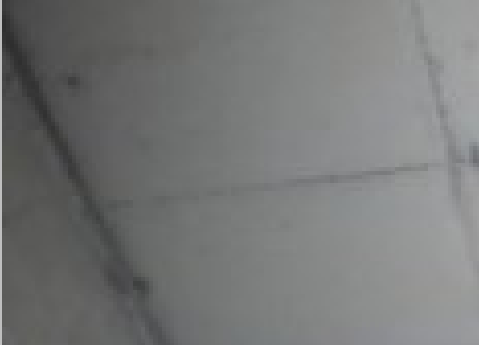
17	As QY000280	Electrical services – door seal/gasket seal to glass redundant light unit	Store Room Z/003	Does not contain asbestos

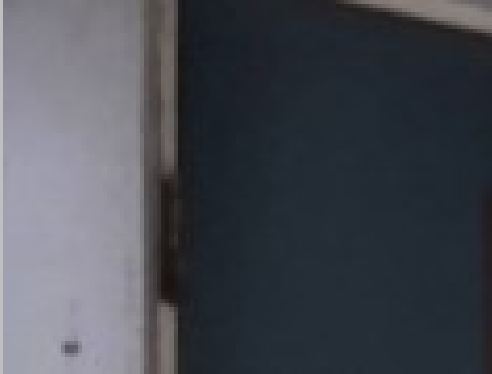
18	QY000253	Door – window beading	Staircase/Stairwell G/001	Does not contain asbestos

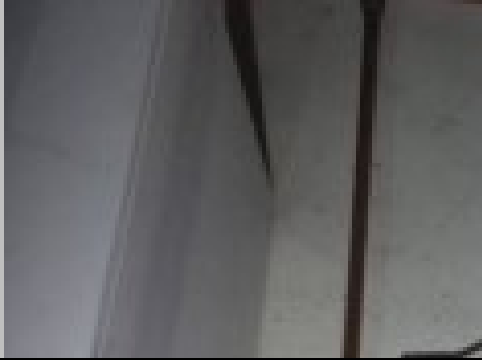
22	QY000257	Pipework Gaskets	Storage Area G/004	Does not contain asbestos

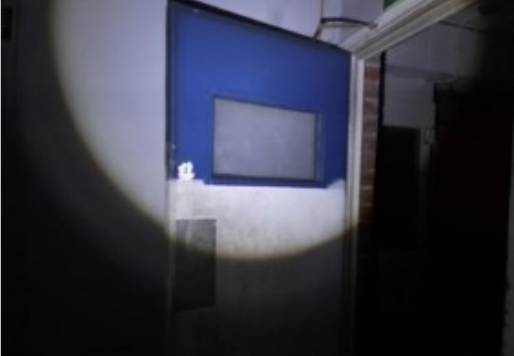
24	As QY000253	Door – window beading	Stairwell/Staircase G/007	Does not contain asbestos

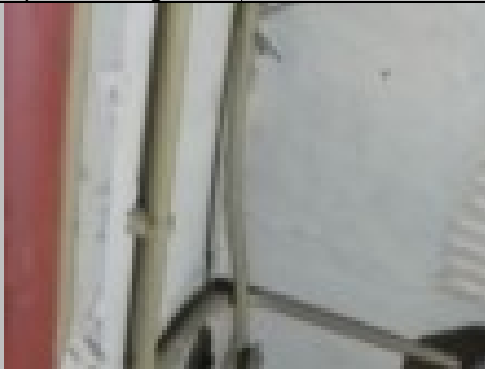
27	QY000261	Electrical services – door seal/gasket lamps, seal to glass	Oil Tank Room G/008	Does not contain asbestos

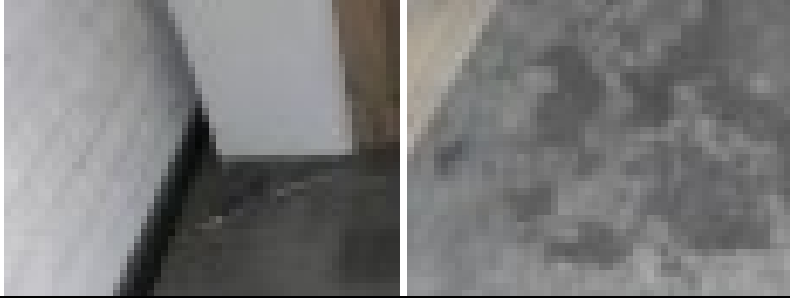
28	QY000262	Floor tile	Office G/009	Contains asbestos - Any change in its appearance should be recorded and passed to Property Services.

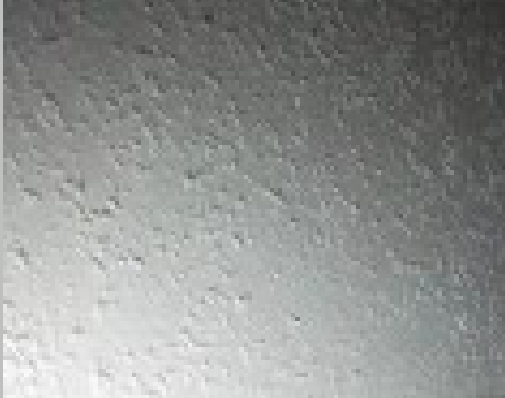
29	QY000263	Wall coating	Stairwell/Staircase G/010	Does not contain asbestos

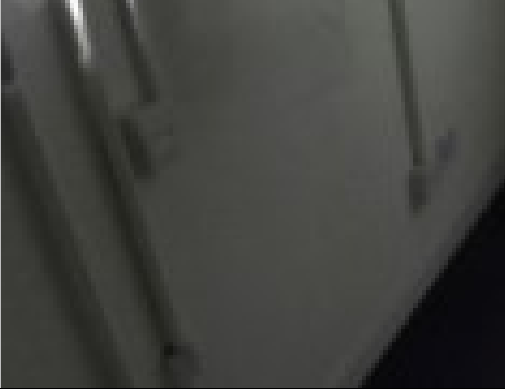
43	As QY000265	Floor tile Beige under carpet	Office G/022	Does not contain asbestos

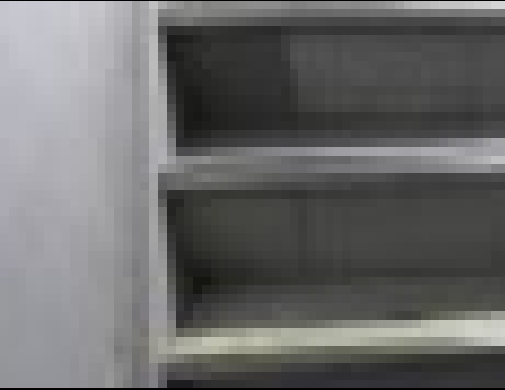
44	QY000285	Floor tile to stairs	Stairwell Staircase G/026	Contains asbestos - Any change in its appearance should be recorded and passed to Property Services.

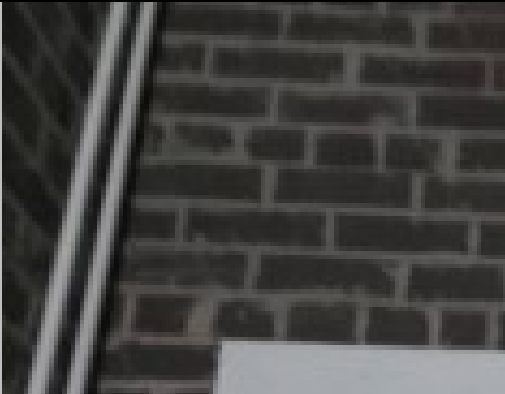
45	QY000286	Door header panel boxing	Stairwell Staircase G/026	Does not contain asbestos

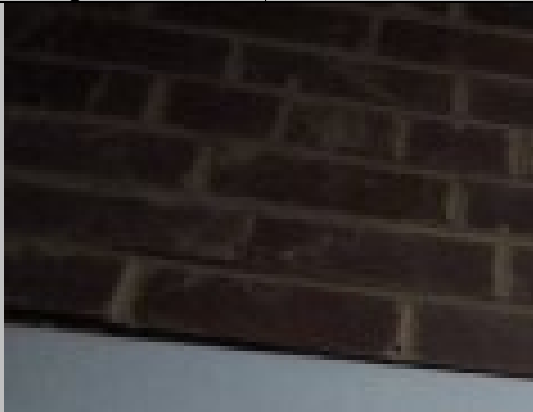
46	As QY000285	Floor tile to stairs	Landing 1/001	Contains asbestos - Any change in its appearance should be recorded and passed to Property Services.
No Photographic Evidence Available				
47	As QY000286	Door header panel boxing	Landing 1/001	Does not contain asbestos

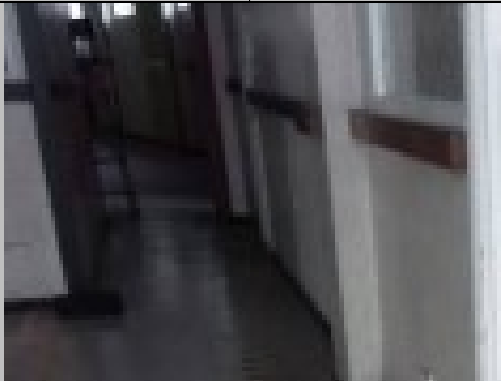
51	QY000288	Wall coating	Office Large 1/005	Does not contain asbestos

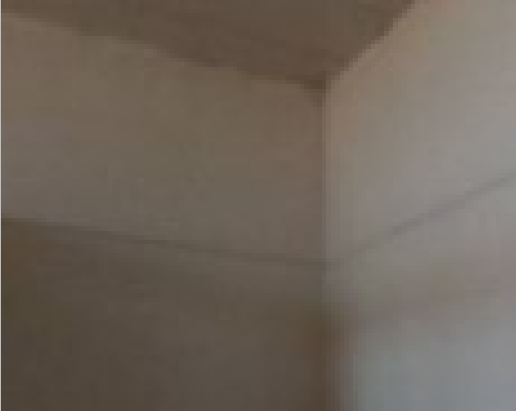
70	As QY000297	Wall coating	Male Toilets 2/011	Does not contain asbestos

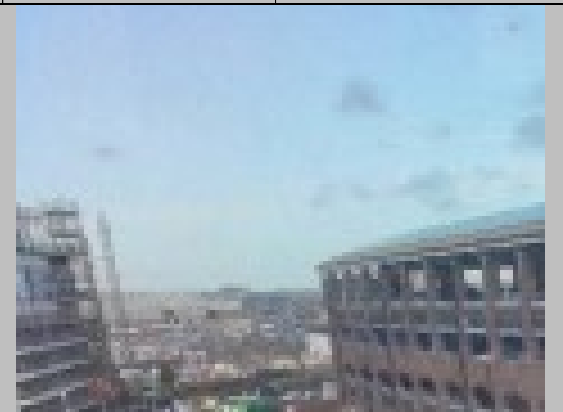
80	QY000294	Window putty seal to metal framed windows	External E/001	Does not contain asbestos

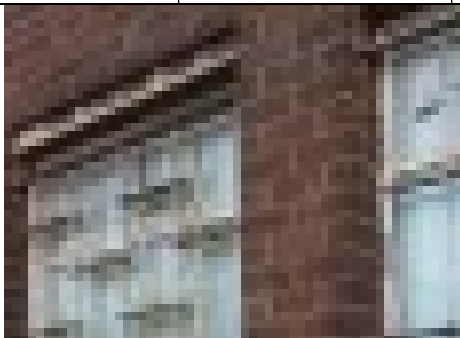
81	QY000301	Window beading to metal framed windows	External E/001	Contains asbestos - Any change in its appearance should be recorded and passed to Property Services.

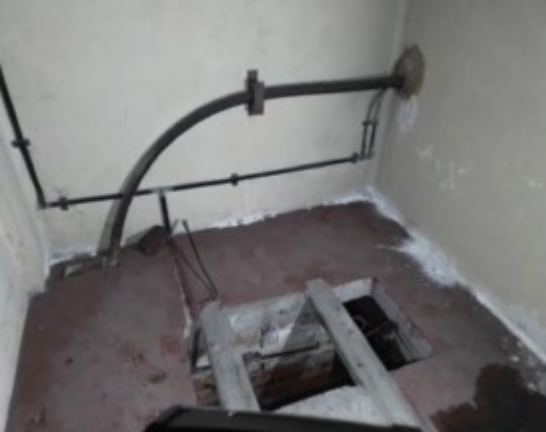
83	QY000284	Electrical Services - Cable Braiding/ Insulation	Switchroom Z1/004	Does not contain asbestos

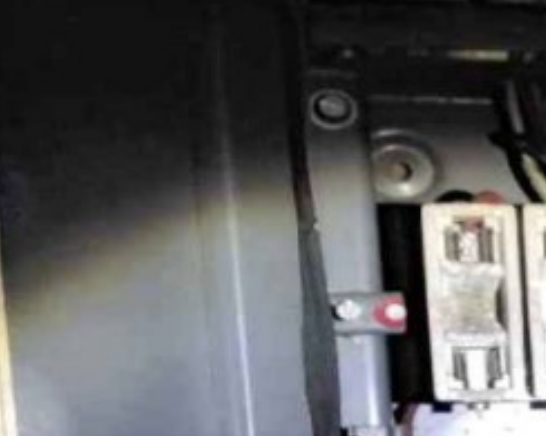
84	CF011661	Electrics – screwcap putty	Cupboard understairs	Does not contain asbestos
