ASBESTOS SURVEY REPORT FOR DURHAM WILDLIFE TRUST, RAINTON MEADOWS, CHILTON MOOR, HOUGHTON LE SPRING

Asbestos Register for Durham Wildlife Trust

Date: 22 April 2024

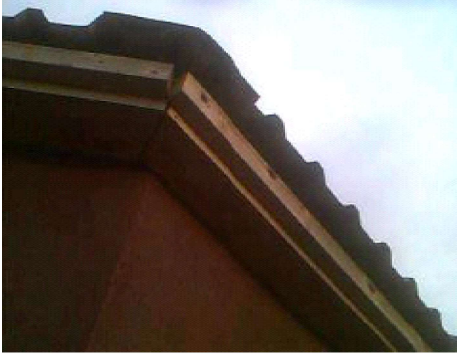
Hide 1 was accessed and no suspect materials were found.

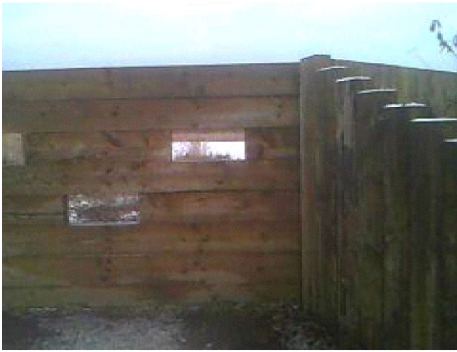
Hide 2 was accessed and no suspect materials were found.

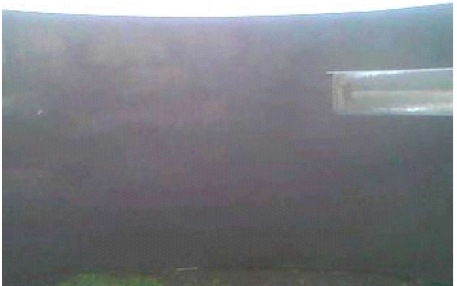
Hide 3 was accessed and no suspect materials were found.

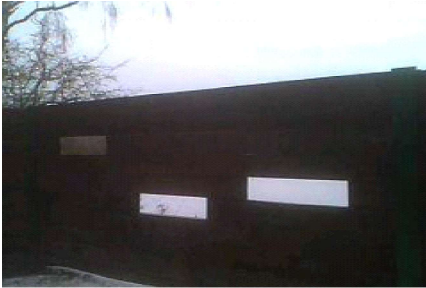
Hide 4 was accessed and no suspect materials were found.

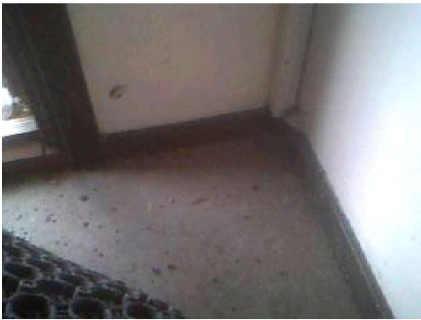
Item 1 – CB009303

CB009303 – Vinyl flooring (Room 1) (Item 1) - No Risk

The vinyl flooring to the lobby (Room 1) does not contain asbestos.

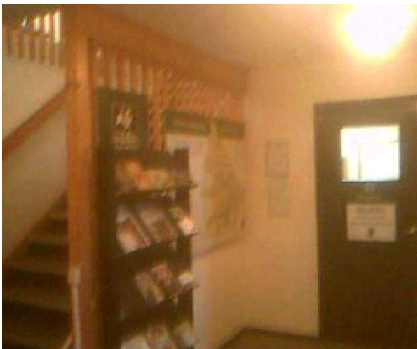
The entrance hall (Room 2) was accessed and no suspect materials were found.

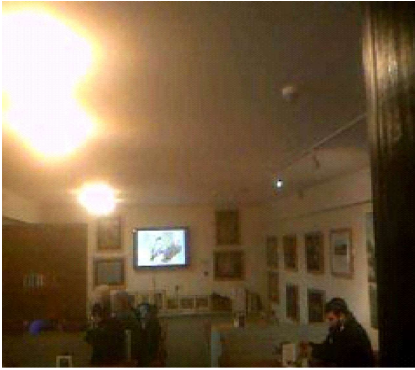
The coffee shop / kitchen (Room 3) were accessed and no suspect materials were found.

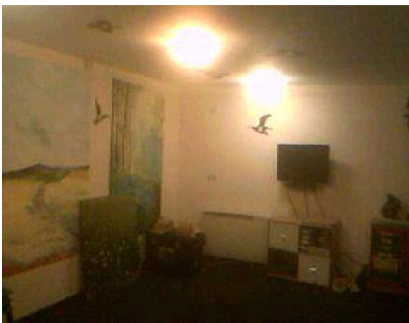
The education Room (Room 4) was accessed and no suspect materials were found.

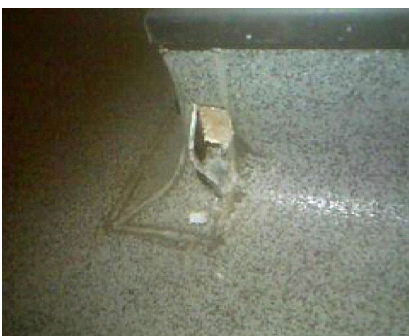
Item 2 – Ref: CB009304

CB009304 – Skirting (Room 5) (Item 2) – No Risk

The skirting behind the modern vinyl in the disabled WC (Room 5) does not contain asbestos.

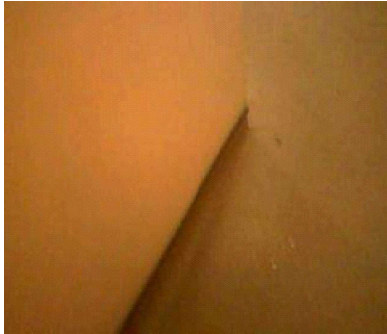
Item 3 As CB009304

As CB009304 – Skirting (Room 6) (Item 3) - No Risk

The skirting behind the modern vinyl in the Male WC (Room 6) does not contain asbestos.

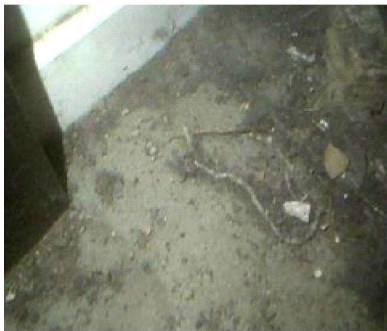
Item 4 – CB009305

CB009305 – String (Room 7) (Item 4) – No Risk

The string lying on the floor to the boiler room (Room 7) does not contain asbestos.

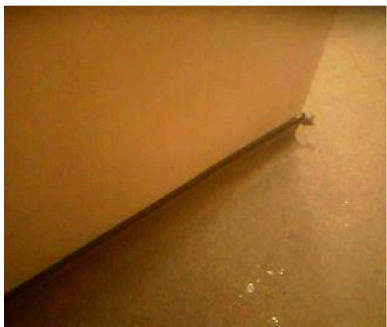
Item 5 As CB009304

As CB009304 – Skirting (Room 8) (Item 5) - No Risk

The skirting behind the modern vinyl in the Female WC (Room 8) does not contain asbestos.

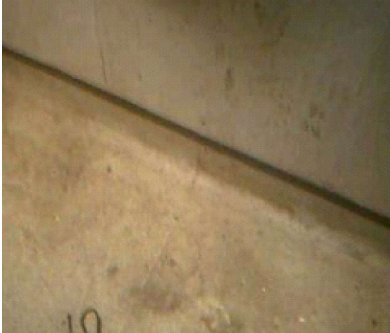
Item 6 As CB009304

As CB009304 – Skirting (Room 9) (Item 6) – No Risk

The skirting behind the modern vinyl in the wet room (Room 9) does not contain asbestos.

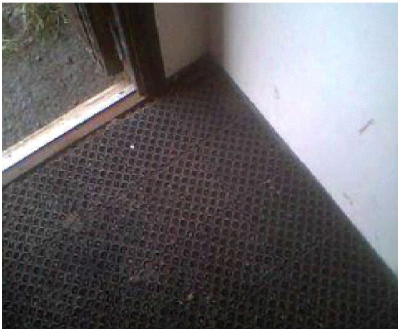
Item 7 Ref: CB009306

CB009306 – Vinyl flooring (Room 10) (Item 7) – No Risk

The vinyl flooring to the rear porch (Room 10) does not contain asbestos.

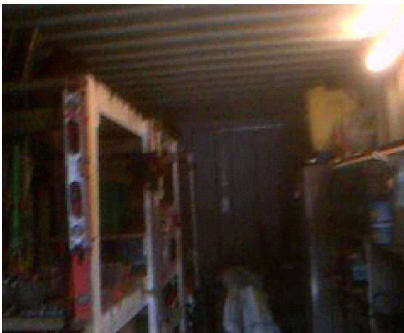
Container 1 (Room 11) was accessed and no suspect materials were found.

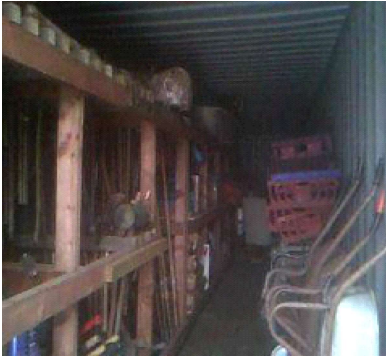
Container 3 (Room 12) was accessed and no suspect materials were found.

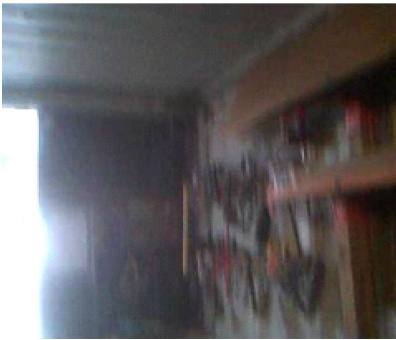
Container 2 (Room 13) was accessed and no suspect materials were found.

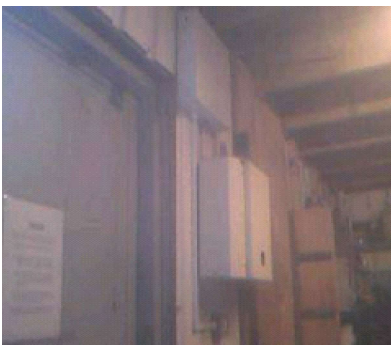
The garage (Room 14) was accessed and no suspect materials were found.

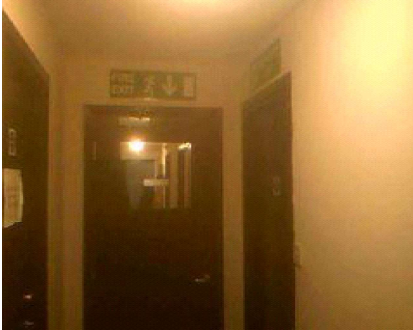
The staff hall (Room 15) was accessed and no suspect materials were found.

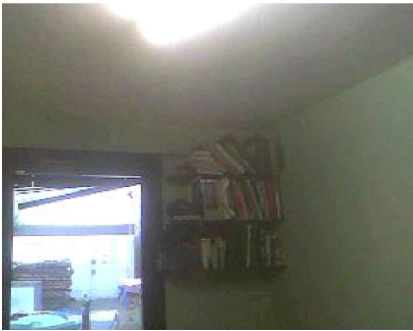
The staff room (Room 16) was accessed and no suspect materials were found.

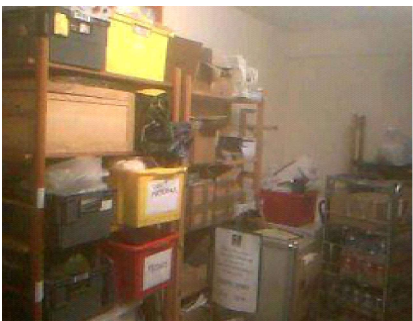
The store room / photo copying room (Room 17) was accessed and no suspect materials were found.

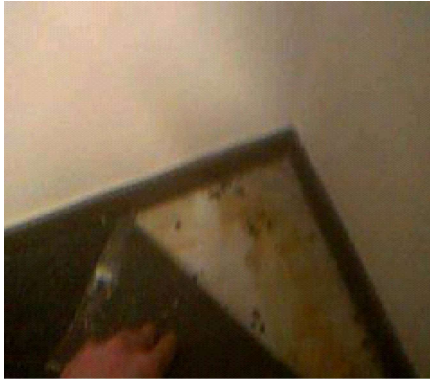
Item 8 As CB009303

As CB009303 – Vinyl flooring (Room 18) (Item 8) – No Risk

The vinyl flooring to the Directors office (Room 18) and no suspect materials were found.

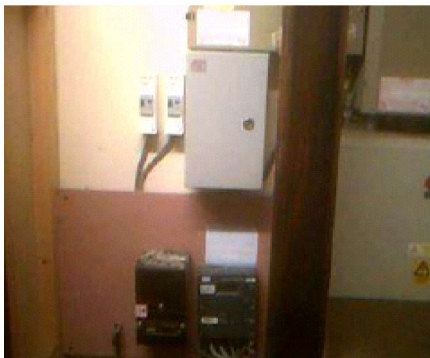
The electrical cupboard (Room 19) was accessed and no suspect materials were found.

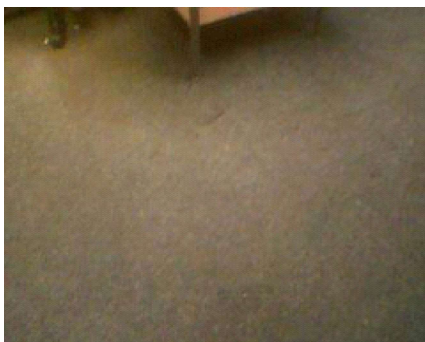
Item 9 As CB009303

As CB009303 – Vinyl flooring (Room 20) (Item 9) – No Risk

The vinyl flooring to the reception office (Room 20) does not contain asbestos.

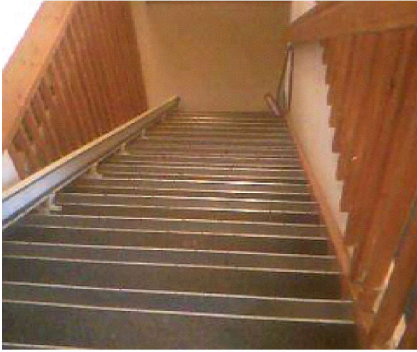
Item 10 Ref: CB009302

CB009302 – Stair nosing (1st flr Room 1) (Item 10) – No Risk

The stair nosing to the landing and the stairs (First floor room 1) does not contain asbestos.

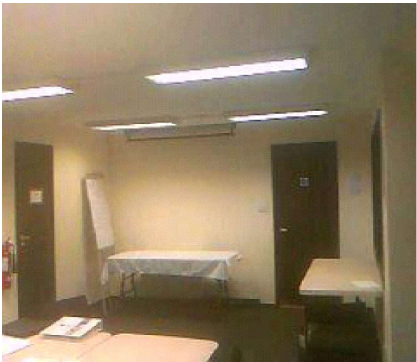
The first floor conference room (Room 2) was accessed and no suspect materials were found.

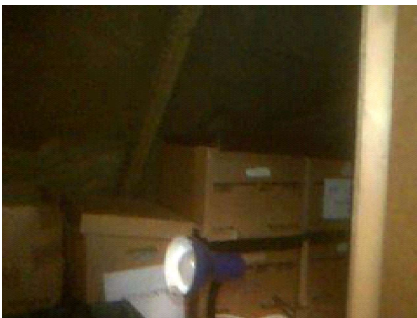
Void 1 to the eaves (Room 3 1st Floor) was accessed and no suspect materials were found.

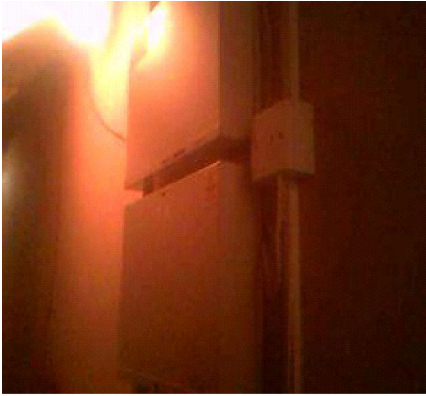
Void 2 to the eaves (Room 4 1st Floor) was accessed and no suspect materials were found.

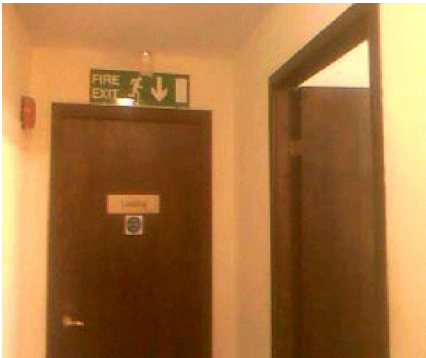
The staff hall way (First floor Room 5) was accessed and no suspect materials were found.

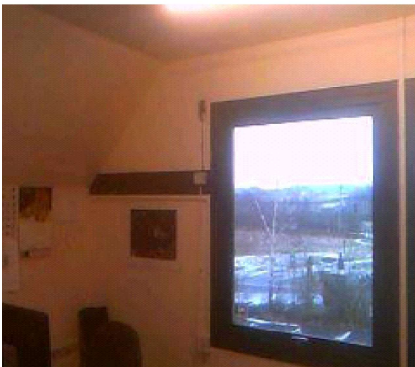
The reserves office (First floor Room 6) was accessed and no suspect materials were found.

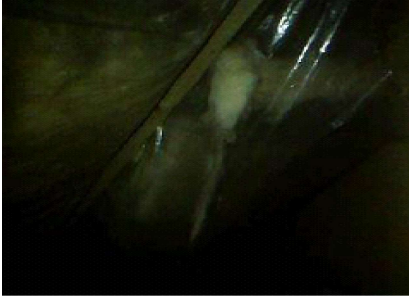
Void 3 to the eaves (Room 7 1st Floor) was accessed and no suspect materials were found.

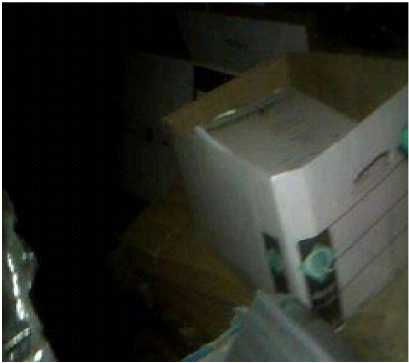
Void 4 to the eaves (Room 8 1st Floor) was accessed and no suspect materials were found.

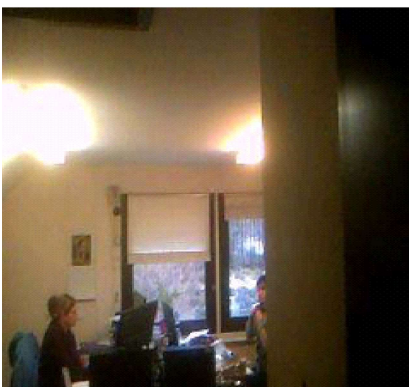
The BAP office (First floor Room 9) was accessed and no suspect materials were found.

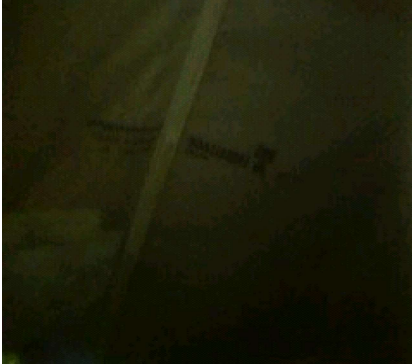
The eaves void 5 (First floor room 10) was accessed and no suspect materials were found.

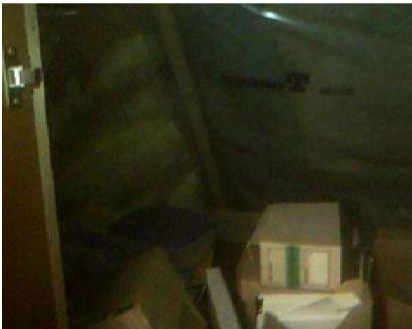
The eaves void 6 (First floor room 11) was accessed and no suspect materials were found.

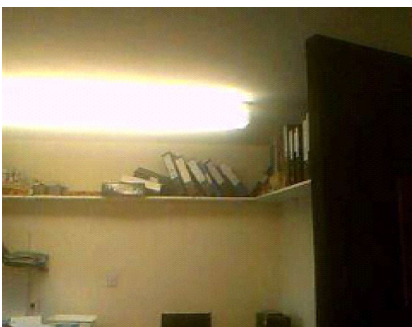
The education and marketing office (First floor room 12) was accessed and no suspect materials were found.

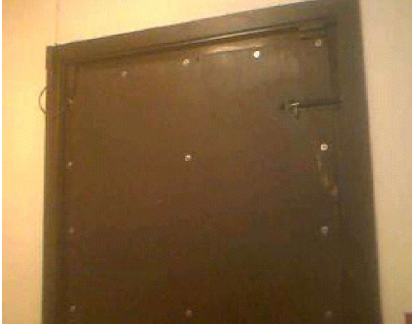
There was no access within the wood fire door to the balcony (First floor Room 13) further investigation may be required.

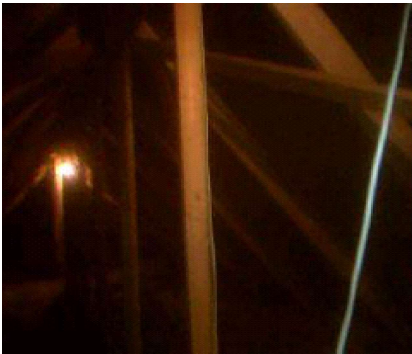
The roof void (Room 1) to the building was accessed and no suspect materials were found.

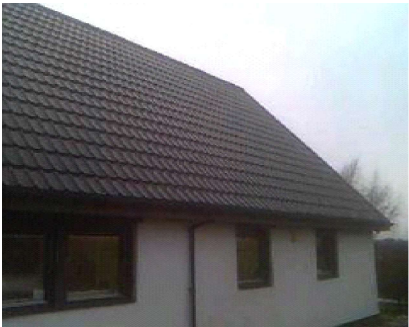
The external to the building was accessed and no suspect materials were found.
