ASBESTOS SURVEY REPORT FOR MARINE PARK PRIMARY SCHOOL,
HATFIELD SQUARE, SOUTH SHIELDS, TYNE AND WEAR, NE33 2RD.

Asbestos Register for

Marine Park Primary School, Hatfield Square, NE33 2RD

Date: 31 December 2024

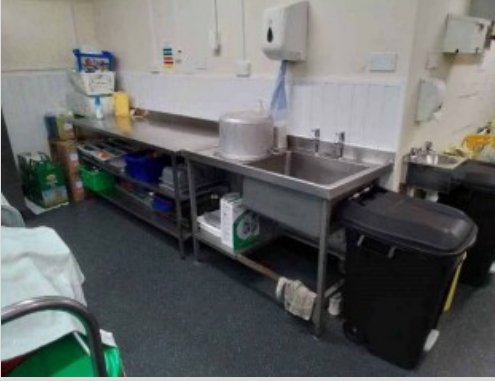
4	OQ002184	Under sink mat painted application	Kitchen G/011	No Risk

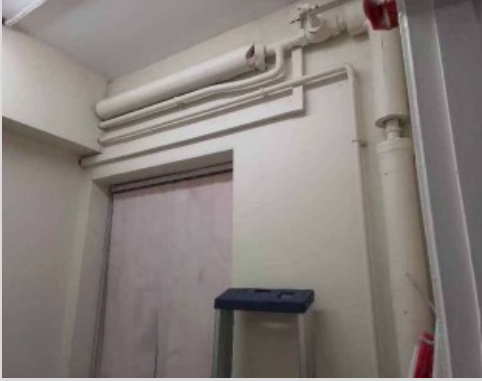
5	OQ002185	Pipework Insulation	Toilets G/015	No Risk

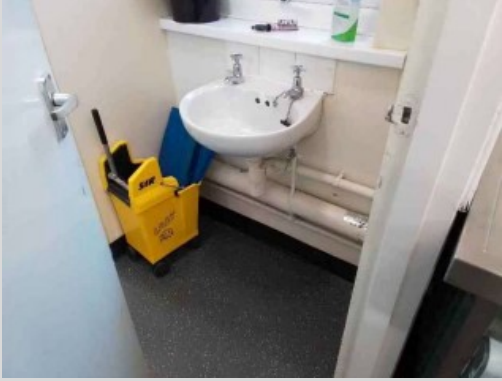
6	As OQ002185	Pipework Insulation	Washroom G/016	No Risk

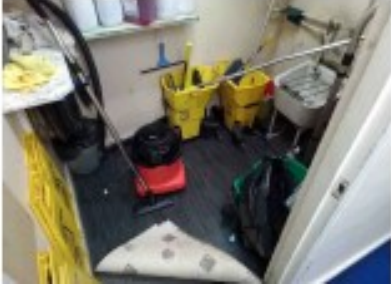
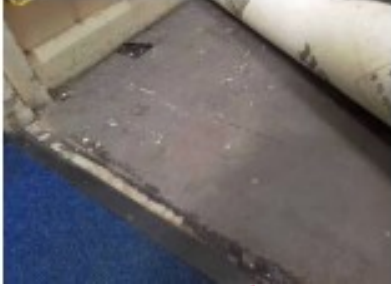
10	OQ002188	Floor tile grey	Cupboard Cleaners G/021	Very Low Risk – 12 Monthly
Photo 1: Wide Angle		Photo 2: Close-up

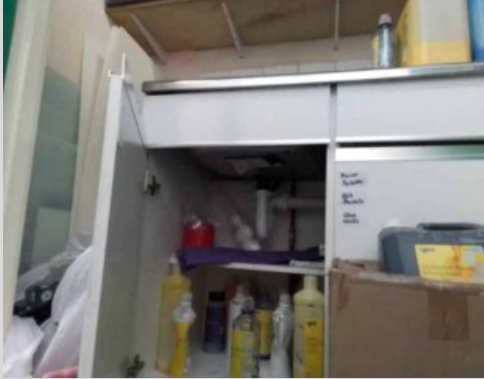
11	OQ002189	Under Sink Mat	Cupboard Store G/024	No Risk

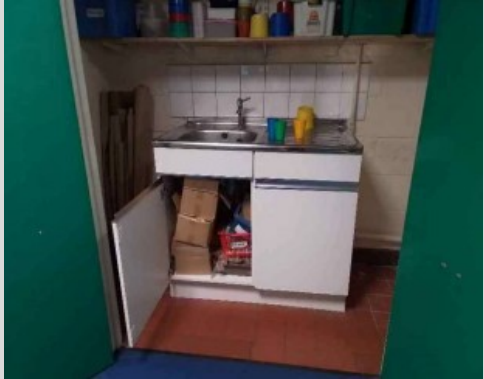
12	As OQ002189	Under Sink Mat	Cupboard G/027	No Risk

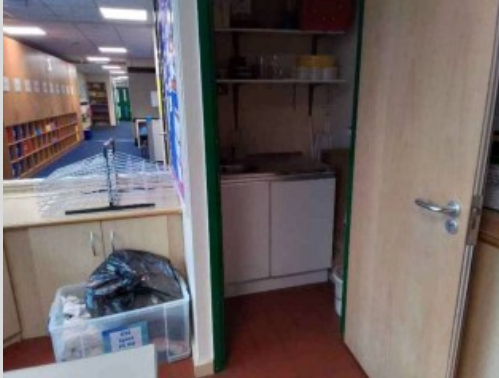
13	As OQ002189	Under Sink Mat	Cupboard G/041	No Risk

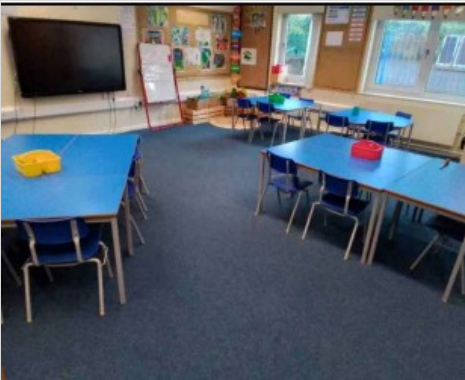
14	OQ002190	Floor tile Beige beneath screed	Classroom G/044	No Risk

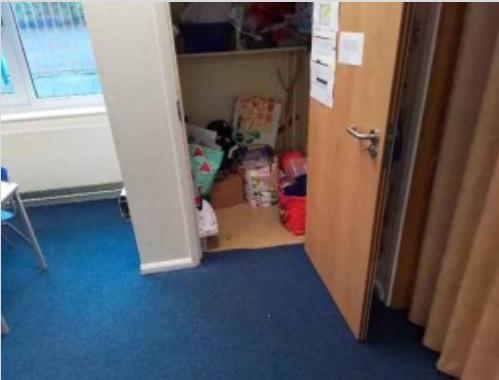
15	As OQ002190	Floor tile Beige beneath screed	Cupboard G/045	No Risk

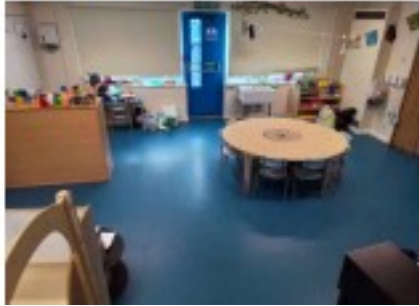
16	OQ002191	Floor former tile adhesive under lino	Classroom G/046	Very Low Risk – 12 Monthly
Photo 1: Wide Angle		Photo 2: Close-up

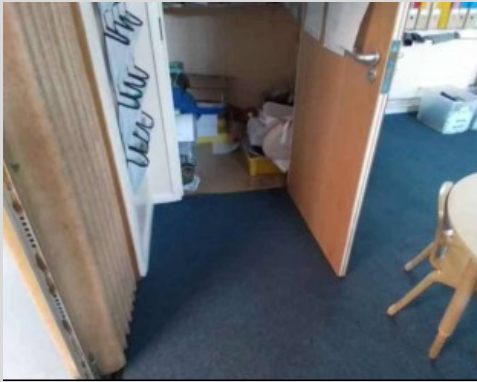
18	As OQ002190	Floor tile Beige beneath screed	Cupboard G/048	No Risk

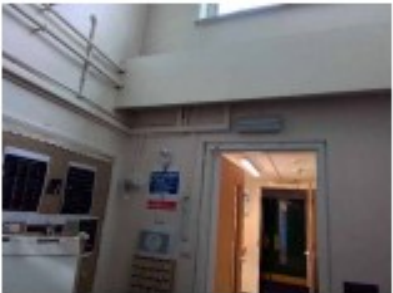
23	Presumed	Pipework Gaskets too deeply recessed to sample	Classroom G/063	Very Low Risk – 12 Monthly
Photo 1: Wide Angle		Photo 2: Close-up

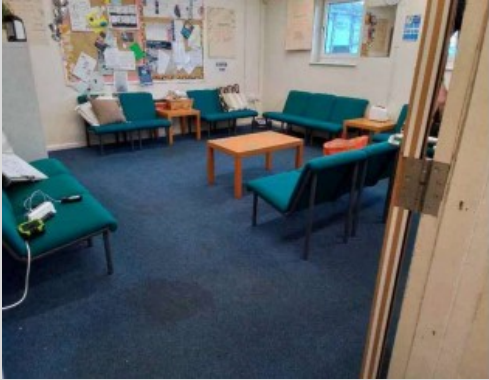
25	As OQ002181	Floor former tile adhesive	Staff Room G/069	No Risk

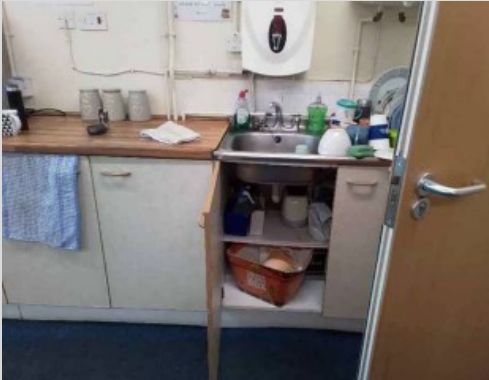
26	As OQ002189	Under Sink Mat	Staff Room G/069	No Risk

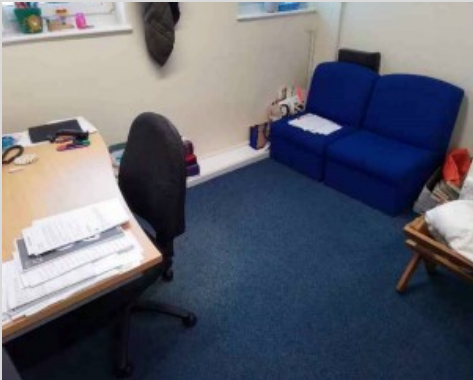
27	As OQ002181	Floor former tile adhesive	Office G/070	No Risk

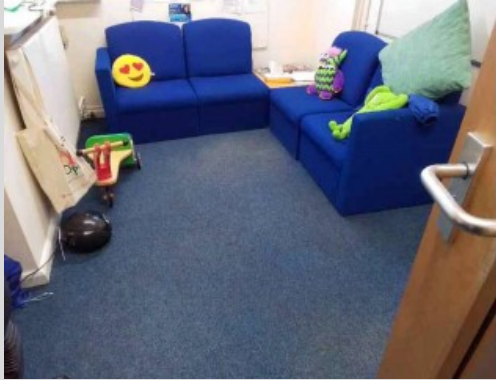
28	As OQ002181	Floor former tile adhesive	Office G/071	No Risk

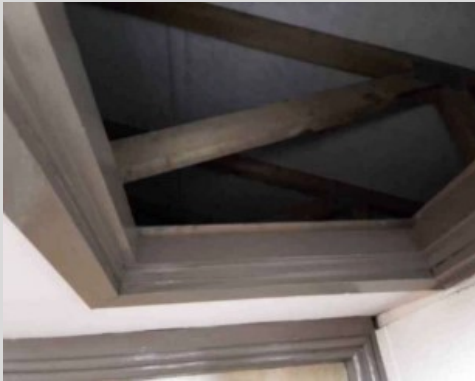
29	OQ002182	Pipework insulation – remnants from removed textile pipe insulation	Roof void R/001	No Risk

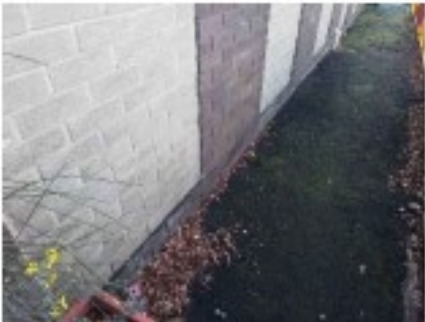
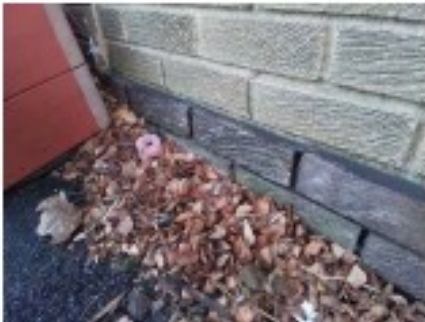
30	OQ002193	Damp proof course	External E/001	Very Low Risk – 12 Monthly
Photo 1: Wide Angle		Photo 2: Close-up

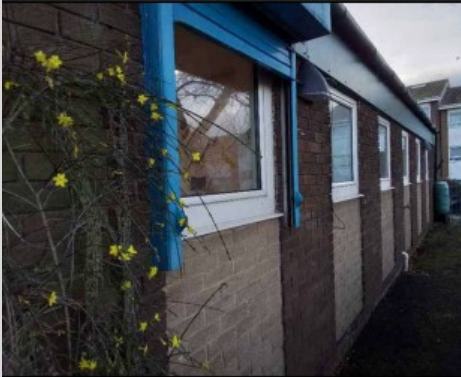
31	OQ002194	Window – remnants to sealant to wall	External E/001	No Risk

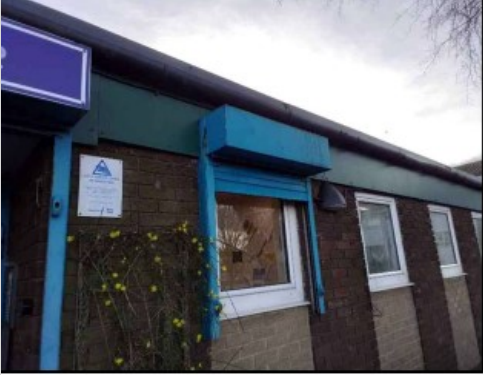
32	OQ002195	Fascias	External E/001	No Risk

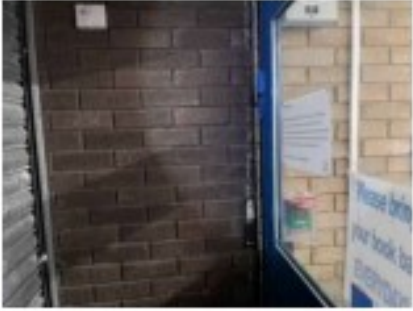
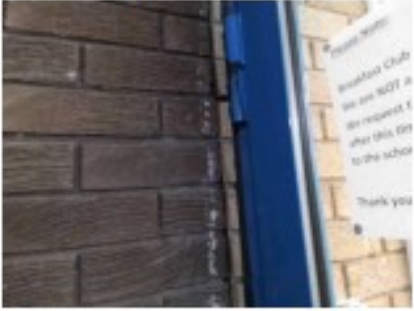
34	OQ002197	Damp proof course in brickwork cavity	External E/001	Very Low Risk – 12 Monthly
Photo 1: Wide Angle		Photo 2: Close-up

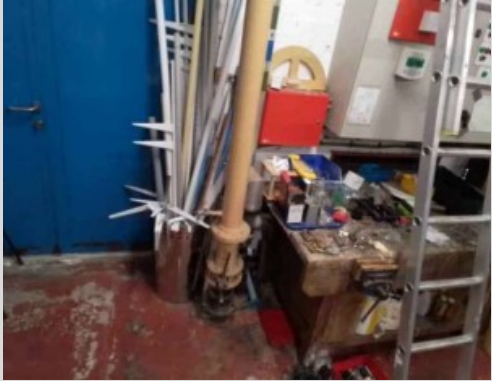
35	OQ002198	Pipework gaskets – gas supply	External E/003	No Risk

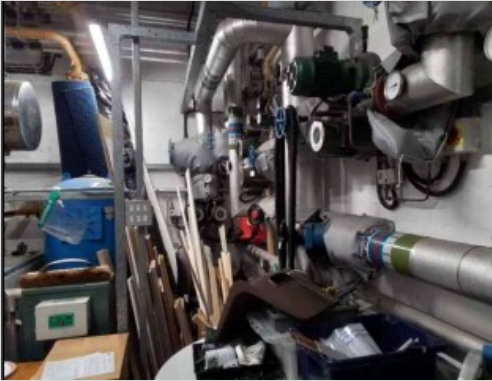
36	OQ002199	Pipework Gaskets	External E/003	No Risk

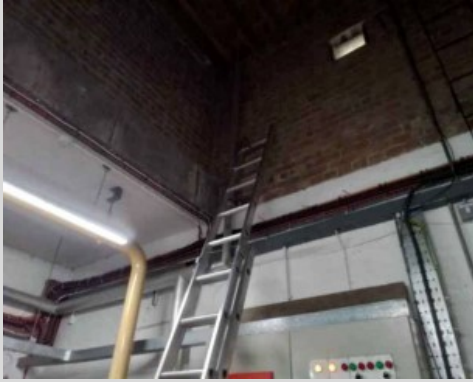
37	OQ002200	Debris/Residue to wall above electrics	External E/003	No Risk

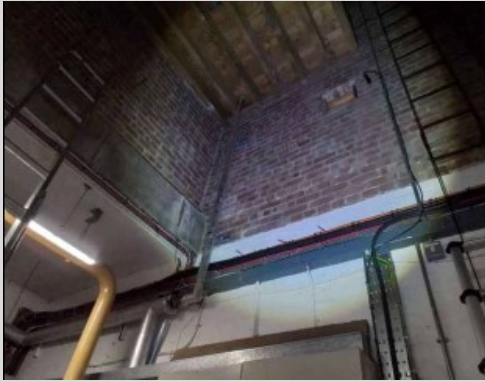
38	OQ002201	Debris/Residue to hardset to wall above electrics	External E/003	No Risk

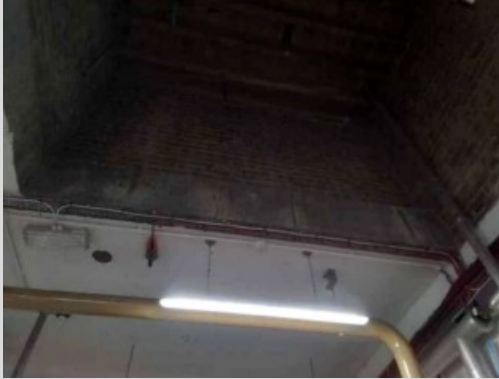
39	OQ002202	Damp proof course – between concrete and brick	External E/003	No Risk

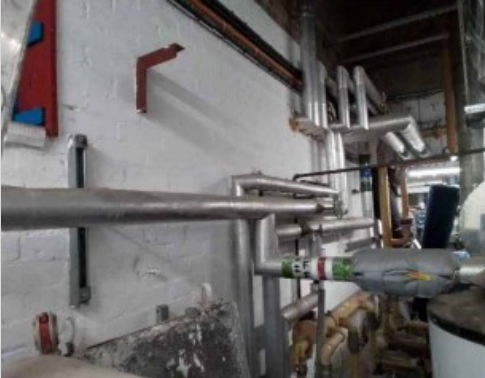
40	OQ002203	Debris/Residue to wall behind boilers	External E/003	No Risk

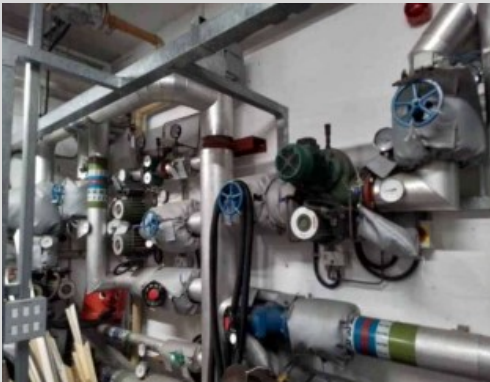
41	OQ002204	Debris/Residue to wall behind pumps	External E/002	No Risk

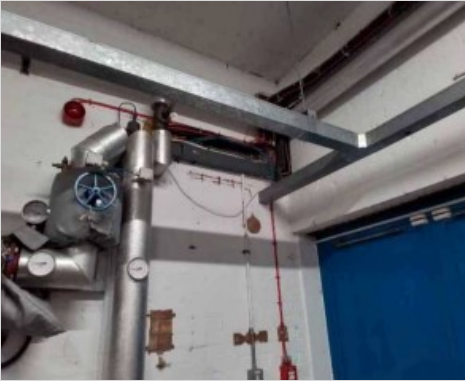
42	OQ002205	Debris/Residue inside conduit/cable tray	External E/003	No Risk
