VERIFICATION REQUIREMENTS FOR COVER SYSTEMS

Technical Guidance for
Developers,
Landowners and
Consultants

**Yorkshire and Lincolnshire
Pollution Advisory Group**

Version 3.3 – October 2016

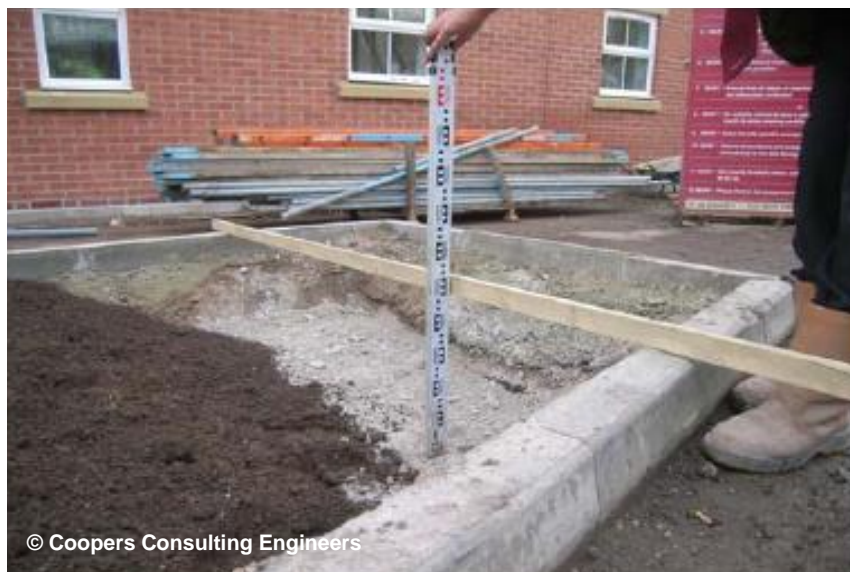
Photograph 1: Depth check of inert cover within area of public open space. Physical break layer and topsoil visible.

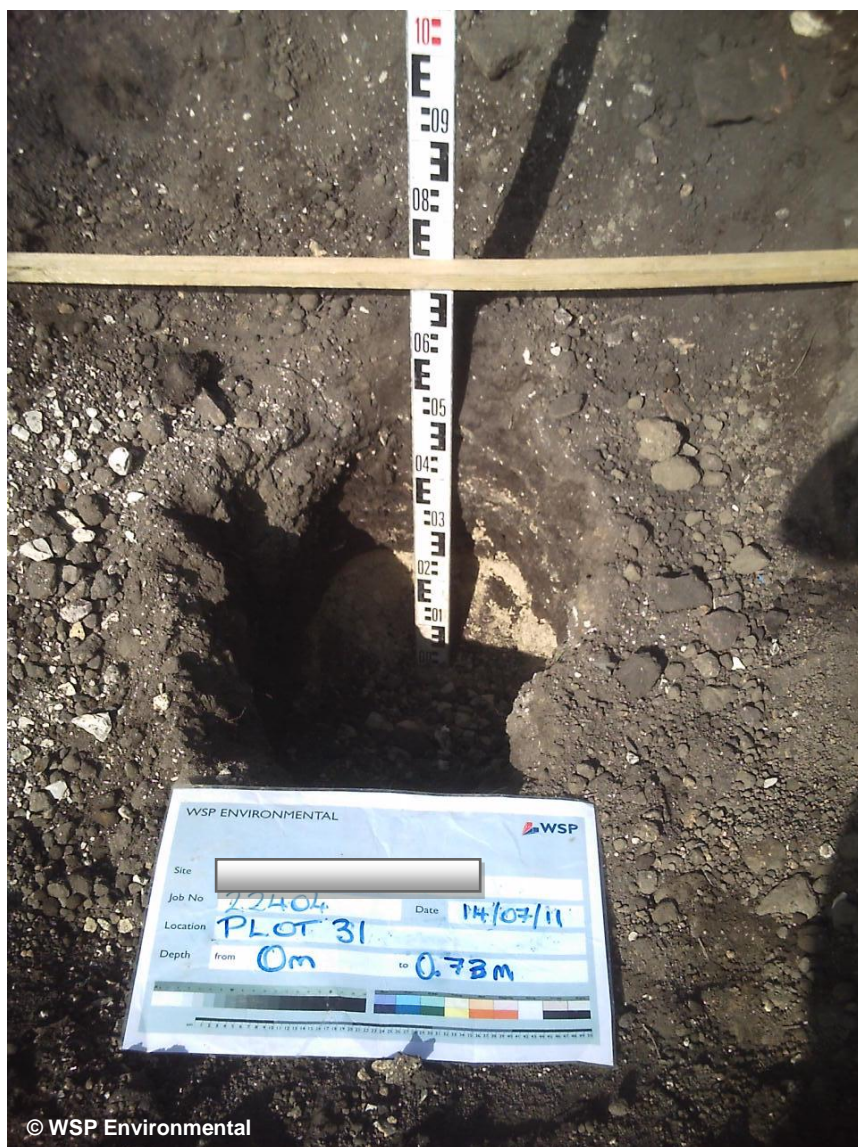
Photograph 2: Depth check of inert cover with Site & Location Information Board.

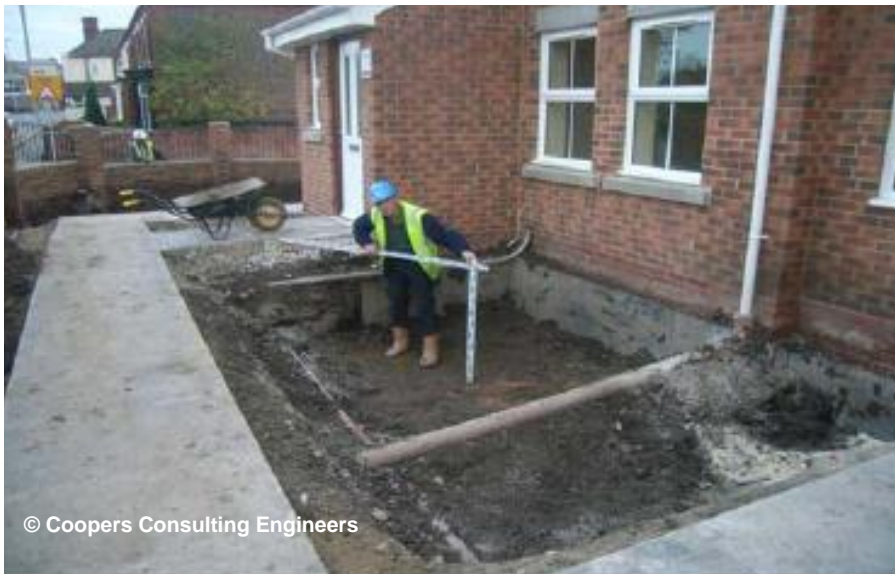
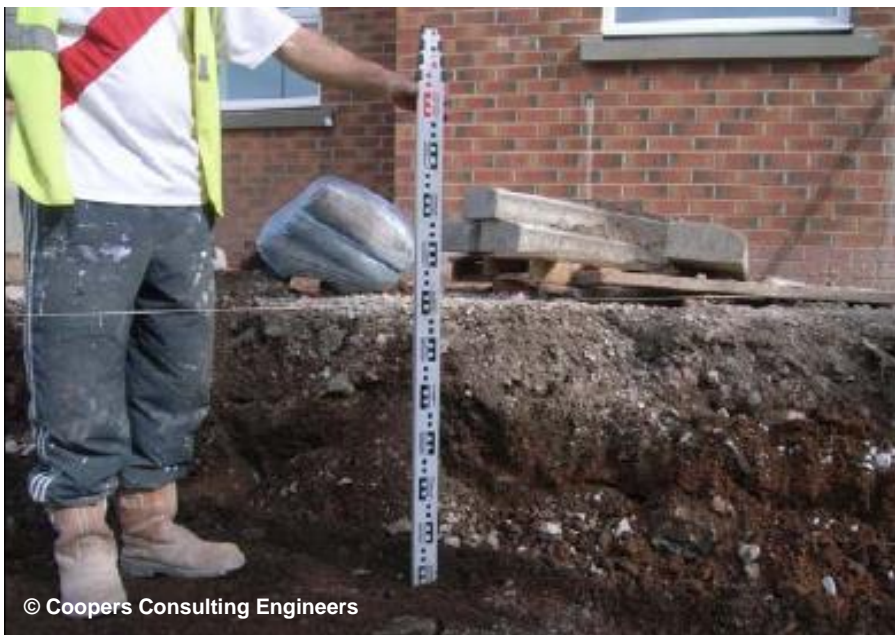
Photographs 3 & 4:
Depth check of inert
cover within areas of
front gardens.

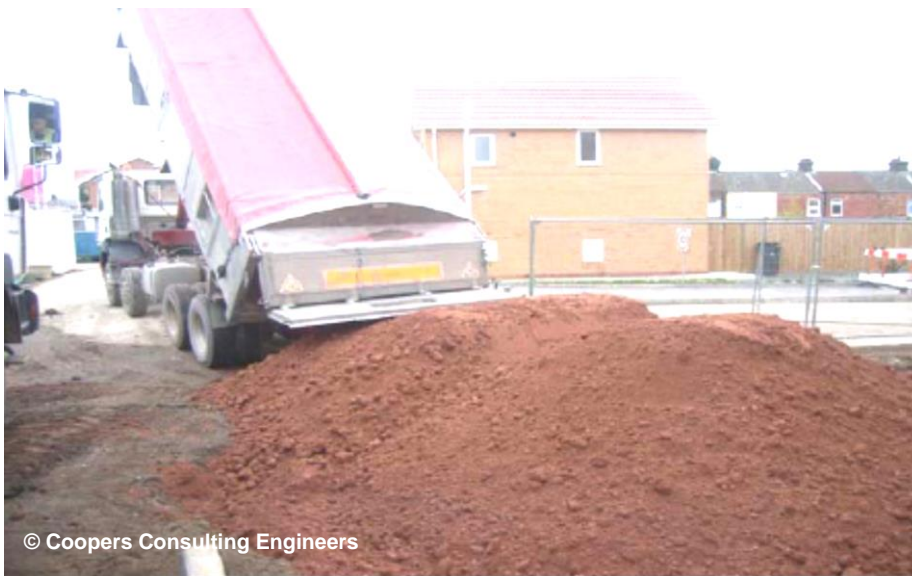
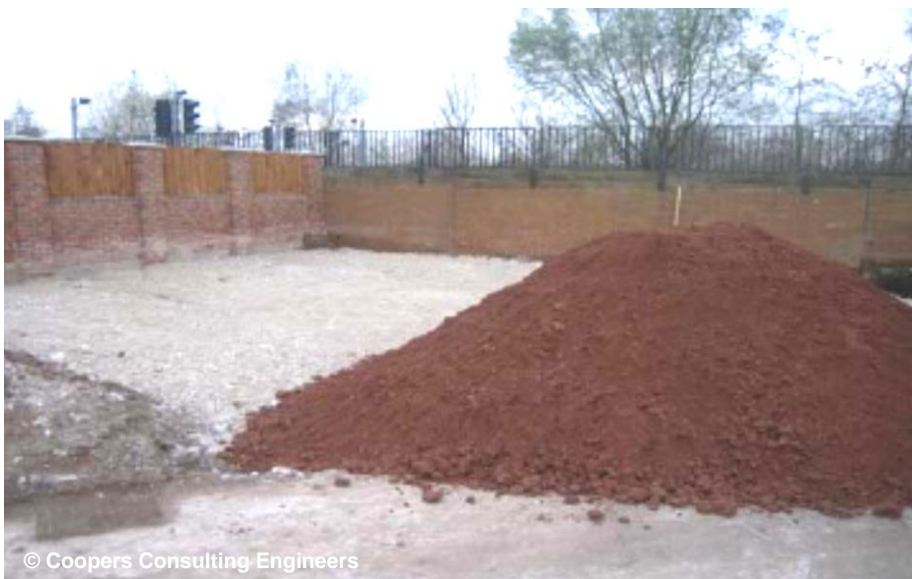
Photographs 9 and 10: Inert crushed sandstone being delivered with remediation break layer visible in Photograph 10. The spatial area of the remediation can be observed from these photographs (old terrace housing in Photograph 9 and traffic lights in photograph 10).

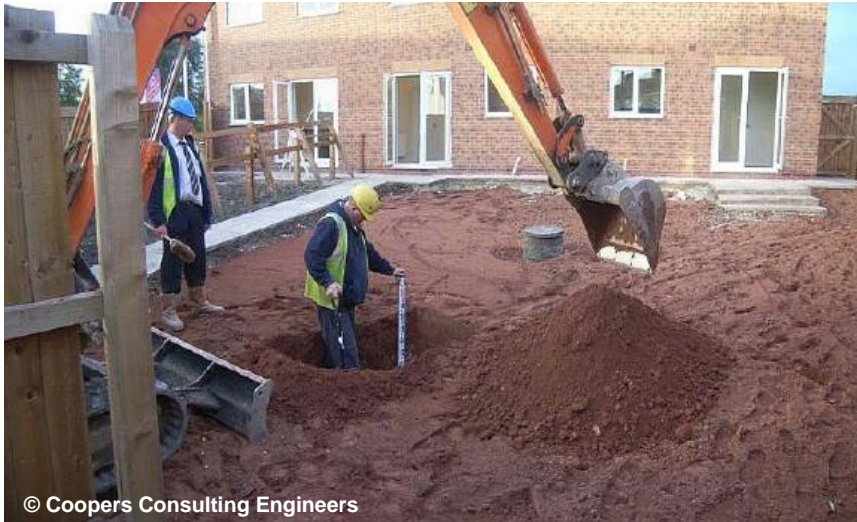
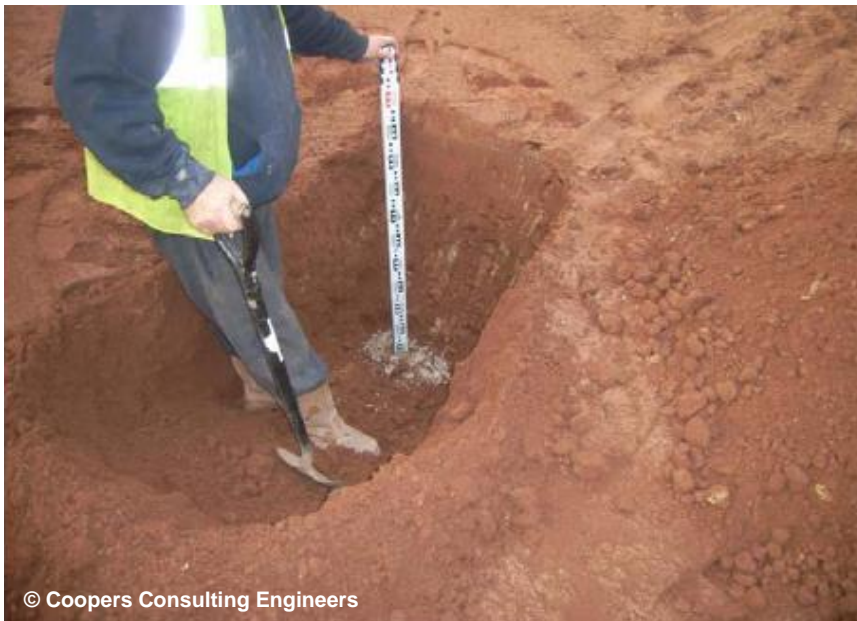
Photographs 11 and 12 show the remediation of the rear garden, with a significant depth (1.0m) of inert cover. Remediation break layer visible at the base of the excavation. Photograph 11 has been stitched to form a panoramic photograph and
