VERIFICATION REQUIREMENTS FOR COVER SYSTEMS

Yorkshire and Lincolnshire Pollution Advisory Group

Version 3.3 - October 2016

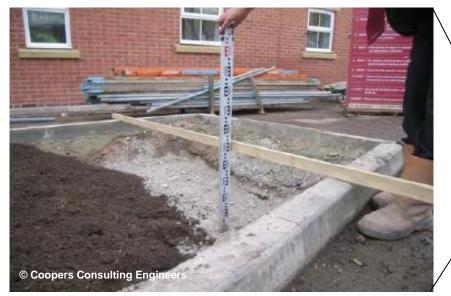
Photograph 1: Depth check of inert cover within area of public open space. Physical break layer and topsoil visible.

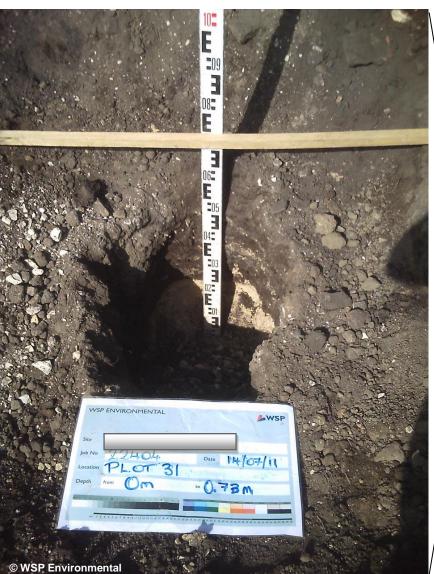
Photograph 2: Depth check of inert cover with Site & Location Information Board

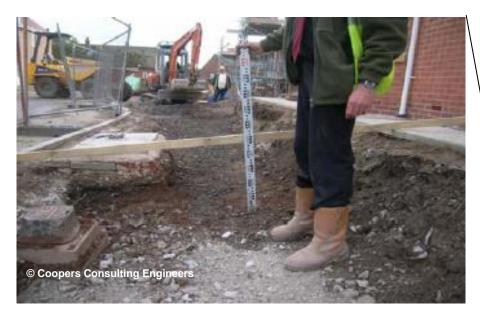
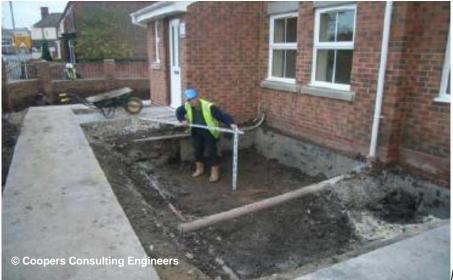
Photographs 3 & 4: Depth check of inert cover within areas of front gardens.

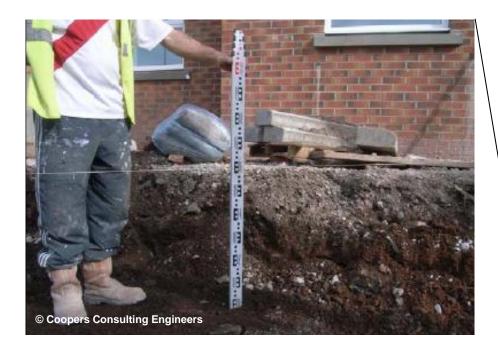
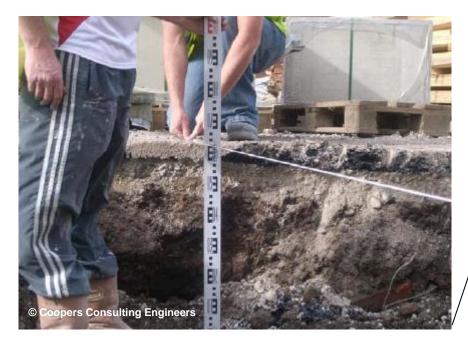
Photographs 5 and 6: Depth check of inert cover within rear gardens. Taut string line spans across excavation.

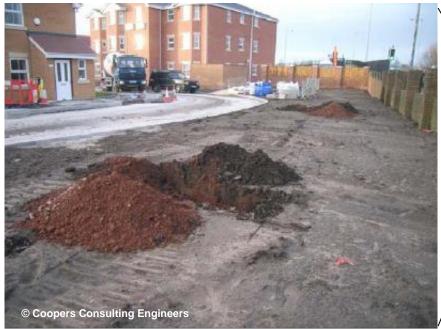
Photograph 7 shows the spatial location of the verification pit.

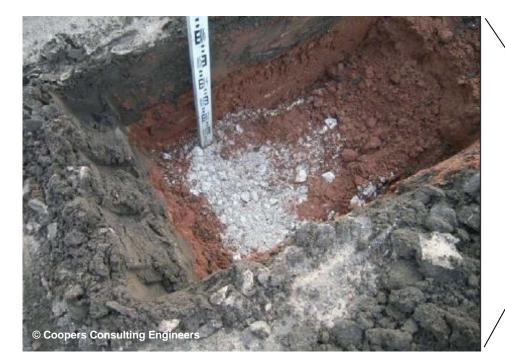
Photograph 8:
Excavation within public open space and verification pit showing the presence of a remediation break layer at the base, a crushed sandstone inert fill overlain by topsoil.

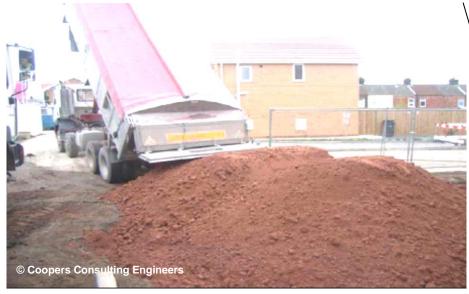
Photographs 9 and 10: Inert crushed sandstone being delivered with remediation break layer visible in Photograph 10. The spatial area of the remediation can be observed from these photographs (old terrace housing in Photograph 9 and traffic lights in photograph 10).

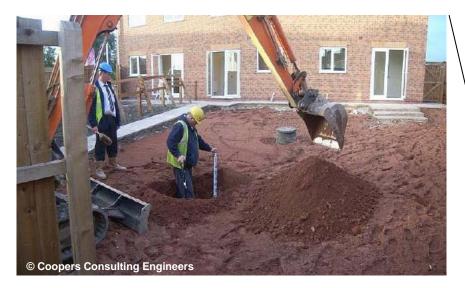
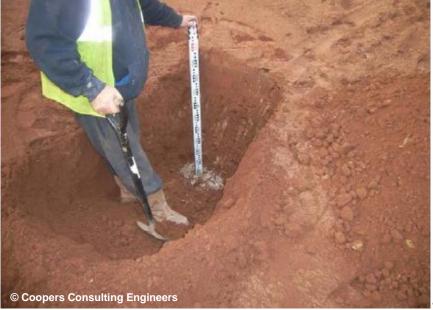
Photographs 11 and 12 show the remediation of the rear garden, with a significant depth (1.0m) of inert cover. Remediation break layer visible at the base of the excavation. Photograph 11 has been stitched to form a panoramic photograph and
