ASBESTOS SURVEY REPORT FOR THE MINI PLACE, EDWARD THOMPSON SITE, RICHMOND STREET, SUNDERLAND, SR5 1BQ

## Asbestos Register for

**The Mini Place Edward Thompson Site, Richmond Street,  
Sunderland, SR5 1BQ**

**Date: 11 October 2024**

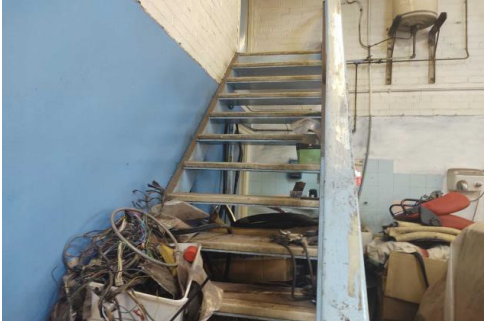
### **Item 1 Ref: 22-47231-4**

The floor – vinyl to stairs (Area 1 Garage) does not contain asbestos.

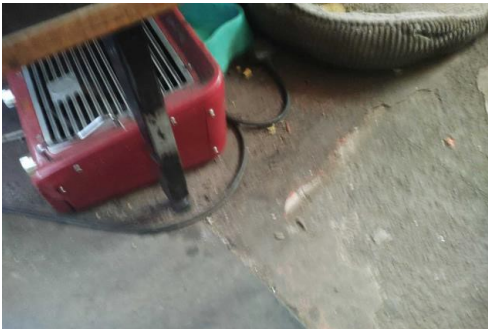
### **Item 2 Ref: 22-47231-1**

The floor – vinyl (Area 2 Office & Store) does not contain asbestos.

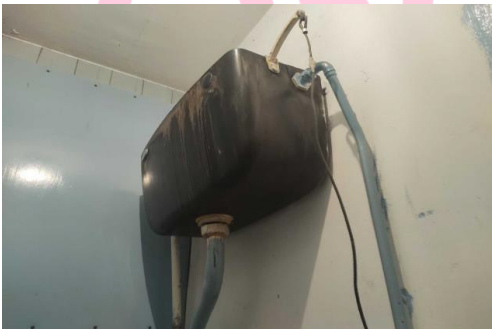
### **Item 3 Ref: 22-47231-2**

The toilet (Bakelite) contains asbestos.

Any change in its appearance should be recorded and passed to Property Services.

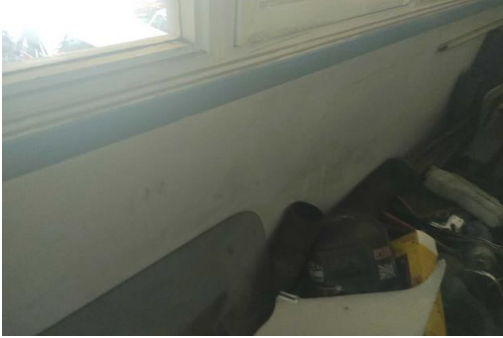
**Item 4 Ref: 22-47231-3**

The infill panels – panels below windows (insulating board) (Area 8 Office) do not contain asbestos.

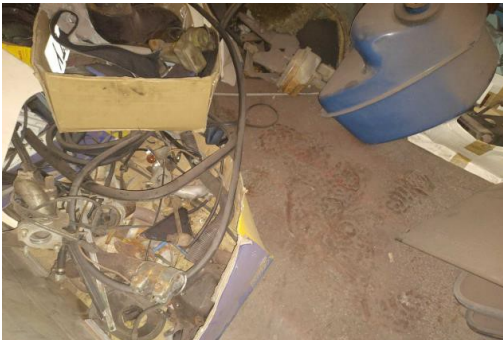
**Item 5 Ref: 22-47231-4**

The floor – vinyl (Area 8 Office) does not contain asbestos.

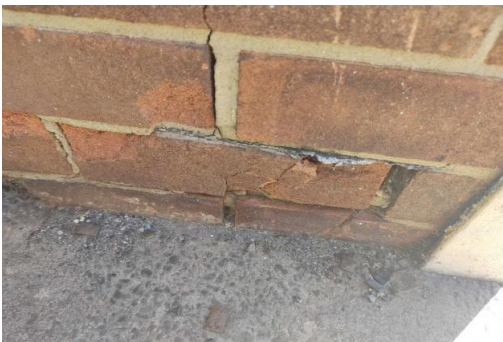
**Item 6 Ref: 22-47231-5**

The damp proof course to walls (Area 9 External) contains asbestos.

Any change in its appearance should be recorded and passed to Property Services.
