ASBESTOS SURVEY REPORT FOR RICHARD AVENUE PRIMARY SCHOOL CARETAKERS HOUSE, SUNDERLAND

RICHARD AVENUE PRIMARY SCHOOL – CARETAKERS HOUSE

Richard Avenue Primary Caretakers House - Last updated 12/11/2024 – Version 3

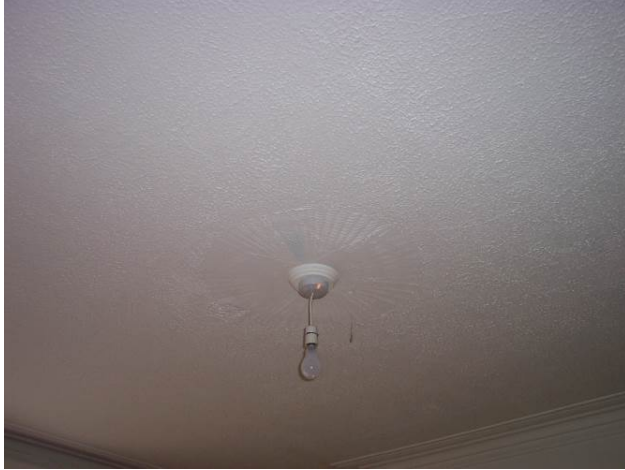
Items 1 -11 Ref: 0316KB2

The textured coating to the ceilings throughout the caretaker's house contain asbestos.

Any change in its appearance should be recorded and passed to Property Services.
