ASBESTOS SURVEY REPORT FOR 1 – 4 LOMBARD STREET,
SUNDERLAND, SR1 2HS.

Asbestos Register for

1 – 4 Lombard Street, Sunderland, SR1 2HS

Date: 04 December 2023

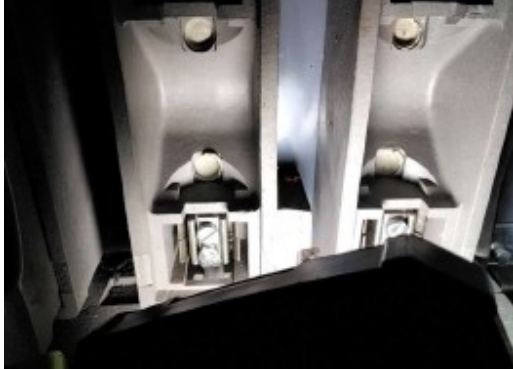
Item 4 Ref: As KX001817

The putty to mounting screws in switch box in Electrical Cupboard (G/005) contains asbestos.

Any change in its appearance should be recorded and passed to Property Services.

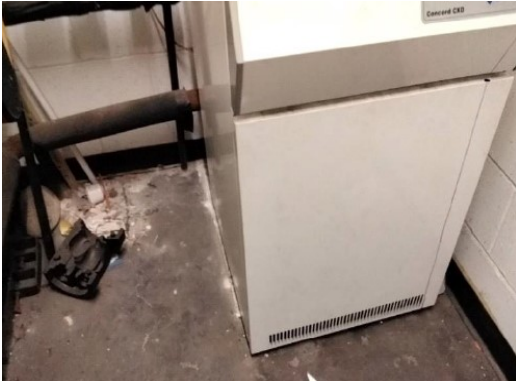
Item 7 Ref: KX001816

The floor plinth under boiler in the Boiler Room (G/011) does not contain asbestos.

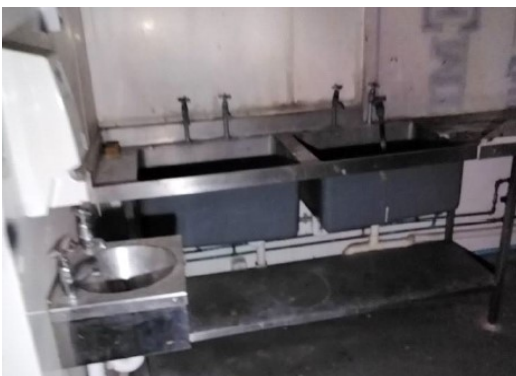
Item 9 Ref: KX001818

The under sink mat in the Kitchen (G/016) does not contain asbestos.
