ASBESTOS SURVEY REPORT FOR SOUTHWICK CEMETERY, EAST LODGE, WEMBLEY ROAD, SUNDERLAND, SR5 5TB

Southwick Cemetery East Lodge

Premises Manager / Samo: - Tenant Date: 25 February 2025

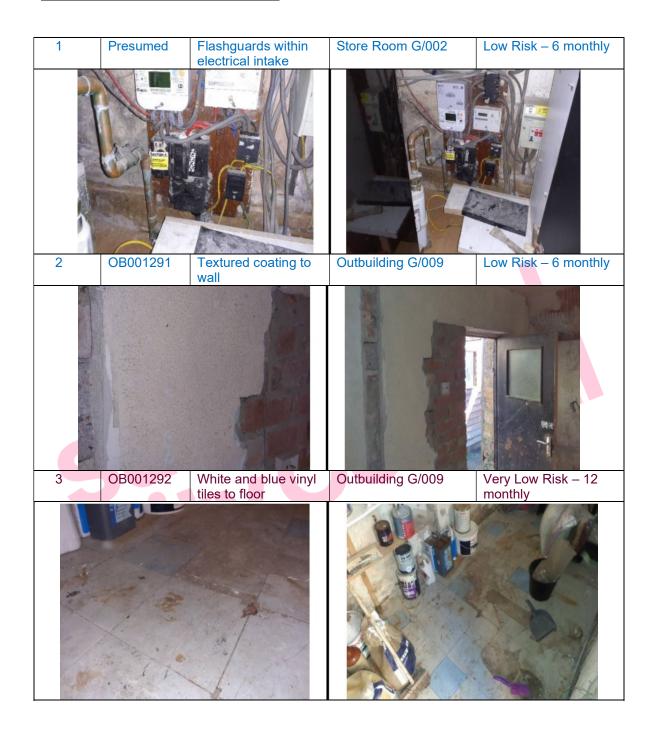
Photographs of Areas Sampled

Item No.	Sample Ref.	Area Sampled	Location Name	Inspection Frequency
1	Presumed	Flashguards within electrical intake	Store Room G/002	Low Risk – 6 monthly
2	OB001291	Textured coating to wall	Outbuilding G/009	Low Risk – 6 monthly
3	OB001292	White and blue vinyl tiles to floor	Outbuilding G/009	Very Low Risk – 12 monthly
4	OB001293	Putty/mastic to outbuilding window	External E/001	No Risk
5	OB001294	Putty/mastic to outbuilding door frame	External E/001	No Risk
6	OB001295	Cement undercloak to porch roof gable only	External E/001	Very Low Risk – 12 monthly
