ASBESTOS SURVEY REPORT FOR FARRINGDON ACADEMY SCHOOL, SUNDERLAND

**FARRINGDON ACADEMY SCHOOL,
SUNDERLAND**

Date: 06 December 2024

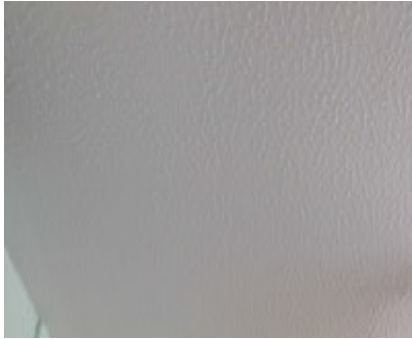
Item 1 Ref: 101894-1

The textured coating to the ceiling in the lobby of the behaviour unit (Rm 001) contains asbestos.

Any change in its appearance should be recorded and passed to Property Services.

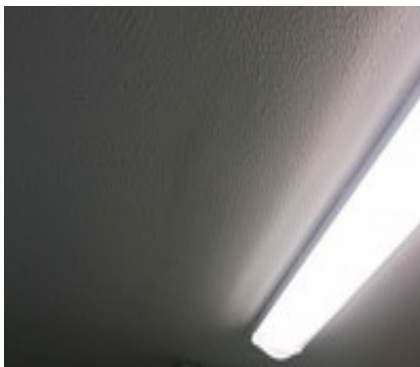
Item 2 – As 101894-1

The textured coating to the ceiling in the kitchen (Room 002) contains asbestos.

Any change in its appearance should be recorded and passed to Property Services.

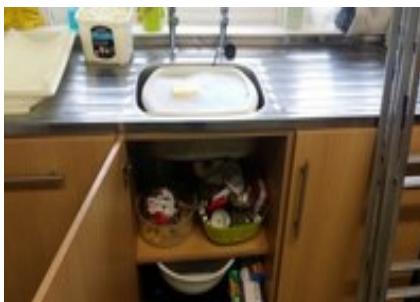
Item 3 Ref: 101894-2

The sink pad to the kitchen the behaviour unit (Rm 002) does not contain asbestos.

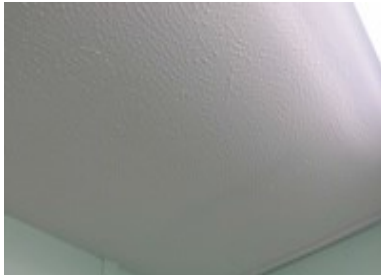
Item 4 As: 101894-1

The textured coating to the ceiling in the toilet of the behaviour unit (Rm 003) contains asbestos.

Any change in its appearance should be recorded and passed to Property Services.

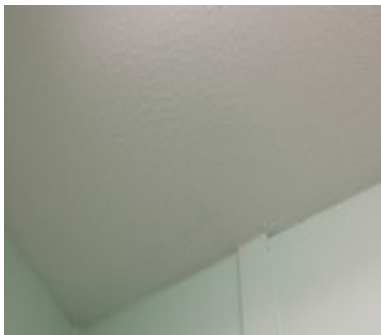
Item 5 As: 101894-1

The textured coating to the ceiling in the staff toilet of the behaviour unit (Rm 004) contains asbestos.

Removed October 2024

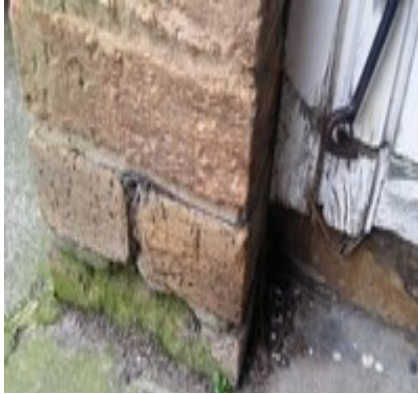
Item 13 Ref: 101894-5

The damp proof course to the behaviour unit (External) contains asbestos.

Any change in its appearance should be recorded and passed to Property Services.

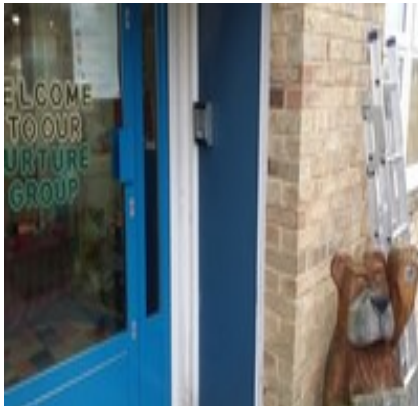
Item 14 Ref: 101894-6

The panels to the side of the door to the behaviour unit (External) contain asbestos.

Any change in its appearance should be recorded and passed to Property Services.

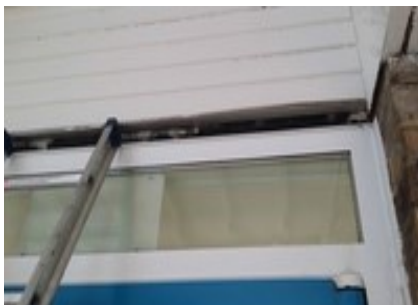
Item 15 Ref: 101894-7

The membrane behind the fascia to the external of the behaviour unit does not contain asbestos.

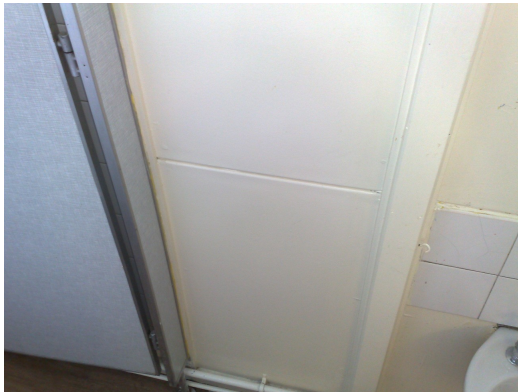
Item 146 Ref: KR09/76

The wall panels in the Behaviour Unit do not contain asbestos.

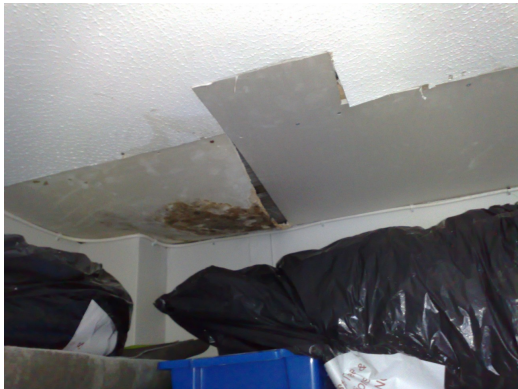
Item 147 Ref: KR09/78

The ceiling panels in the Behaviour Unit do not contain asbestos.

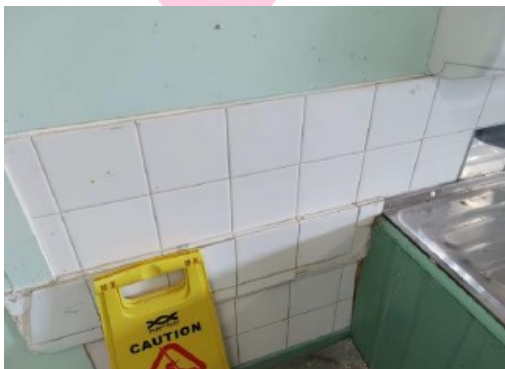
Item 157 Ref: 21-34101-2

The adhesive behind ceramic tiles (Area 1/Main Room) does not contain asbestos.

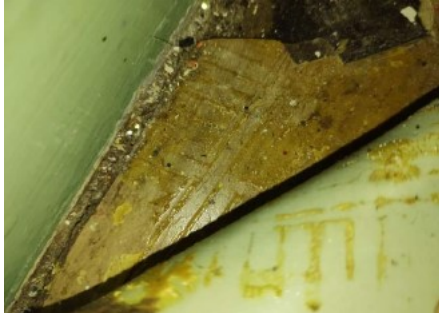
Item 158 Ref: 21-34101-3

The brown vinyl floor tile (Area 1/Main Room) contains asbestos.

Any change in its appearance should be recorded and passed to Property Services.

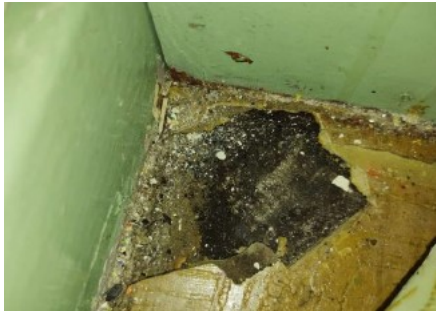
Item 159 Ref: 21-34101-4

The composite floor (Area 1/Main Room) does not contain asbestos.

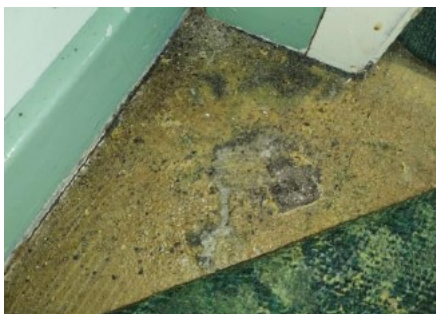
Item 160 Ref: 21-34101-4

The composite floor (Area 2/Back Office) does not contain asbestos.

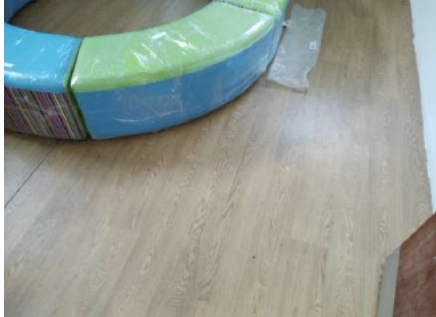
Item 161 Ref: 21-34101-4

The composite floor (Area 3/Side Office) does not contain asbestos.

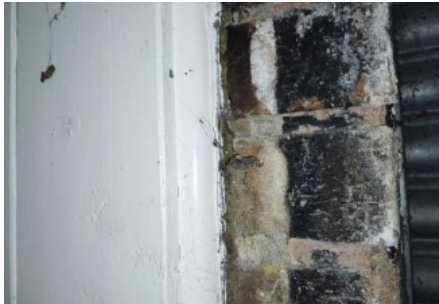
Item 165 Ref: 21-34101-8

The sealant between wood cladding and brickwork (Area 6/Side Lobby) does not contain asbestos.

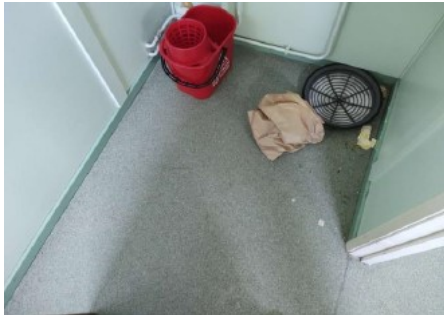
Item 174 Ref: 21-34101-4

The composite floor (Area 8/Staff WC) does not contain asbestos.

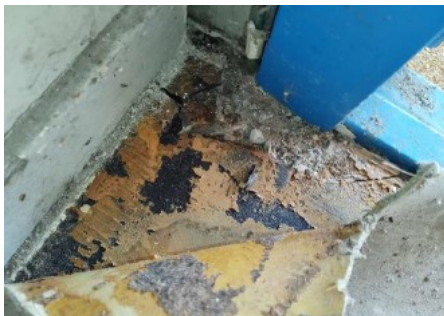
Item 175 Ref: 21-34101-4

The composite floor (Area 9/Boiler Room) does not contain asbestos.

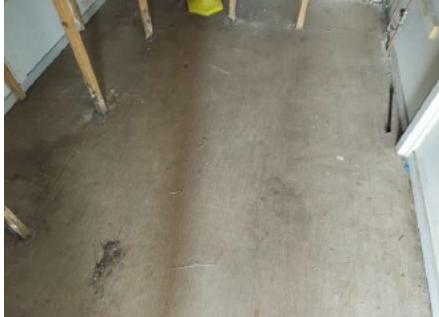
Item 176 Ref: 21-34101-6

The beige vinyl floor covering (Area 9/Boiler Room) contains asbestos.

Any change in its appearance should be recorded and passed to Property Services.

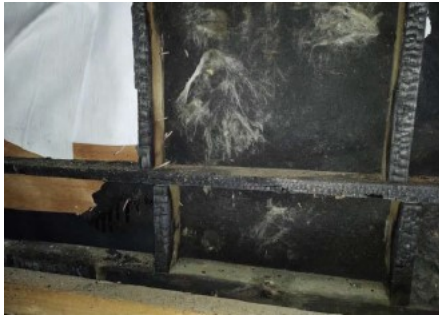
Item 177 Ref: 21-34101-12

The bitumen felt lining to wood walls (Area 10/Ceiling void) does not contain asbestos.

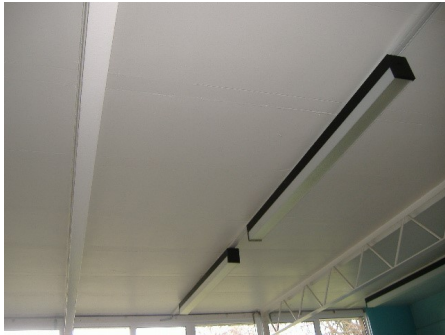
Item 20 - Ref: AW0438/08

The ceiling coating to the classroom (Rm 0/02) does not contain asbestos.

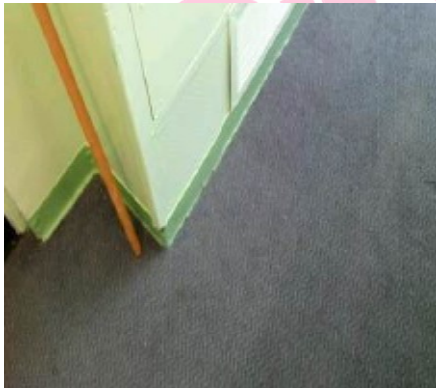
Item 21 - Ref: AW0439/08

The wall kick protection to the classroom (Rm 0/02) contained asbestos.

This was removed in July 2015.

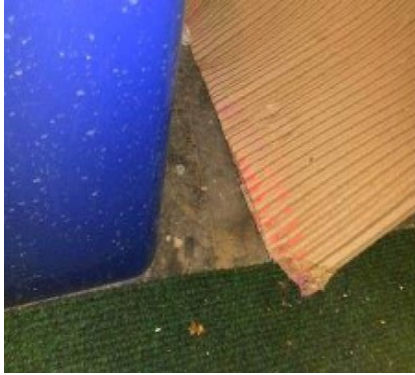
Item 22 - Ref: AW0440/08

The floor tiles to the fire hose cupboards in the corridor (Rm 0/18) contain asbestos.

Any change in its appearance should be recorded and passed to Property Services.

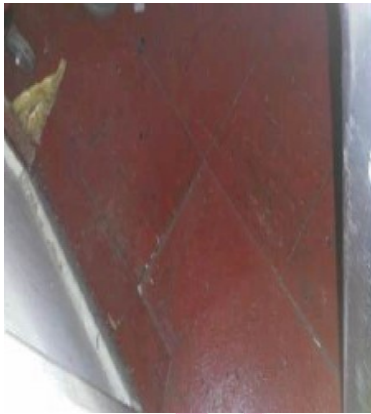
Item 23 - Ref: AW0441/08

The black floor tiles (painted red) to the store room (Rm 0/25) contain asbestos.

Any change in its appearance should be recorded and passed to Property Services.

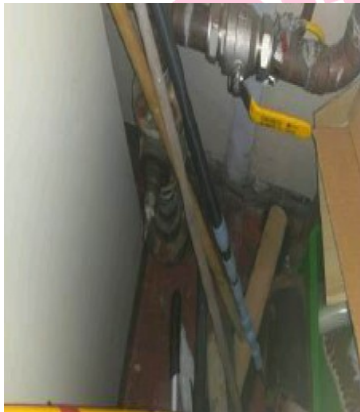
Item 24 - Ref: Presumed

The gaskets to the pipework in the store room (Rm 0/25) are presumed to contain asbestos.

Any change in its appearance should be recorded and passed to Property Services.

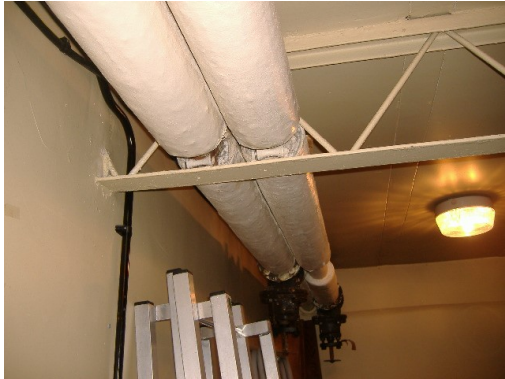
Various- Ref: AW0442/08

The pipework insulation to the store room (Rm 0/43) contains asbestos.

Similar insulation is located in Rm 0/44.

Any change in its appearance should be recorded and passed to Property Services.

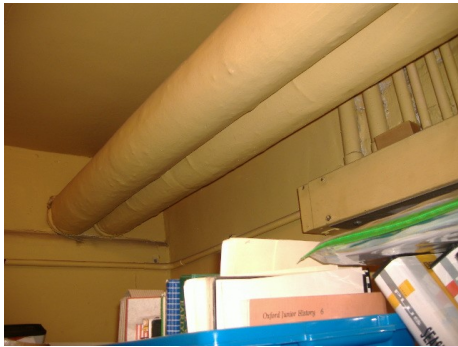
Item 27 - Ref: AW0443/08

The pipework insulation to the store room (Rm 0/45) contains asbestos.

Any change in its appearance should be recorded and passed to Property Services.

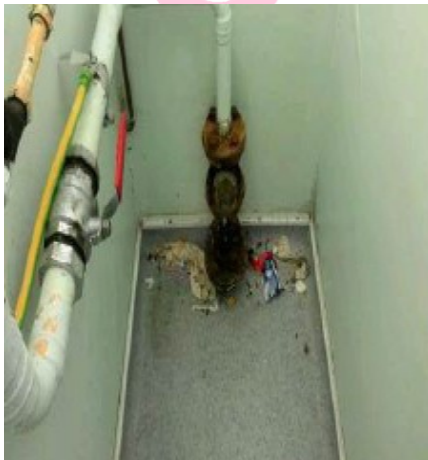
Item 28 - Ref: Presumed

The gaskets to the female toilets (Rm 0/48) are presumed to contain asbestos.

Any change in its appearance should be recorded and passed to Property Services.

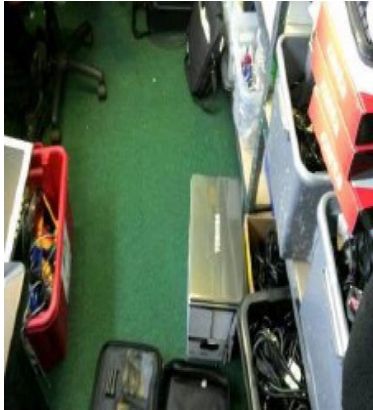
Item 29- Ref: AW0444/08

The grey floor tiles to the ICT office (Rm 0/50) contain asbestos.

Any change in its appearance should be recorded and passed to Property Services.

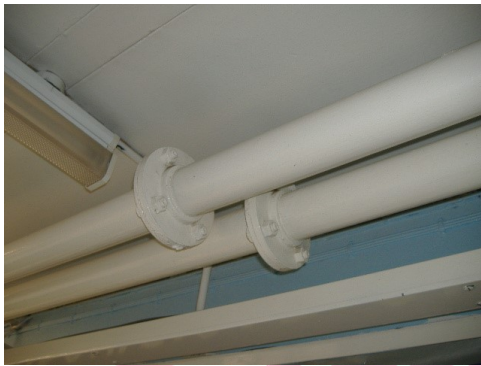
Item 30 - Ref: Presumed

The gaskets to corridor (Rm 0/59) are presumed to contain asbestos.

Any change in its appearance should be recorded and passed to Property Services.

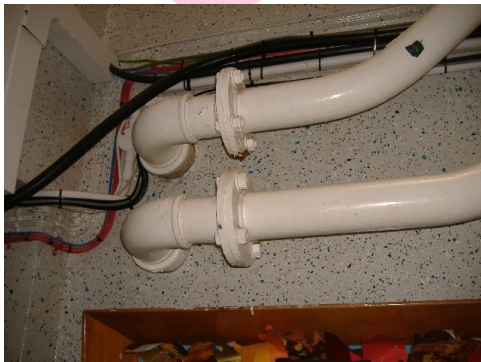
Item 31 - Ref: Presumed

The gaskets to corridor (Rm 0/83) are presumed to contain asbestos.

Any change in its appearance should be recorded and passed to Property Services.

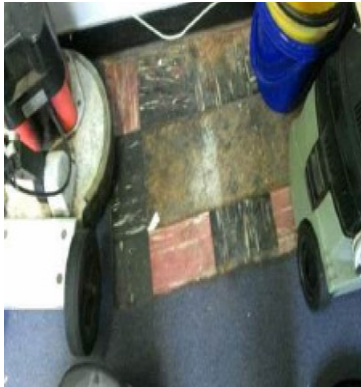
Item 32 - Ref: WC0473/08

The black/red floor tiles to the store room (Rm 0/85) contained asbestos.

These were removed in July 2015.

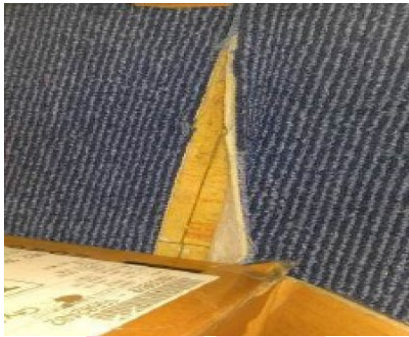
Item 33 - Ref: WC0474/08

The beige floor tiles to the office (Rm 0/86) contained asbestos.

These were removed in May 2016.

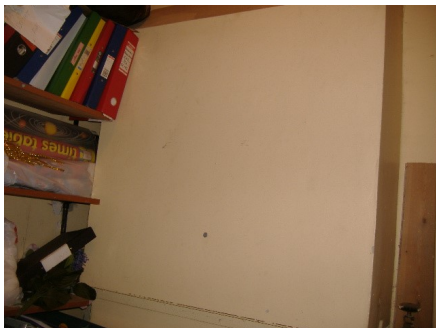
Item 34 - Ref:WC0475/08

The boxing to the rear of the heater in the store room (Rm 0/92) contains asbestos.

Any change in its appearance should be recorded and passed to Property Services.

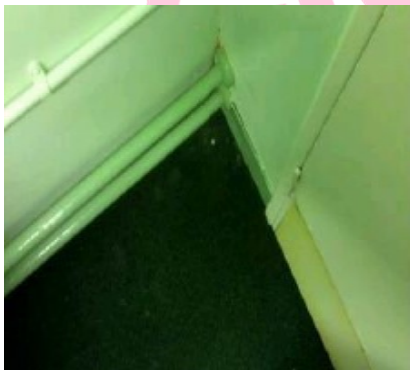
Item 37 - Ref: WC0478/08

The wall kick protection to the office (Rm 0/105) contains asbestos.

This was removed in February 2016.

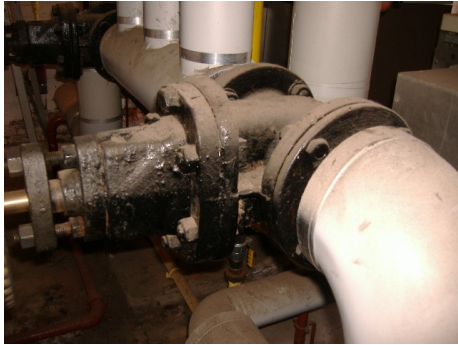
Item 38- Ref: Presumed

The gaskets to the boiler room (Rm 0/109) were presumed to contain asbestos.

These have been removed and replaced.

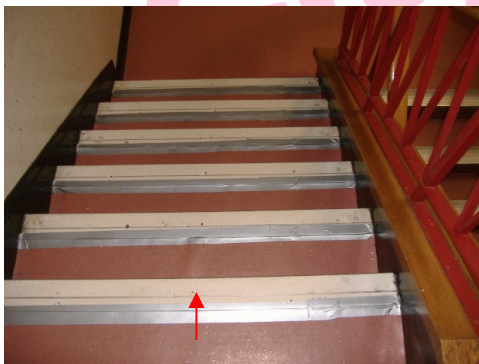
Item 40 - Ref:WC0480/08

The stair nosing to the stairwell (Rm 0/111) contained asbestos.

These were removed in November 2015.

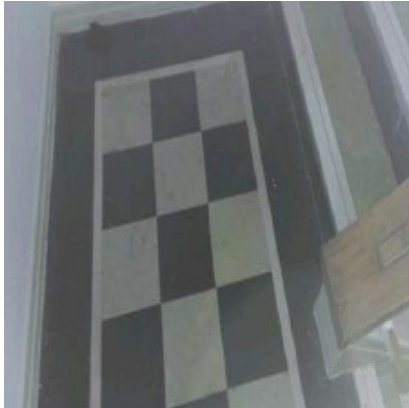
Item 41- Ref: WC0482/08

The floor tiles to stairwell (Rm 0/112) contain asbestos.

Any change in its appearance should be recorded and passed to Property Services.

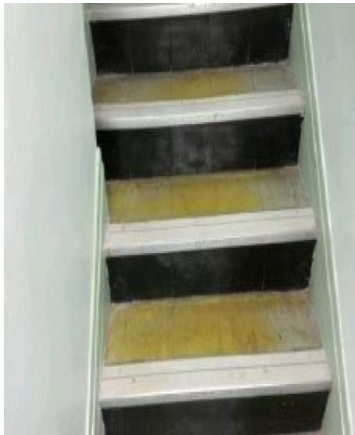
Item 42 - Ref: WC0481/08

The stair nosing to the stairwell (Rm 0/112) contains asbestos.

Any change in its appearance should be recorded and passed to Property Services.

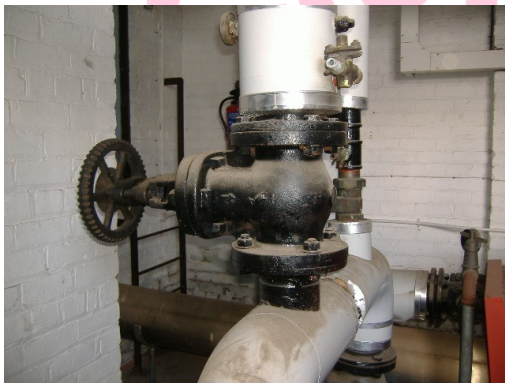
Item 43 - Ref: Presumed

The gaskets to the boiler room (Rm 0/113) were presumed to contain asbestos.

These have been removed and replaced.

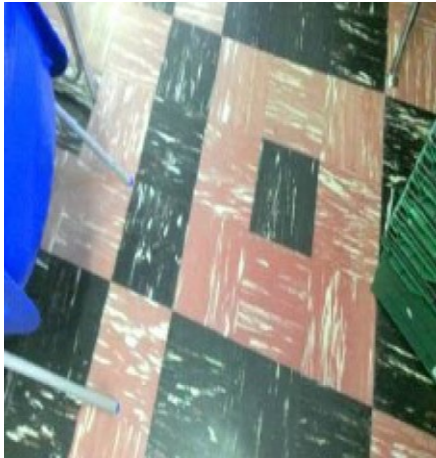
Item 45 - Ref: Presumed

The black/red floor tiles to the store room (Rm 1/06) are presumed to contain asbestos.

Any change in its appearance should be recorded and passed to Property Services.

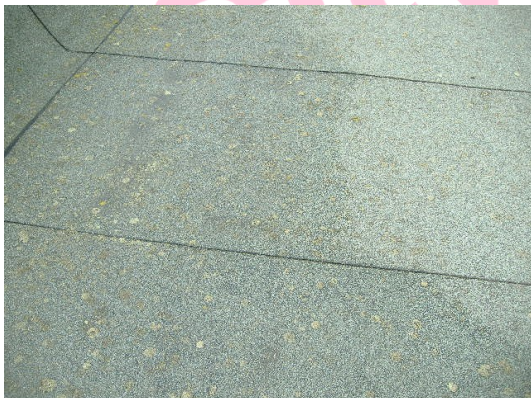
Item 46- Ref: WC0484/08

The roof felt to the exterior of the building does not contain asbestos.

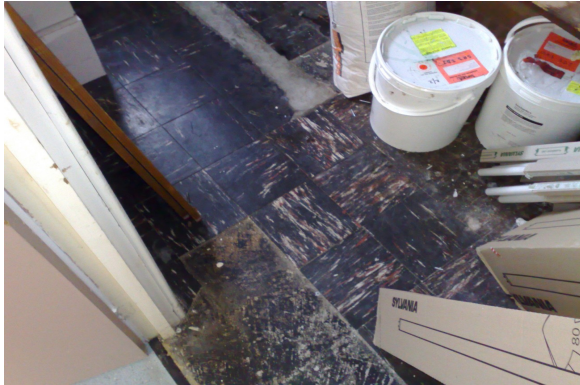
Item 111 - Ref: KR09/62

The floor tiles and adhesive in Chemical Store B (Room 0/70) contains asbestos.

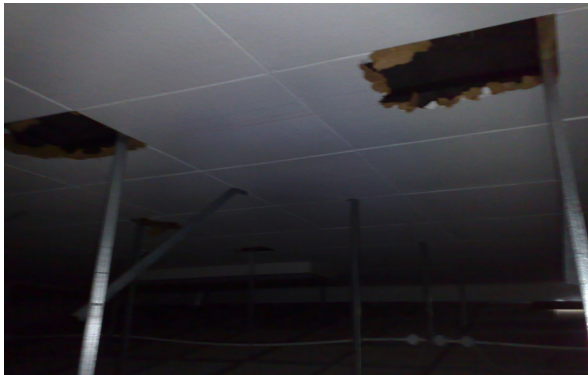
Item 136 - Ref: KR09/70

The ceiling tiles above suspended ceiling in the Nursery and cloakroom (Room 0/97) does not contain asbestos.

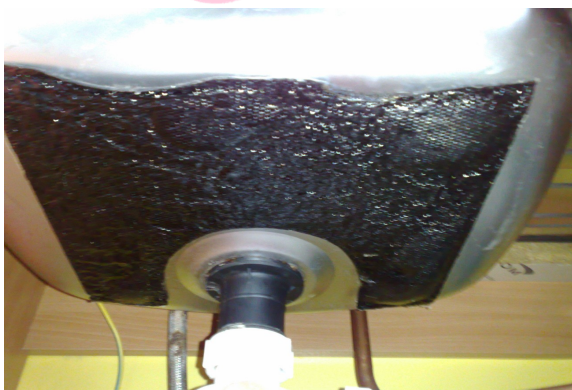
Item 138 - Ref: KR09/71

The sink pad in the Nursery and cloakroom (Room 0/97) does not contain asbestos.

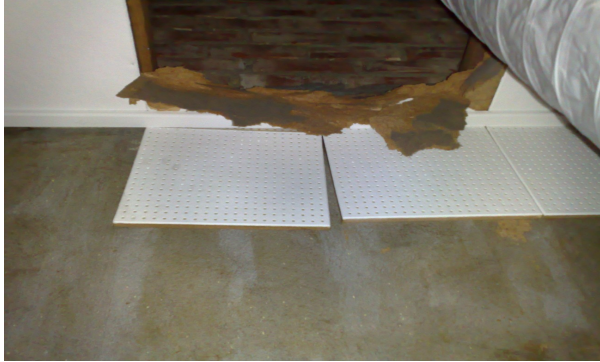
Item 139 - Ref: KR09/72

The acoustic tiles in the Nursery and Cloakroom (Room 0/97) does not contain asbestos.

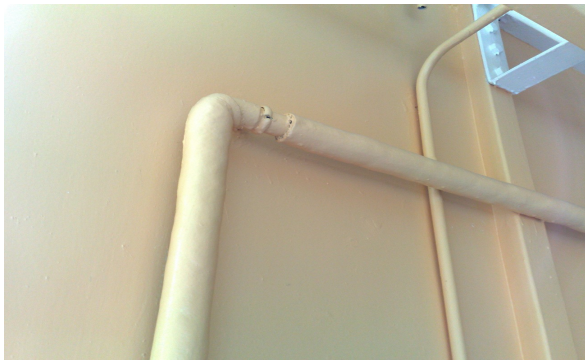
Item 140 - Ref: KR09/74

The pipe insulation in the extended school kitchen club (Room 0/101) does not contain asbestos.

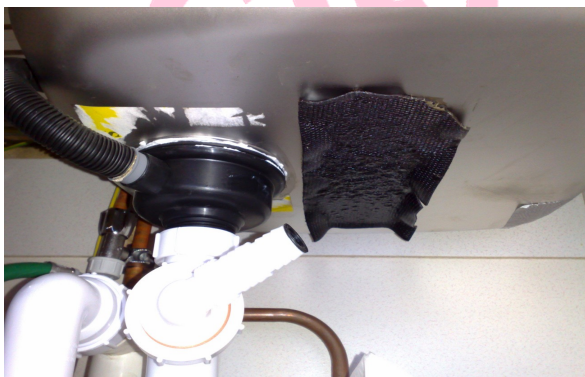
Item 141 - Ref: KR09/75

The sink pad in the extended school kitchen club (Room 0/101) does not contain asbestos.

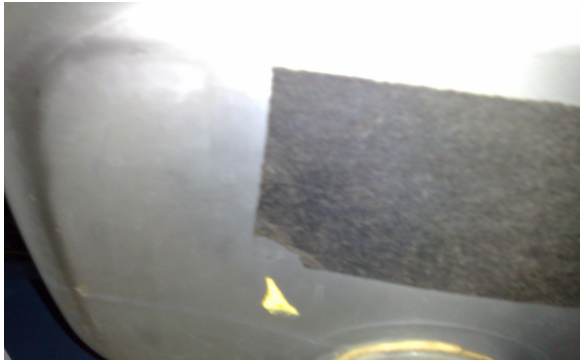
Item 142 - Ref: KR09/48

The sink pad in class 7 (Room 0/010) does not contain asbestos.

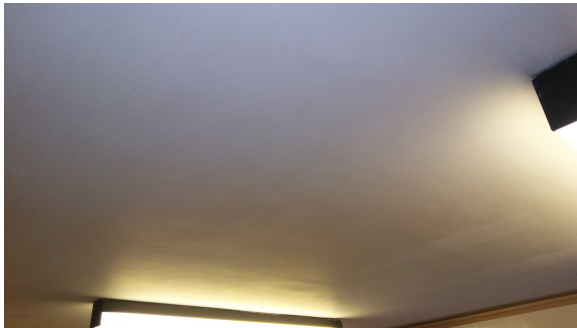
Item 153 - Ref: 383326-1

The ceiling in 005/Music Room does not contain asbestos.

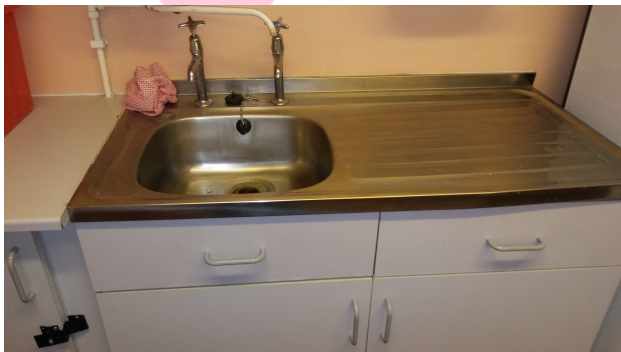
Item 156 - Ref: 383326-4

The sealant to pipe beneath sink in 005/Music Room does not contain asbestos.

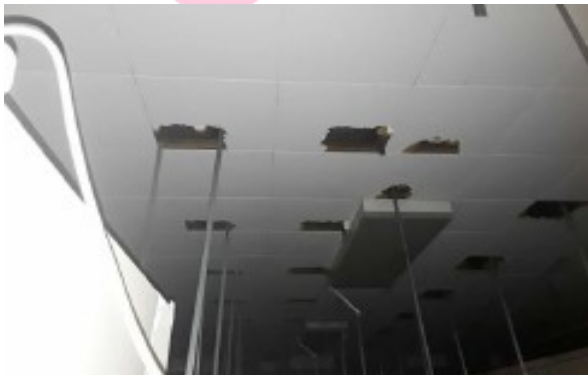
Item 181 - Ref: 22-45169-2

The fibreboard ceiling in Area 2 Classroom Reception ceiling void does not contain asbestos.

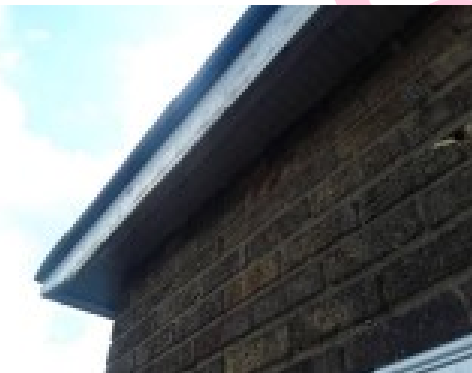
Item 222 - Ref: As NZ001566

The Soffits (External area 3
Roof E/004).
