ASBESTOS SURVEY REPORT FOR NORTHERN SAINTS C OF E PRIMARY SCHOOL, SUNDERLAND

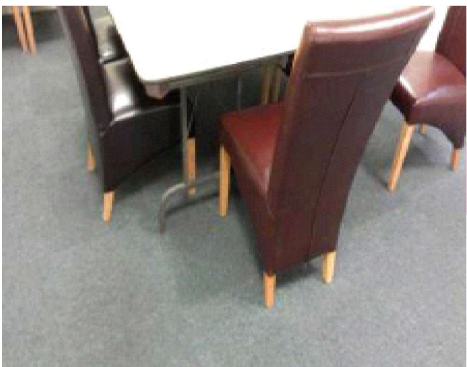
Item 2: Presumed

The bitumen adhesive to the floor below the cement skim to the floor in the meeting room (Room 2) is presumed to contain asbestos.

Any changes in its appearance should be noted and passed to Property Services.

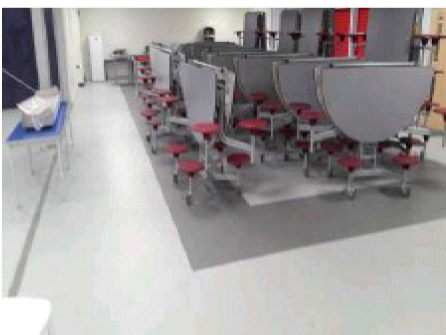
Item 3: Presumed

The bitumen adhesive to the floor below the cement skim to the floor in the dining area (Room 4) is presumed to contain asbestos.

Any changes in its appearance should be noted and passed to Property Services.

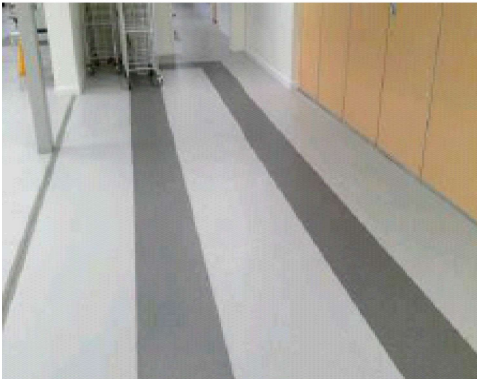
Item 5: Presumed

The bitumen adhesive to the floor below the cement skim to the floor in the main hall lobby (Room 6) is presumed to contain asbestos.

Any changes in its appearance should be noted and passed to Property Services.

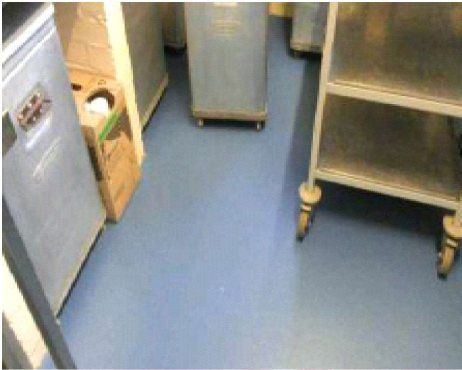
Item 8: Presumed

The bitumen adhesive to the floor below the cement skim to the floor in the kitchen store (Room 9) is presumed to contain asbestos.

Any changes in its appearance should be noted and passed to Property Services.

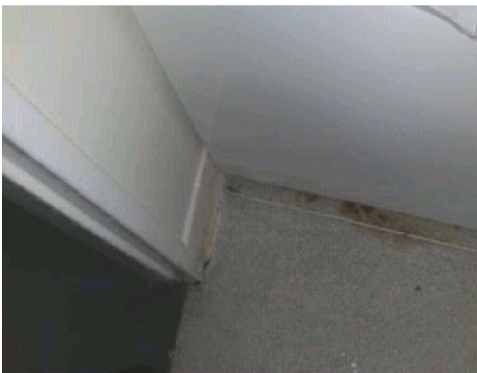
Item 11: NSPS/002

The skirting to the base of the wall in the kitchen store (Room 005) contains asbestos.

Any changes in its appearance should be noted and passed to Property Services.

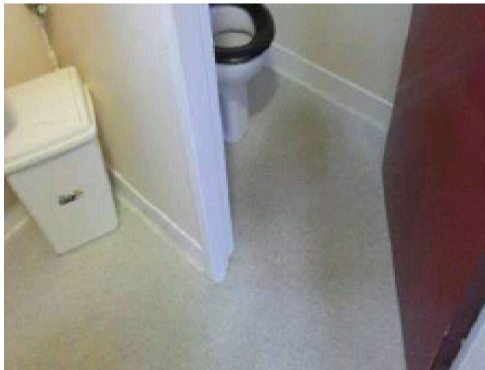
Item 14: Presumed

The bitumen adhesive below flooring in the kitchen staff toilet (Room 12) is presumed to contain asbestos.

Any changes in its appearance should be noted and passed to Property Services.

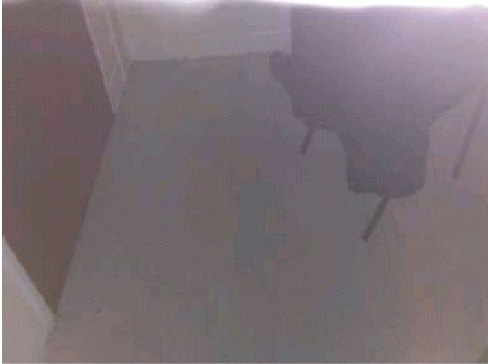
Item 16: Presumed

The bitumen adhesive below modern lino in the kitchen office (Room 14) is presumed to contain asbestos.

Any changes in its appearance should be noted and passed to Property Services.

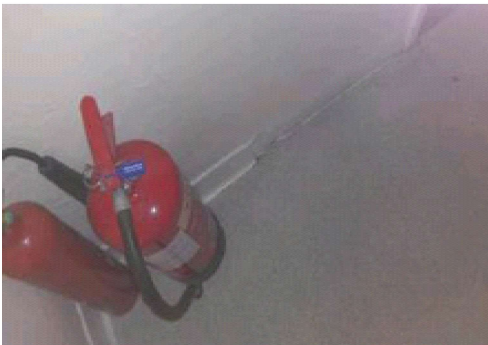
Item 17: As KR09/86

The skirting to the base of the wall in the kitchen office (Room 14) contains asbestos.

Any changes in its appearance should be noted and passed to Property Services.

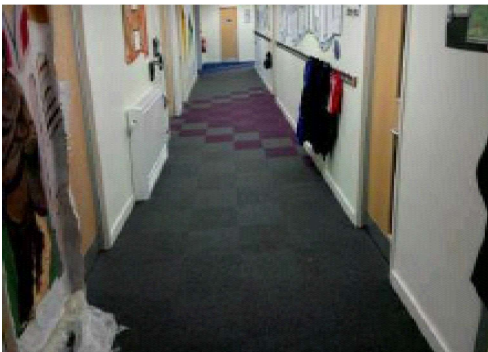
Item 18: Presumed

The bitumen adhesive to the floor below the cement skim to the floor in the corridor (Room 18) is presumed to contain asbestos.

Any changes in its appearance should be noted and passed to Property Services.

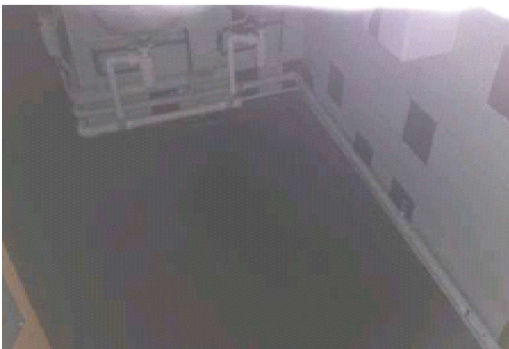
Item 20: Presumed

The vinyl floor tiles beneath the lino in the boys toilet (Room 23) contained asbestos.

These were removed in July 2015.

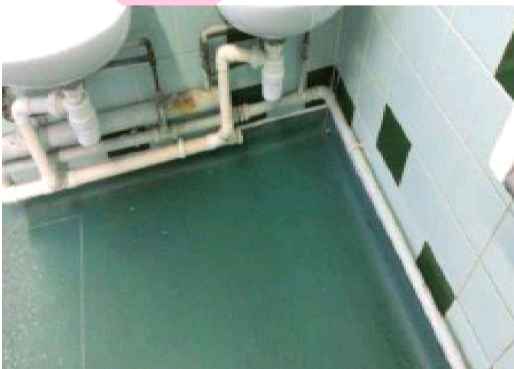
Item 21: Presumed

The skirting to the base of the wall beneath the lino in the boys wc (Room 23) contained asbestos.

These were removed in July 2015.

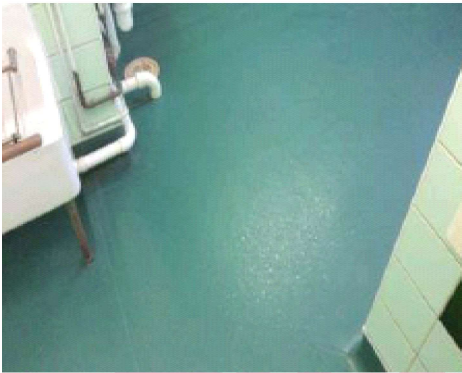
Item 23: Presumed

The vinyl floor tiles beneath the lino in the Girls toilet (Room 26) contain asbestos.

Any changes in its appearance should be noted and passed to Property Services.

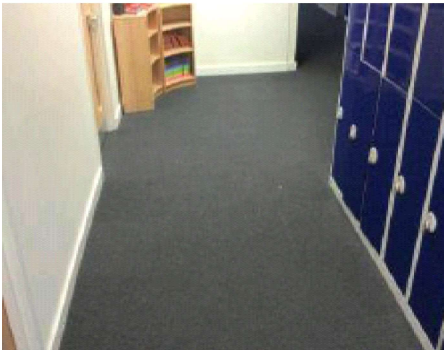
Item 26: Presumed

The bitumen adhesive to the floor below the cement skim to the floor in the corridor (Room 27) is presumed to contain asbestos.

Any changes in its appearance should be noted and passed to Property Services.

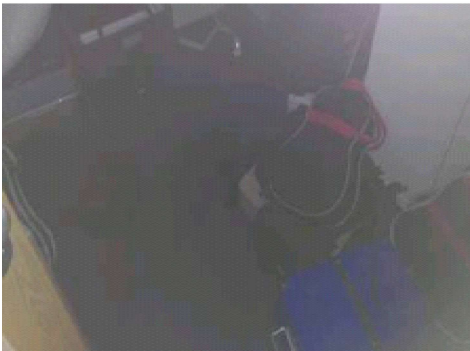
Item 29: Presumed

The bitumen adhesive to the floor below the cement skim to the floor in the store (Room 30) is presumed to contain asbestos.

Any changes in its appearance should be noted and passed to Property Services.

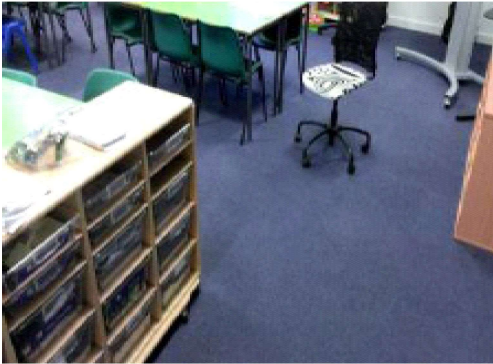
Item 31: Presumed

The bitumen adhesive to the floor below the cement skim to the floor in the classroom (Room 32) is presumed to contain asbestos.

Any changes in its appearance should be noted and passed to Property Services.

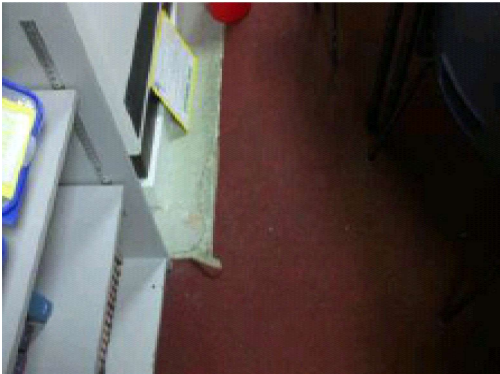
Item 32: Presumed

The bitumen adhesive to the floor in the classroom (Room 33) is presumed to contain asbestos.

Any changes in its appearance should be noted and passed to Property Services.

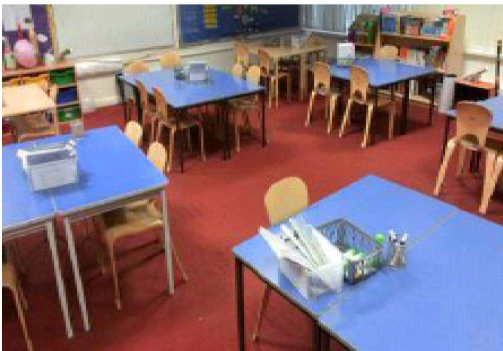
Item 35: Presumed

The bitumen adhesive to the floor in the classroom (Room 35) is presumed to contain asbestos.

Any changes in its appearance should be noted and passed to Property Services.

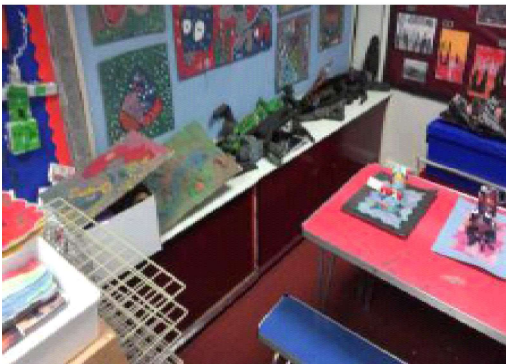
Item 38: Presumed

The skirting to the base of the wall behind the cupboards in the classroom (Room 36) was presumed to contain asbestos.

This was removed in July 2015.

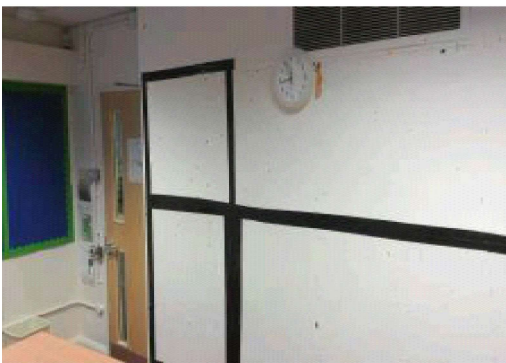
Item 39: Presumed

The lagging to the pipework within the heater boxing in the classroom (Room 36) was presumed to contain asbestos.

This was removed by Building Needs in July 2015.

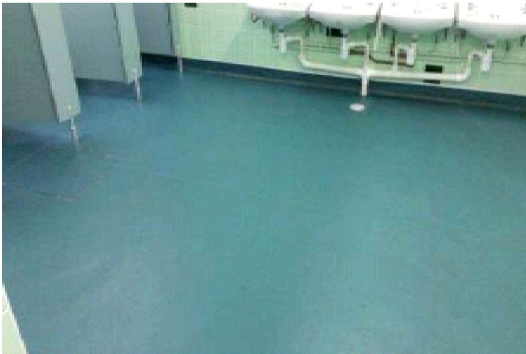
Item 41: Presumed

The vinyl floor tiles beneath the modern lino in the girls wc (Room 41) is presumed to contain asbestos.

Any changes in its appearance should be noted and passed to Property Services.

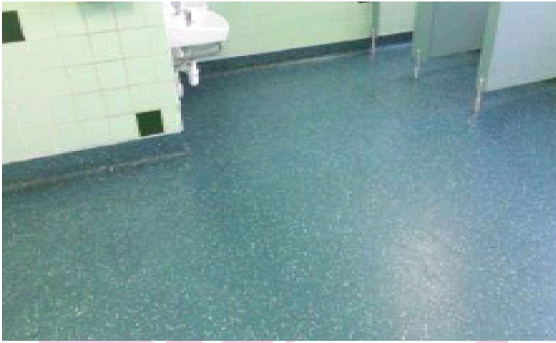
Item 47: Presumed

The bitumen adhesive beneath modern lino in the Boys wc (Room 44) is presumed to contain asbestos.

This was removed in July 2015.

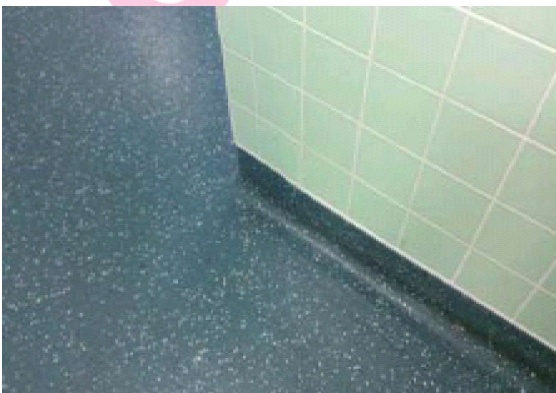
Item 48: As KR09/86

The skirting to wall beneath the lino in the Boys wc (Room 44) was presumed to contain asbestos.

This was removed in July 2015.

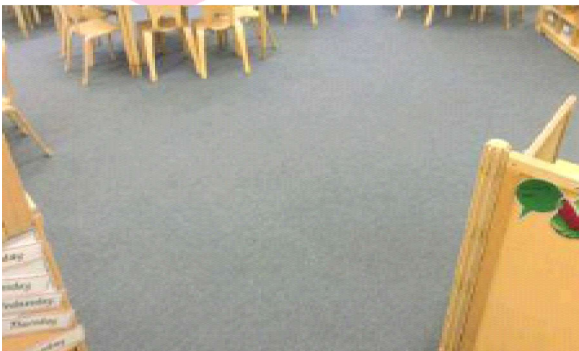
Item 54: Presumed

The bitumen adhesive beneath carpet in the classroom (Room 47) is presumed to contain asbestos.

Any changes in its appearance should be noted and passed to Property Services.

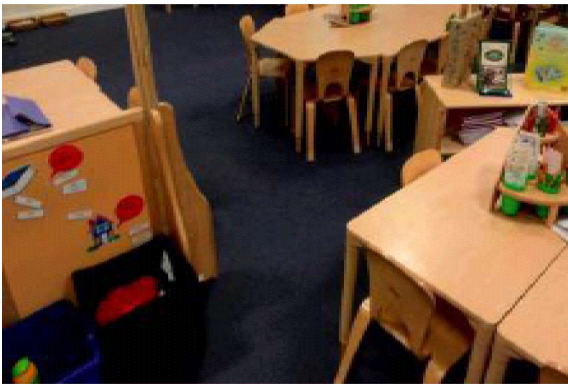
Item 56: Presumed

The bitumen adhesive to the floor below the cement skim to the floor in the classroom (Room 48) is presumed to contain asbestos.

Any changes in its appearance should be noted and passed to Property Services.

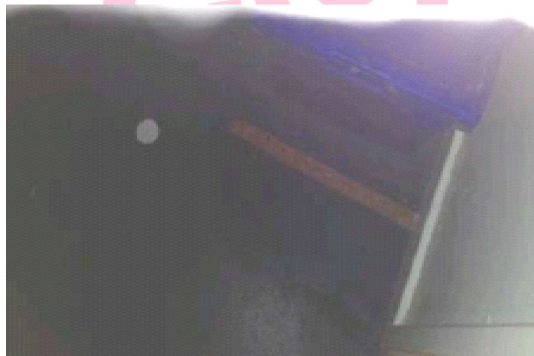
Item 63: Presumed

The vinyl floor tiles beneath the carpet in the store (Room 55) were presumed to contain asbestos.

These were removed in July 2015.

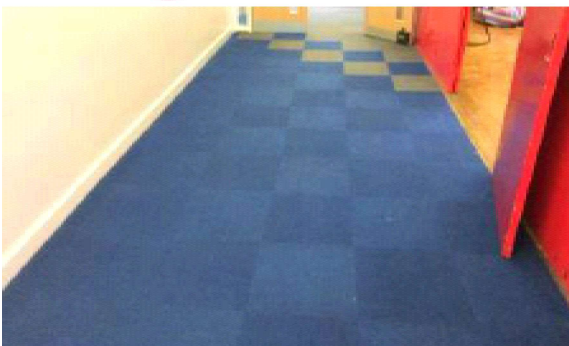
Item 81: Presumed

The bitumen adhesive to the floor in the corridor (Room 74) is presumed to contain asbestos.

Any changes in its appearance should be noted and passed to Property Services.

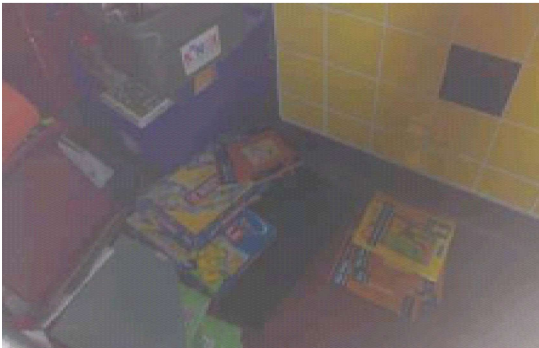
Item 86: Presumed

The vinyl floor tiles beneath the lino in the store (Room 80) are presumed to contain asbestos.

This was removed August 2017.

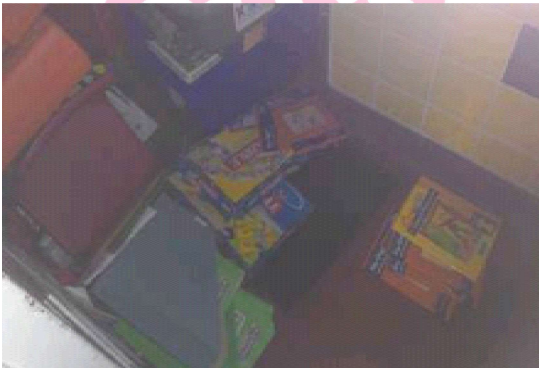
Item 87: Presumed

The bitumen adhesive to the floor in the store (Room 80) is presumed to contain asbestos.

Any changes in its appearance should be noted and passed to Property Services.

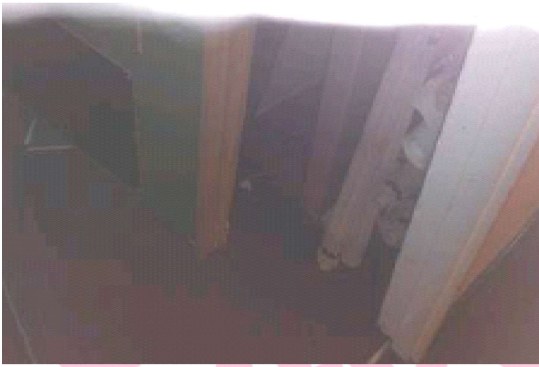
Item 89: Presumed

The bitumen adhesive to the floor in the store (Room 81) is presumed to contain asbestos.

Any changes in its appearance should be noted and passed to Property Services.

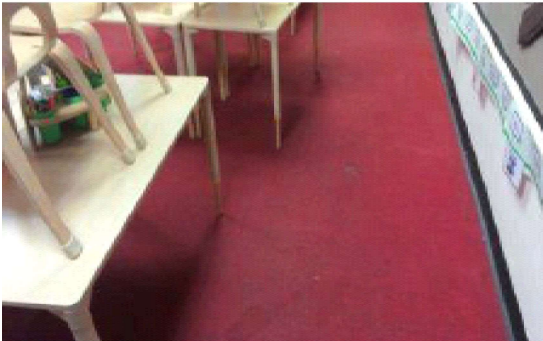
Item 94: Presumed

The vinyl floor tiles beneath the carpet in the classroom (Room 87) are presumed to contain asbestos.

This was removed August 2017.

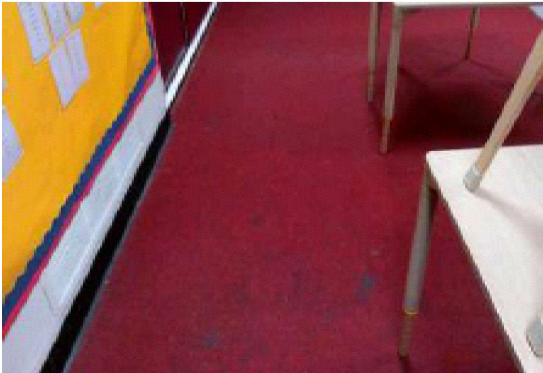
Item 95: Presumed

The bitumen adhesive to the floor in the classroom (Room 87) is presumed to contain asbestos.

Any changes in its appearance should be noted and passed to Property Services.

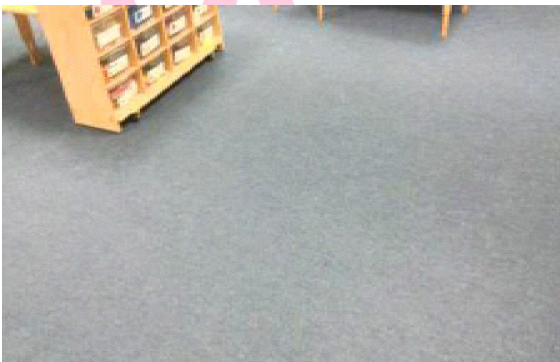
Item 99: Presumed

The bitumen adhesive beneath the carpet in the classroom (Room 89) is presumed to contain asbestos.

Any changes in its appearance should be noted and passed to Property Services.

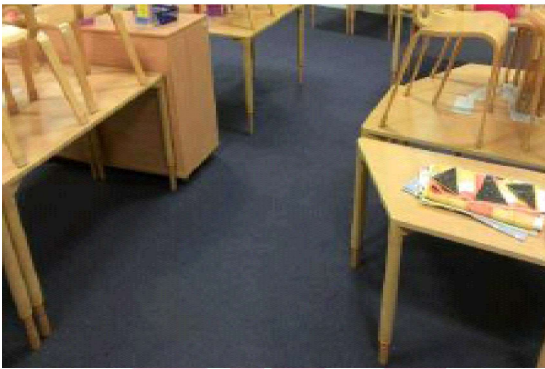
Item 101: Presumed

The bitumen adhesive below the cement skim to the floor in the classroom (Room 90) is presumed to contain asbestos.

Any changes in its appearance should be noted and passed to Property Services.

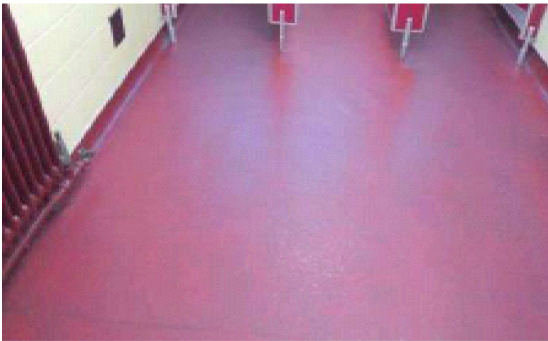
Item 107: Presumed

The bitumen adhesive beneath the modern lino to the Girls toilets (Room 96) is presumed to contain asbestos.

Any changes in its appearance should be noted and passed to Property Services.

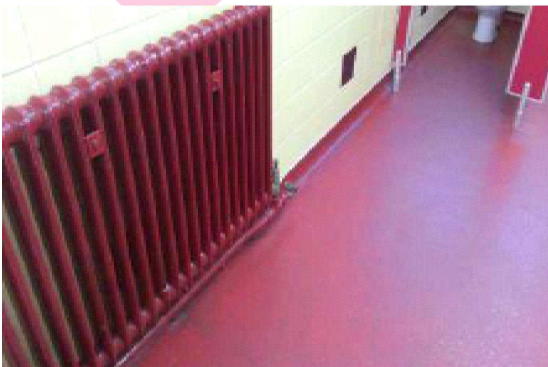
Item 108: Presumed

The skirting to base of wall behind modern lino in the Girls toilets (Room 96) is presumed to contain asbestos.

Any changes in its appearance should be noted and passed to Property Services.

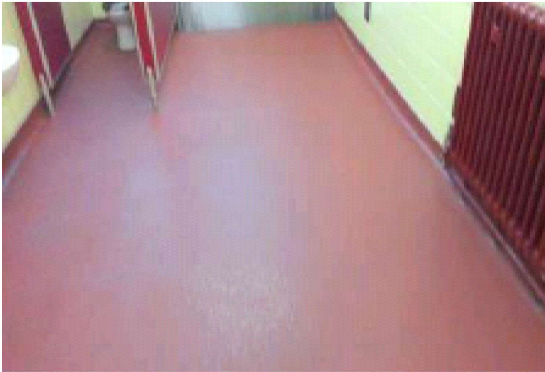
Item 110: Presumed

The bitumen adhesive beneath the modern lino to the Boys toilets (Room 97) is presumed to contain asbestos.

Any changes in its appearance should be noted and passed to Property Services.

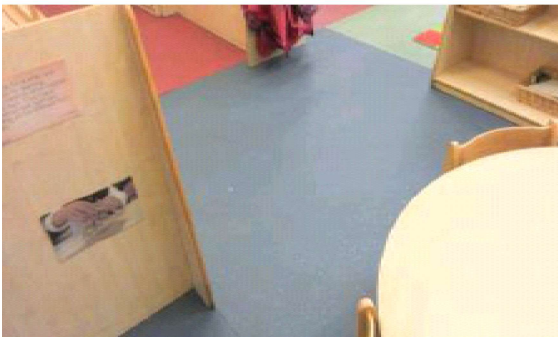
Item 113: NSPS/002

The bitumen adhesive beneath the modern lino to the classroom (Room 007) contains asbestos.

Any changes in its appearance should be noted and passed to Property Services.

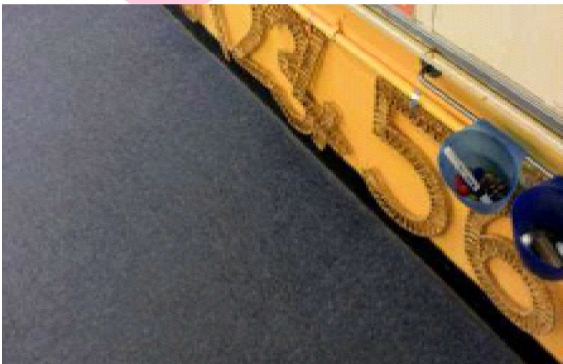
Item 114: NSPS/003

The skirting to base of wall behind modern in the classroom (Room 006) does not contain asbestos.

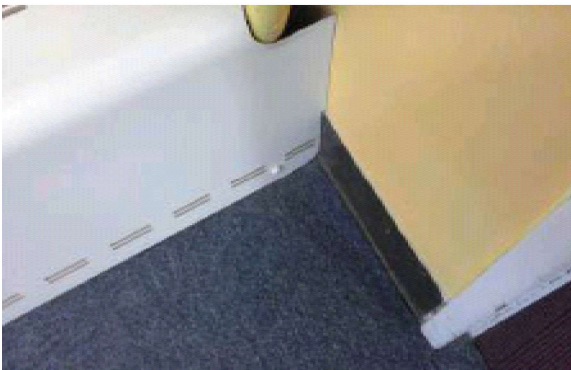
Item 116: NSPS/003

The skirting to base of wall in the classroom (Room 005) does not contain asbestos.

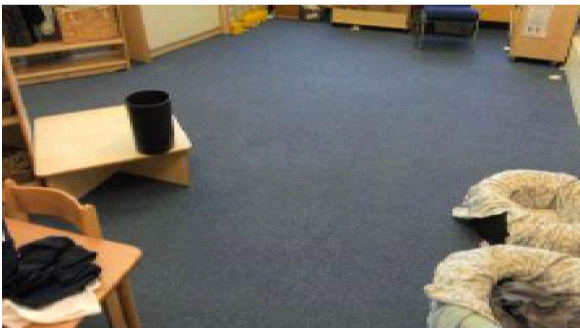
Item 117: Presumed

The bitumen adhesive beneath the carpet in the classroom (Room 102) is presumed to contain asbestos.

Any changes in its appearance should be noted and passed to Property Services.

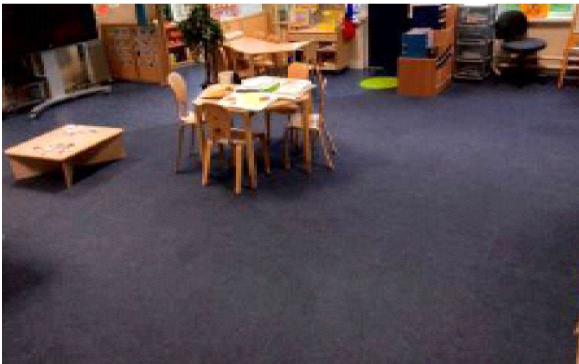
Item 119: Presumed

The bitumen adhesive beneath the cement skim to the classroom (Room 104) is presumed to contain asbestos.

Any changes in its appearance should be noted and passed to Property Services.

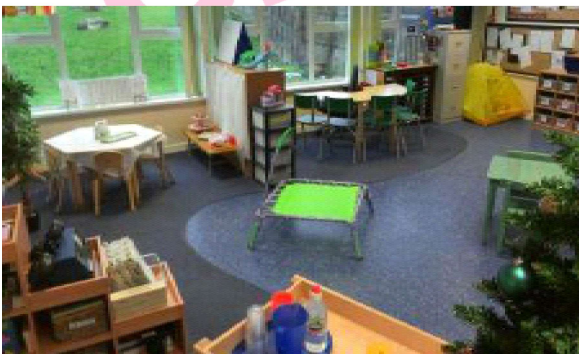
Item 120: Presumed

The bitumen adhesive beneath the cement skim to the classroom (Room 105) is presumed to contain asbestos.

Any changes in its appearance should be noted and passed to Property Services.

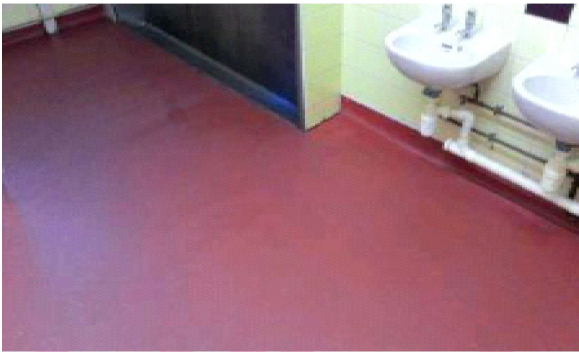
Item 122: Presumed

The bitumen adhesive beneath the modern lino to the Boys toilet (Room 108) is presumed to contain asbestos.

Any changes in its appearance should be noted and passed to Property Services.

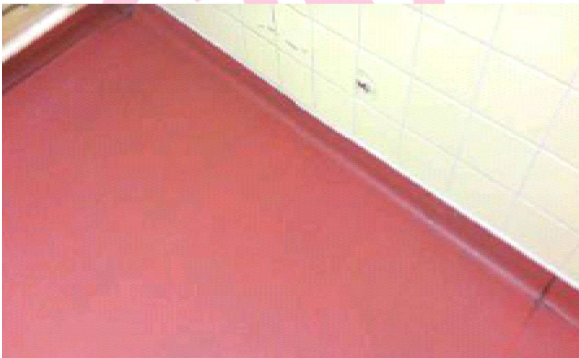
Item 123: Presumed

The skirting to base of wall behind modern lino in the boys toilet (Room 108) is presumed to contain asbestos.

Any changes in its appearance should be noted and passed to Property Services.

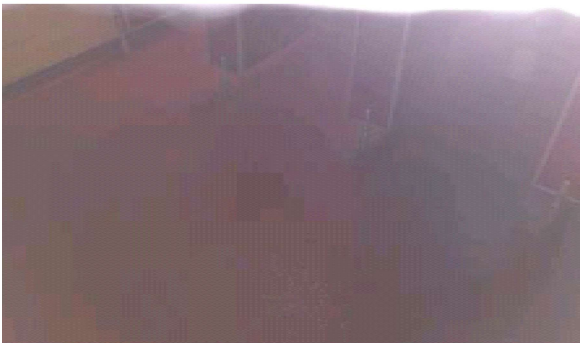
Item 125: Presumed

The bitumen adhesive beneath the modern lino to the Girls toilets (Room 110) is presumed to contain asbestos.

Any changes in its appearance should be noted and passed to Property Services.

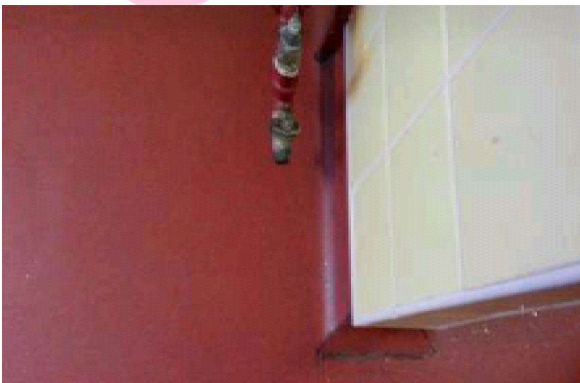
Item 126: Presumed

The skirting to base of wall behind modern lino in the Girls toilet (Room 110) is presumed to contain asbestos.

Any changes in its appearance should be noted and passed to Property Services.

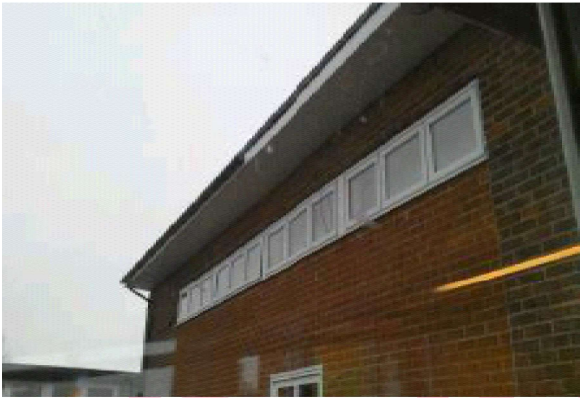
Item 128: NSPS/004

The corrugated soffits (throughout) to the external of the building contain asbestos.

Any changes in its appearance should be noted and passed to Property Services.

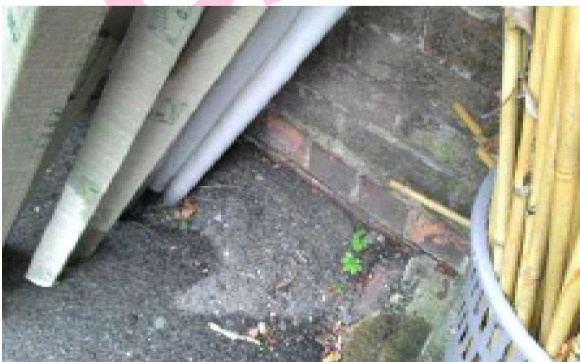
Item 129: KR09/140

The damp proof course to the external of the building contains asbestos.

Any changes in its appearance should be noted and passed to Property Services.

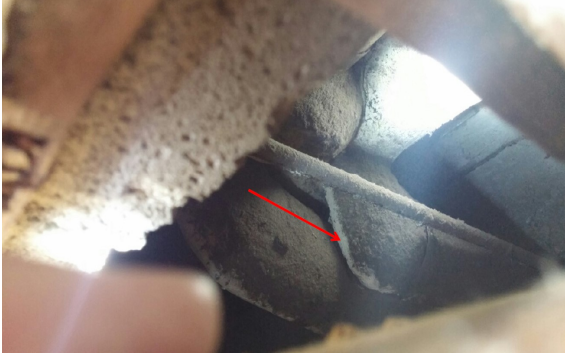
Item 130: Presumed

The pipe lagging within the heater cupboard is presumed to contain asbestos.

Any changes in its appearance should be noted and passed to Property Services.

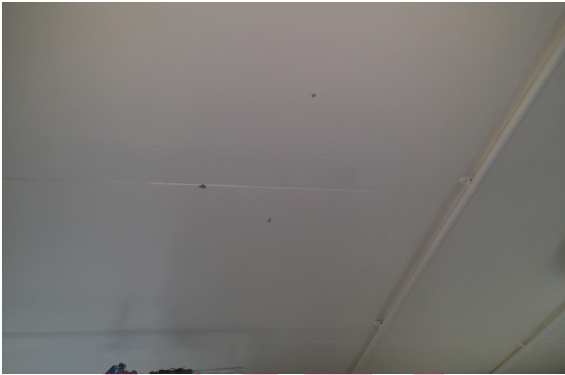
Item 131: 107693-3

The ceiling in the staff toilet does not contain asbestos.

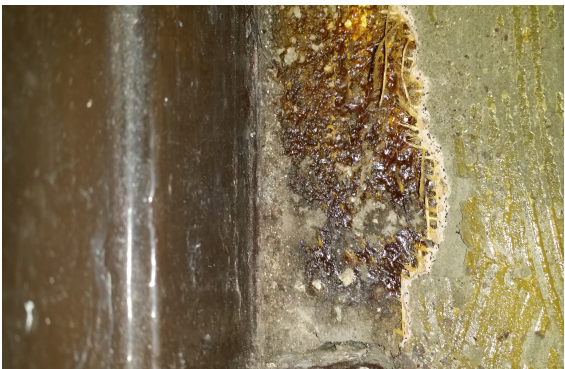
Item 132: 107693-1

The adhesive backing to lino subfloor to the ramped corridor does contain asbestos.

Any changes in its appearance should be noted and passed to Property Services.

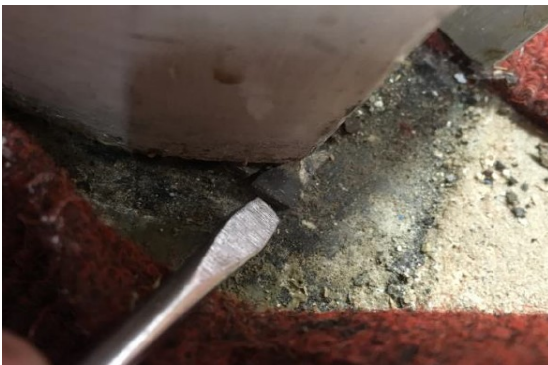
Item 147: BS001671

The floor tile remnants beneath carpet in the year 4 Classroom does not contain asbestos.

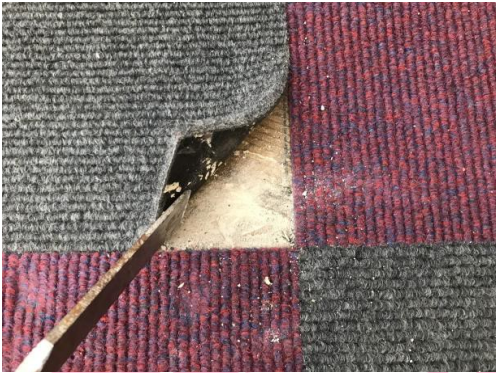
Item 149: BS017806

The floor screed to the floor below the carpet tiles in Internal cloakroom (to be WC) contains asbestos.

Any changes in its appearance should be noted and passed to Property Services.

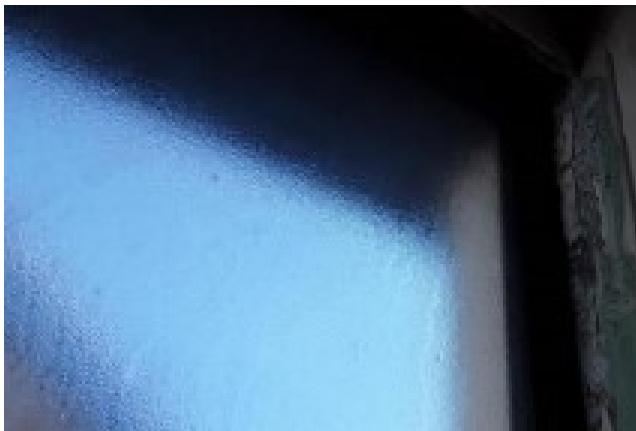
Item 152: 21-36878-2

The sealant to the old window frame (Area 1/Boys toilet) does not contain asbestos.

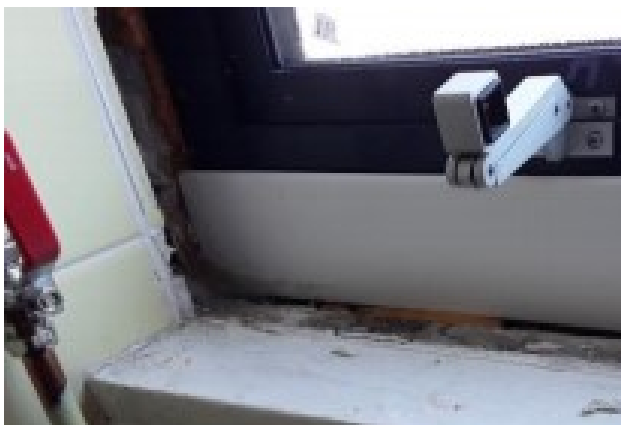
Item 153: 21-36878-2

The sealant to the old window frame (Area 2/Girls toilet) does not contain asbestos.

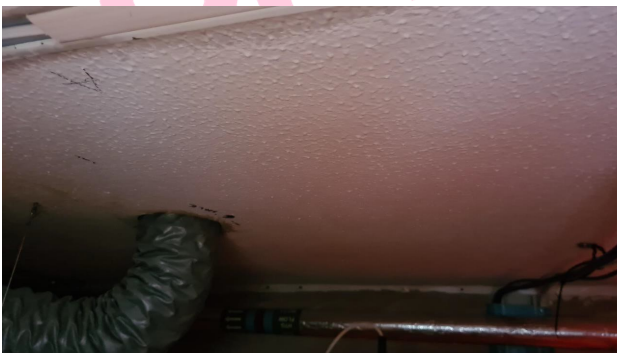
Item 156: NSPS/005

The textured coating to ceiling above suspended ceiling (G/013/Office) does not contain asbestos.

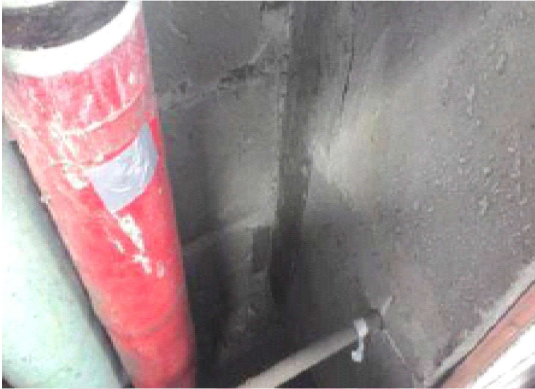
Ref: EV001735

The red pipework in the void to the left of the heater in classroom 3/4 contained asbestos.

This was removed by Building Needs in July 2015.

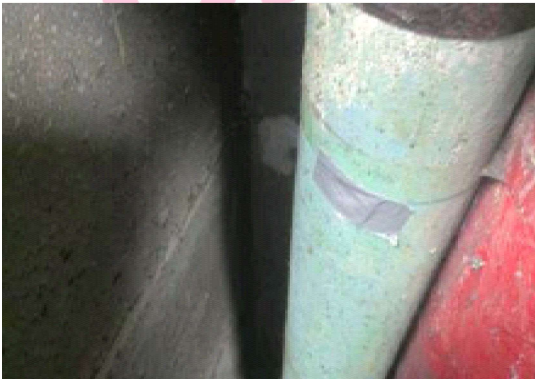
Ref: EV001736

The green pipework in the void to the left of the heater in classroom 3/4 contained asbestos.

This was removed by Building Needs in July 2015.

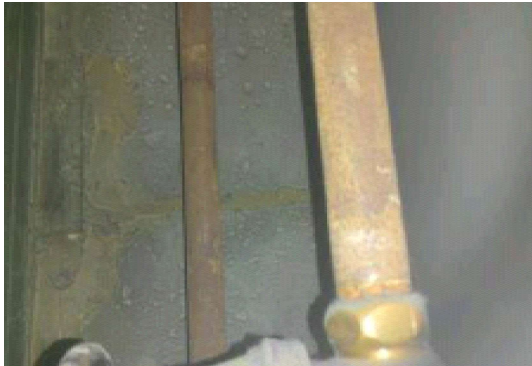
Ref: EV001737

A swab sample of the pipework to the upright heater in Year 5 room 2 does not contain asbestos.

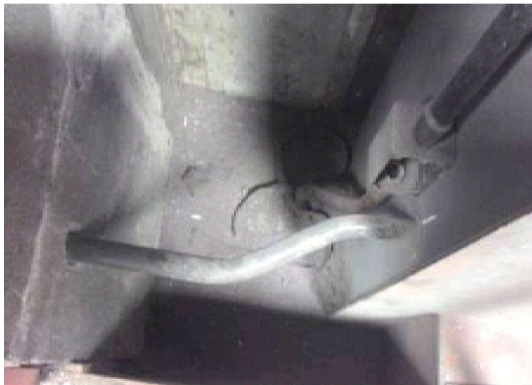
Ref: EV001738

A swab sample of the floor to the void to the upright heater in Year 5 room 2 does not contain asbestos.

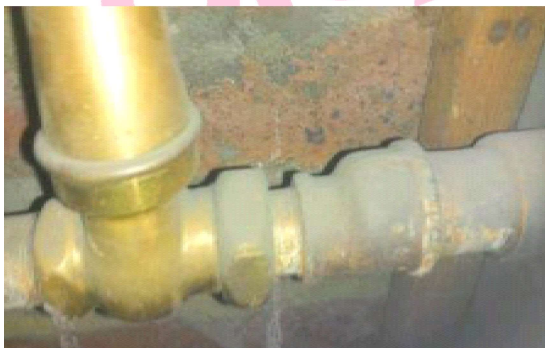
Ref: EV001739

The residue to the pipework to the void to the upright heater in Year 2 room 3 does not contain asbestos.

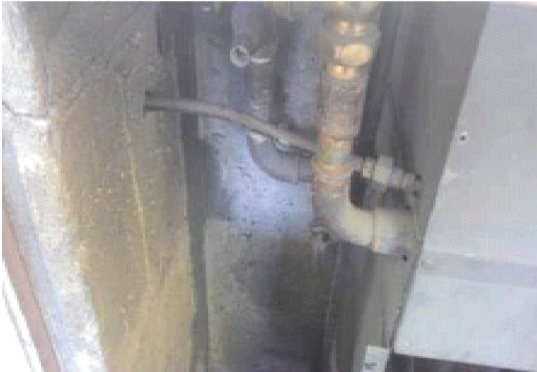
Ref: EV001741

The debris on the pipework to the void to the upright heater in Year 1 room 5 does not contain asbestos.

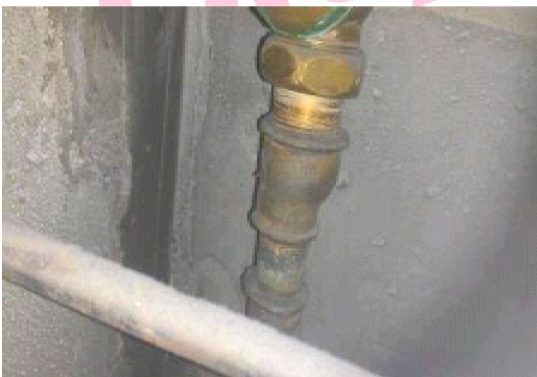
Ref: EV001742

The debris on the pipework to the void to the upright heater in Year 1 room 6 does not contain asbestos.
