ASBESTOS SURVEY REPORT FOR BENEDICT BISCOP, SUNDERLAND

Asbestos Register for BENEDICT BISCOP, SUNDERLAND

Date: 13 February 2025

**BENEDICT BISCOP
CE PRIMARY SCHOOL**

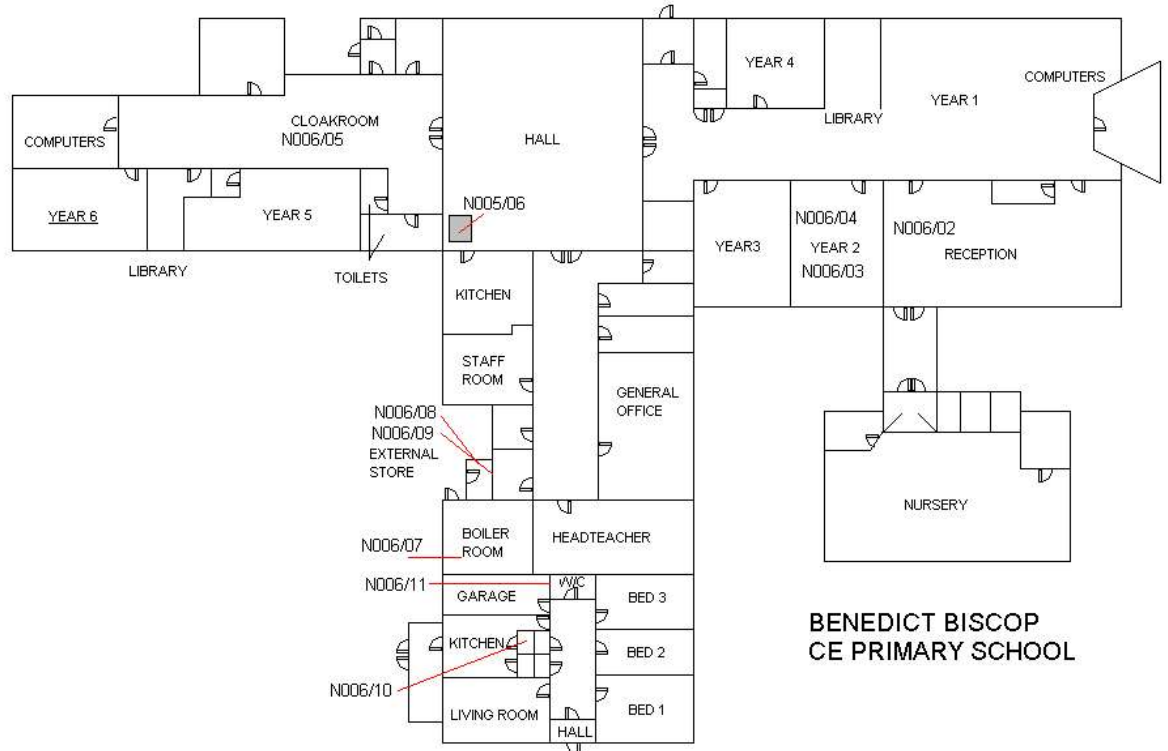
Plan of Building and Samples Location- Cont.

Please note the survey carried out was non-intrusive. Should major refurbishment be planned for the property, further investigation will be required.
