ASBESTOS SURVEY REPORT FOR NOOK LODGE, NOOKSIDE, SUNDERLAND

Asbestos Register for

NOOK LODGE, NOOKSIDE, SUNDERLAND

Date: 17th January 2025

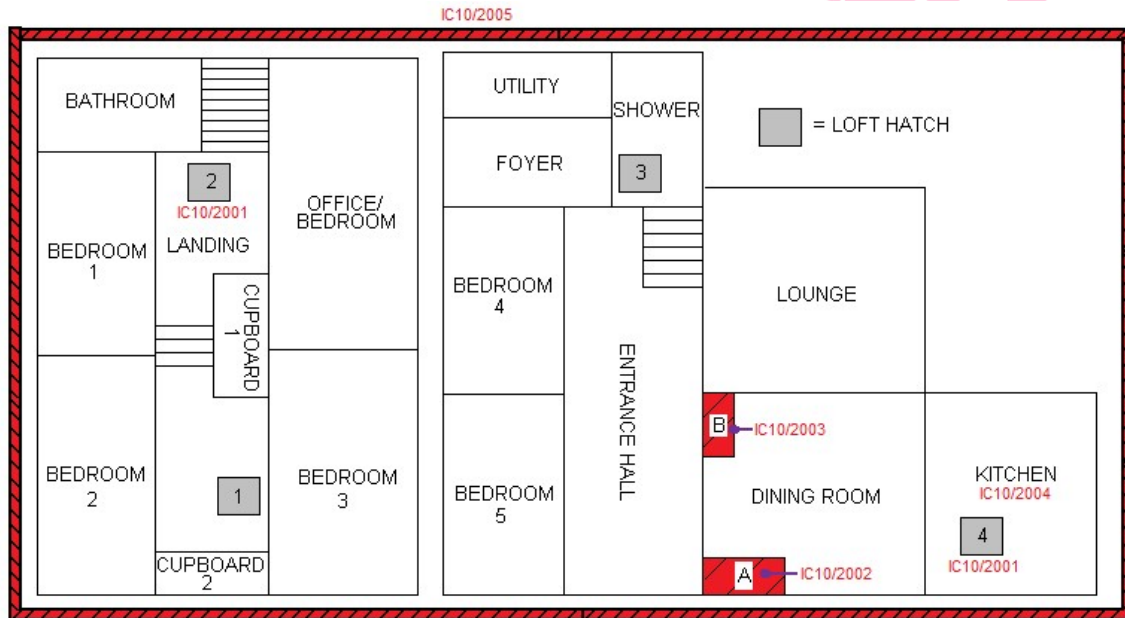
385803-9 – Damp proof course to original building (External) (Item 12) No Risk

KN001533 – Roof felt flashing (External) (Item 13) No Risk

= Areas Where Asbestos
Containing Materials Have
Been Found
