ASBESTOS SURVEY REPORT FOR ASHLEY PRIMARY ACADEMY, TEMPLE PARK ROAD, SOUTH SHIELDS, NE33 0QA

Asbestos Register for ASHLEY PRIMARY ACADEMY, TEMPLE PARK ROAD

Date: 13 February 2025

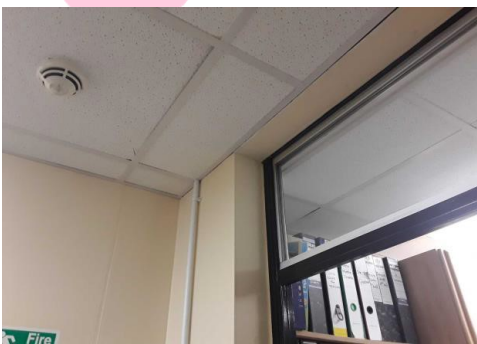
Item 39 Ref: Presumed

The walls – lining inside clasp columns - Ground Floor, Room 18, Deputy Head teachers office – are presumed to contain asbestos.

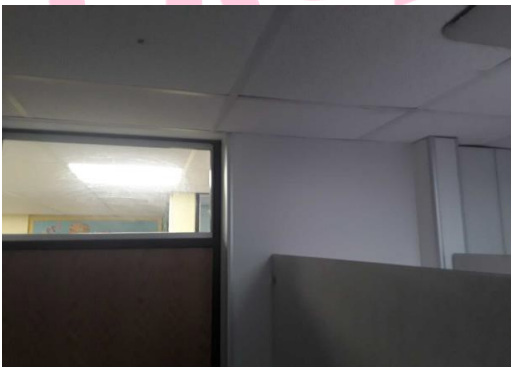
Item 48 Ref: Presumed

The walls – lining inside clasp columns - Ground Floor, Room 21, Girls Toilet – are presumed to contain asbestos.

Any change in its appearance should be recorded and passed to Property Services.

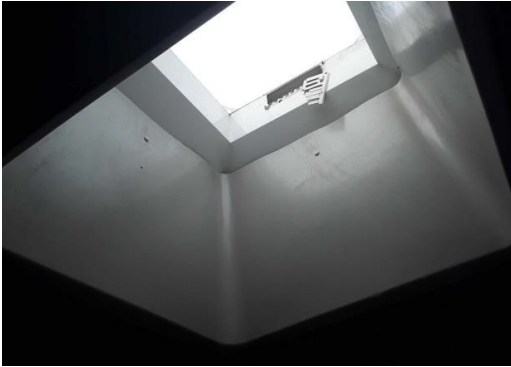
Item 49 Ref: Presumed

The ceiling – textile rope seal to fibreglass skylight - Ground Floor, Room 21, Girls Toilet – is presumed to contain asbestos.

Any change in its appearance should be recorded and passed to Property Services.

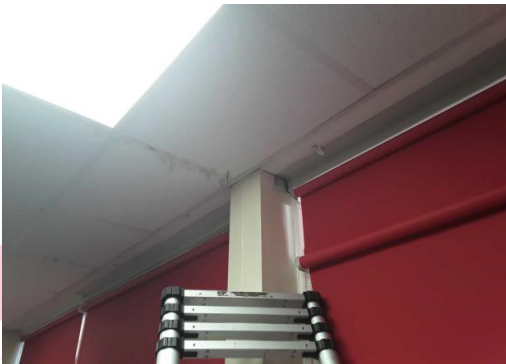
Item 50 Ref: Presumed

The walls – lining inside clasp columns - Ground Floor, Room 22, Classroom – are presumed to contain asbestos.

Any change in its appearance should be recorded and passed to Property Services.

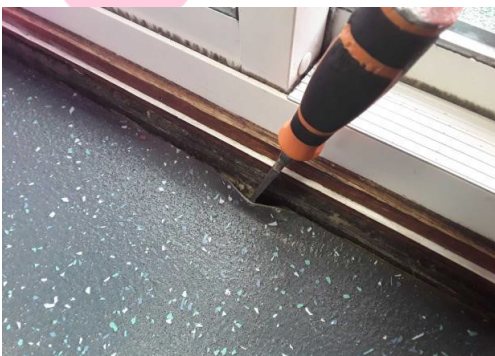
Item 51 Ref: 22-53098-3

The floor – residual adhesive beneath floor screed - Ground Floor, Room 22, Classroom - contains asbestos.

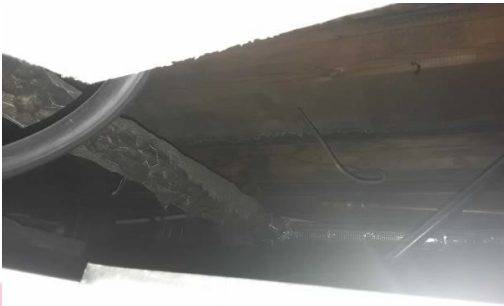
Item 53 Ref: 22-53098-1

The pipes – string to mmmf lagged metal pipes - Ground Floor, Room 25, Classroom store cupboard - do not contain asbestos

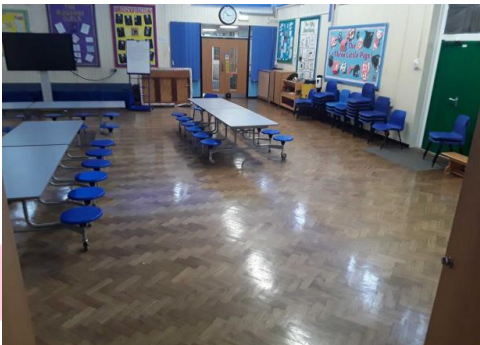
Item 62 Ref: Presumed

The floor -adhesive beneath parquet flooring - Ground Floor, Room 28, Main School Hall – is presumed to contain asbestos.

Any change in its appearance should be recorded and passed to Property Services.

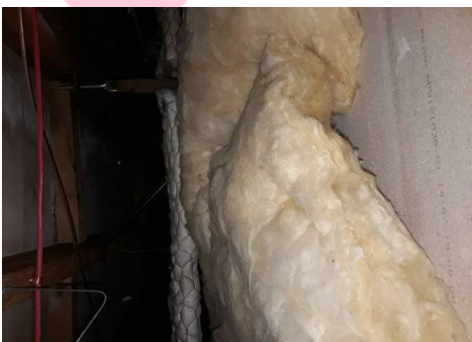
Item 63 Ref: 22-53098-1

The pipes – string to mmmf lagged metal pipes - Ground Floor, Room 29, Hall Store Room - do not contain asbestos

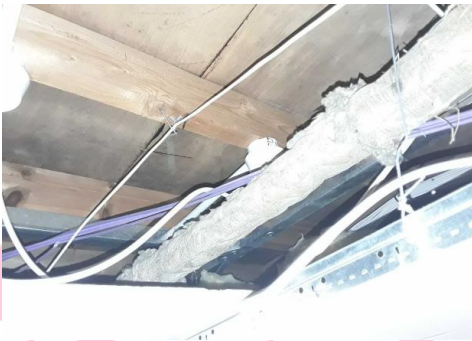
Item 65 Ref: 22-53098-1

The pipes – string to mmmf lagged metal pipes - Ground Floor, Room 30, Corridor and Study Areas - do not contain asbestos

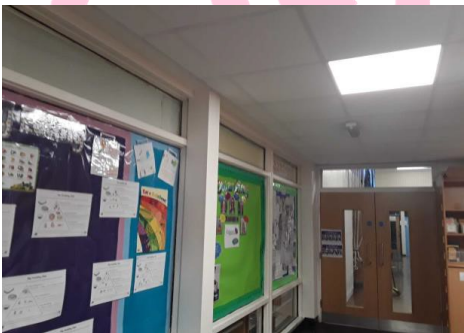
Item 66 Ref: Presumed

The walls – lining inside clasp columns - Ground Floor, Room 30, Corridor ad Study Areas – are presumed to contain asbestos.

Any change in its appearance should be recorded and passed to Property Services.

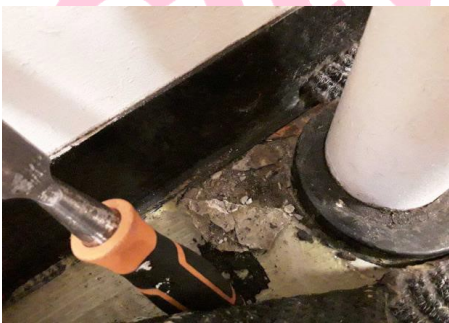
Item 69 Ref: 22-53098-7

The floor – residual adhesive beneath floor screed - Ground Floor, Room 31, Cloakroom, classroom - contains asbestos.

Any change in its appearance should be recorded and passed to Property Services.

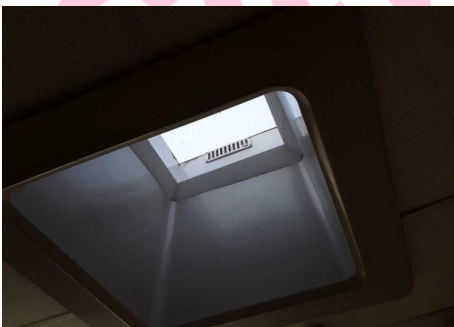
Item 72 Ref: Presumed

The ceiling – textile rope seal to fibreglass skylight - Ground Floor, Room 32, Girl's toilet – is presumed to contain asbestos.

Any change in its appearance should be recorded and passed to Property Services.

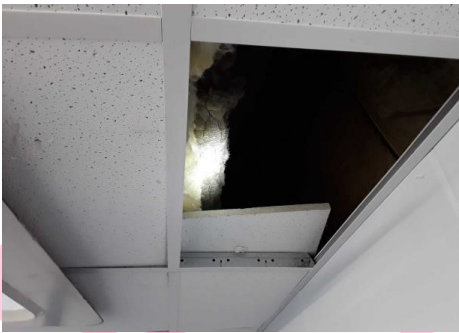
Item 74 Ref: 22-53098-1

The pipes – string to mmmf lagged metal pipes - Ground Floor, Room 33, Boy's toilet - do not contain asbestos

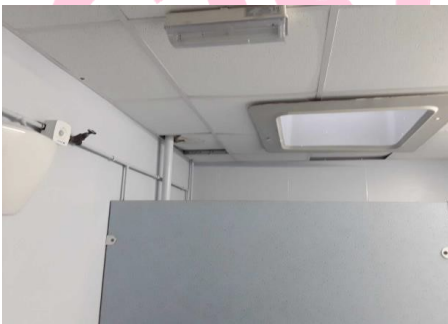
Item 75 Ref: Presumed

The walls – lining inside clasp columns - Ground Floor, Room 33, Boy's toilet – are presumed to contain asbestos.

Any change in its appearance should be recorded and passed to Property Services.

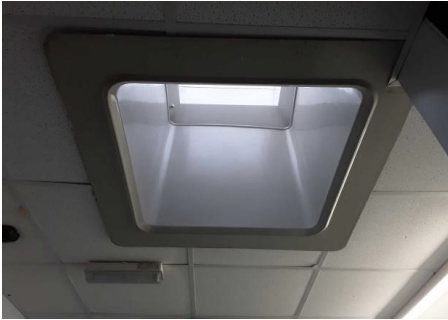
Item 76 Ref: Presumed

The ceiling – textile rope seal to fibreglass skylight - Ground Floor, Room 33, Boy's toilet – is presumed to contain asbestos.

Any change in its appearance should be recorded and passed to Property Services.

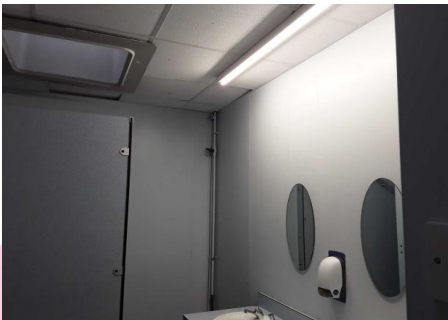
Item 77 Ref: Presumed

The pipes – stop taps (gaskets) – Ground Floor, Room 33, Boy's toilet - are presumed to contain asbestos.

Any change in its appearance should be recorded and passed to Property Services.

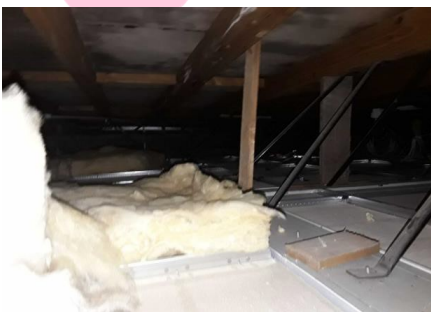
Item 78 Ref: 22-53098-1

The pipes – string to mmmf lagged metal pipes - Ground Floor, Room 34, Classroom - do not contain asbestos

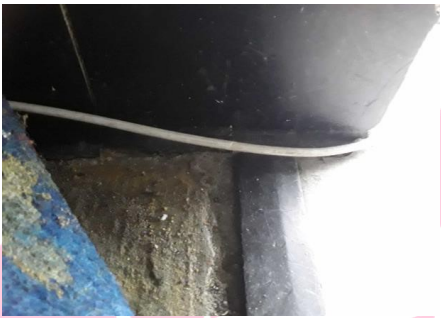
Item 80 Ref: 22-53098-7

The floor – residual adhesive beneath floor screed - Ground Floor, Room 34, Classroom - contains asbestos.

Any change in its appearance should be recorded and passed to Property Services.

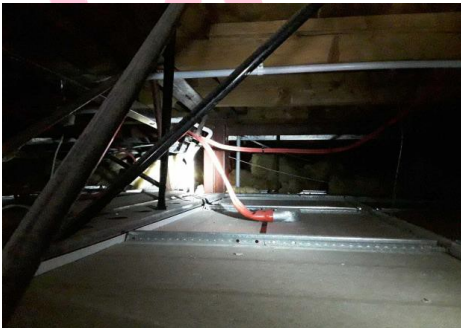
Item 81 Ref: Presumed

The walls – lining inside clasp columns - Ground Floor, Room 35 Hallway between Classrooms – are presumed to contain asbestos.

Any change in its appearance should be recorded and passed to Property Services.

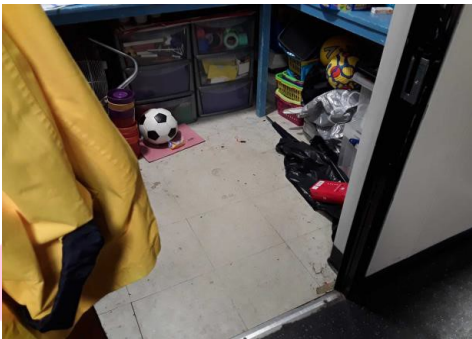
Item 83 Ref: 22-53098-10

The floor – tiles and adhesive - Ground Floor, Room 37, Classroom cupboard - contains asbestos.

Any change in its appearance should be recorded and passed to Property Services.

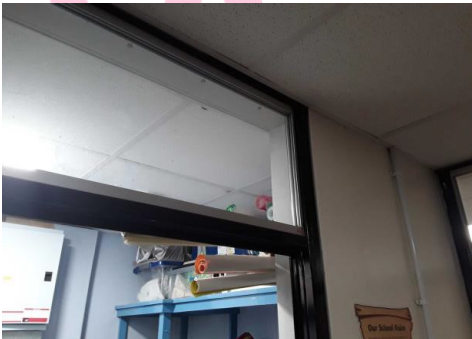
Item 84 Ref: Presumed

The walls – lining inside clasp columns - Ground Floor, Room 37, Classroom cupboard – are presumed to contain asbestos.

Any change in its appearance should be recorded and passed to Property Services.

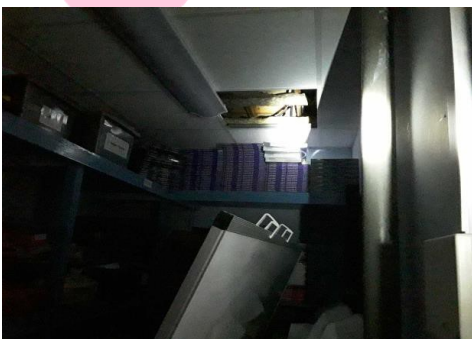
Item 87 Ref: 22-53098-1

The pipes – string to mmmf lagged metal pipes - Ground Floor, Room 39, Store Cupboard - do not contain asbestos

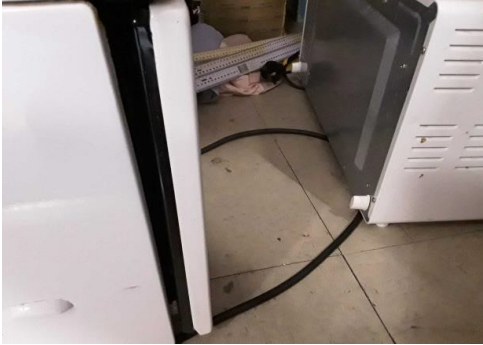
Item 88 Ref: 22-53098-10

The floor – tiles and adhesive
- Ground Floor, Room 39,
Store Cupboard - contains
asbestos.

Any change in its appearance
should be recorded and
passed to Property Services.

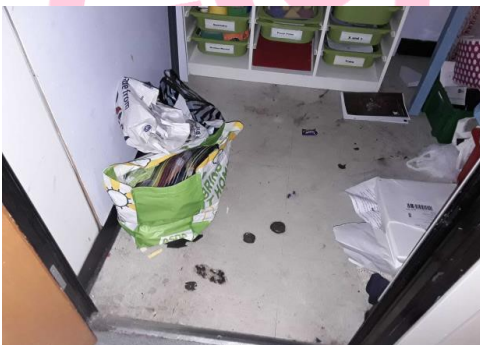
Item 96 Ref: 22-53098-10

The floor – tiles and adhesive - Ground Floor, Room 42, Classroom Cupboard - contains asbestos.

Any change in its appearance should be recorded and passed to Property Services.

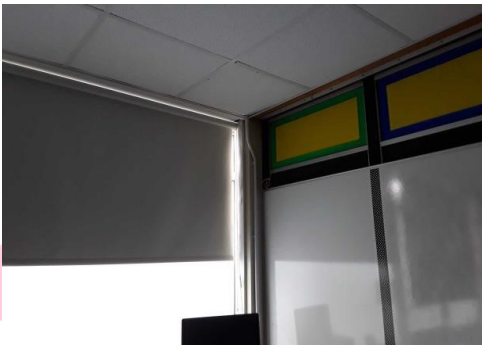
Item 98 Ref: Presumed

The walls – lining inside clasp columns - Ground Floor, Room 43, Classroom between two classrooms – are presumed to contain asbestos.

Any change in its appearance should be recorded and passed to Property Services.

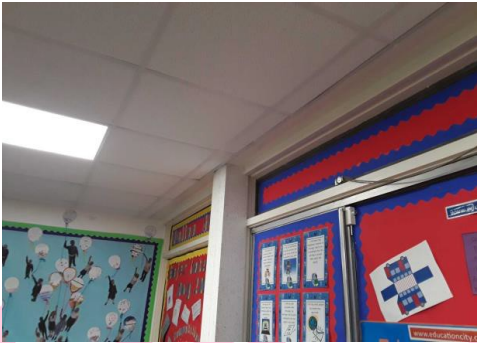
Item 101 Ref: Presumed

The walls – lining inside clasp columns - Ground Floor, Room 45, Classroom – are presumed to contain asbestos.

Any change in its appearance should be recorded and passed to Property Services.

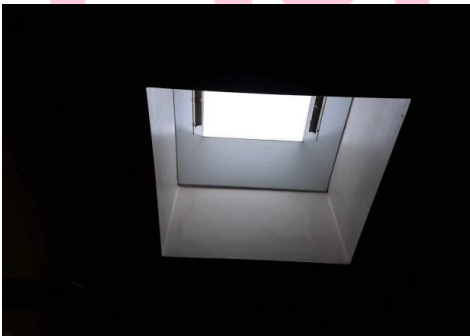
Item 102 Ref: Presumed

The ceiling – textile rope seal to fibreglass skylight - Ground Floor, Room 45, Cloakroom & Computer Room – is presumed to contain asbestos.

Any change in its appearance should be recorded and passed to Property Services.

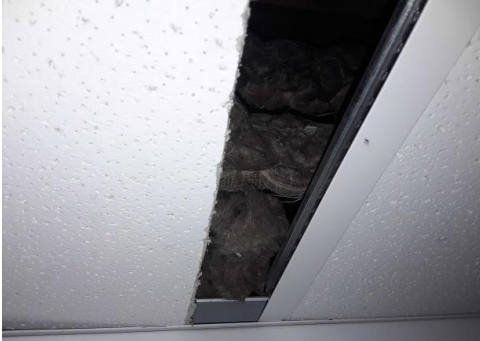
Item 103 Ref: 22-53098-1

The pipes – string to mmmf lagged metal pipes - Ground Floor, Room 46, Girls Toilet - do not contain asbestos

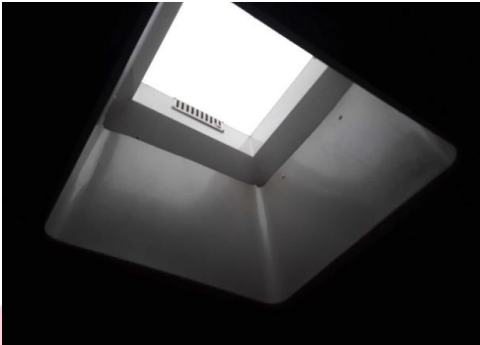
Item 104 Ref: Presumed

The ceiling – textile rope seal to fibreglass skylight - Ground Floor, Room 46, Girls Toilet – is presumed to contain asbestos.

Any change in its appearance should be recorded and passed to Property Services.

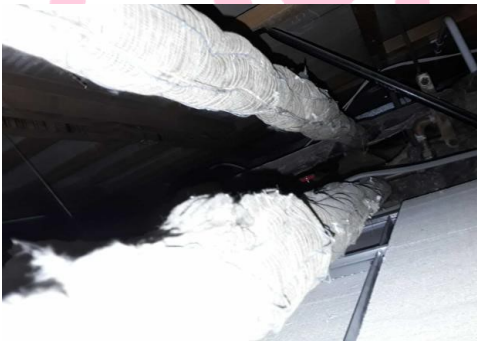
Item 105 Ref: Presumed

The pipes – string to mmmf lagged metal pipes - Ground Floor, Room 47 Boys Toilet - do not contain asbestos

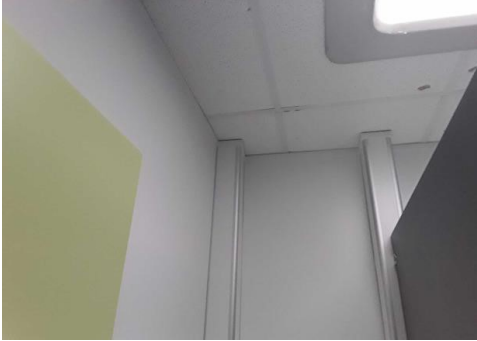
Item 106 Ref: Presumed

The walls – lining inside clasp columns - Ground Floor, Room 47 Boys Toilet – are presumed to contain asbestos.

Any change in its appearance should be recorded and passed to Property Services.

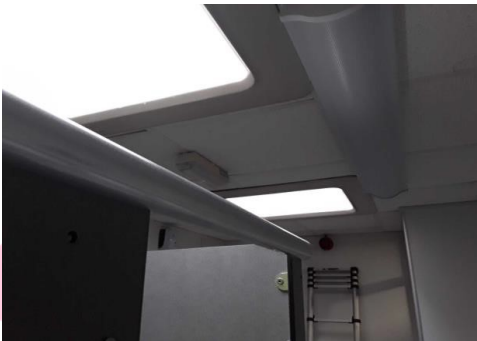
Item 107 Ref: Presumed

The ceiling – textile rope seal to fibreglass skylight - Ground Floor, Room 47 Boy's Toilet – is presumed to contain asbestos.

Any change in its appearance should be recorded and passed to Property Services.

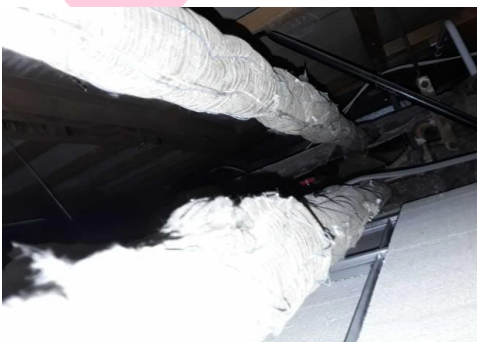
Item 108 Ref: 22-53098-1

The pipes – string to mmmf lagged metal pipes - Ground Floor, Room 51 Classroom - do not contain asbestos

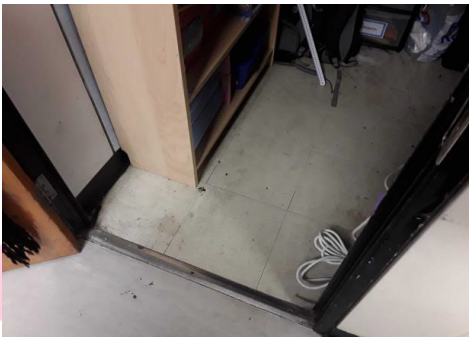
Item 110 Ref: 22-53098-10

The floor – tiles and adhesive - Ground Floor, Room 52, Classroom Cupboard - contains asbestos.

Any change in its appearance should be recorded and passed to Property Services.

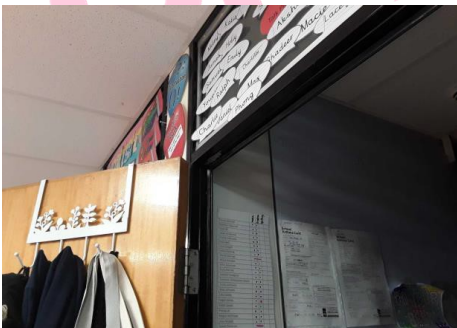
Item 111 Ref: Presumed

The walls – lining inside clasp columns - Ground Floor, Room 52 Classroom – are presumed to contain asbestos.

Any change in its appearance should be recorded and passed to Property Services.

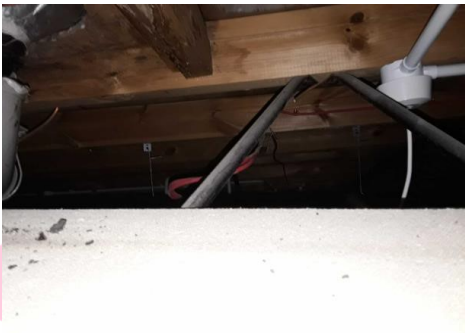
Item 113 Ref: 22-53098-1

The pipes – string to mmmf lagged metal pipes - Ground Floor, Room 53 Classroom - do not contain asbestos

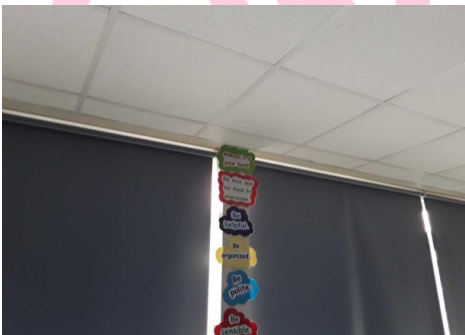
Item 114 Ref: Presumed

The walls – lining inside clasp columns - Ground Floor, Room 53 Classroom – are presumed to contain asbestos.

Any change in its appearance should be recorded and passed to Property Services.

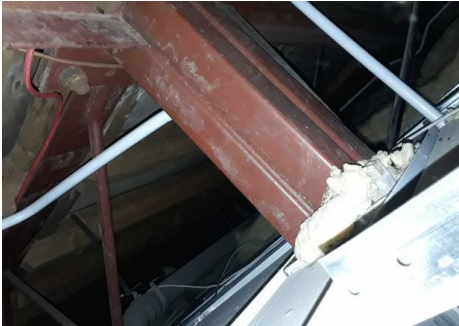
Item 115 Ref: Presumed

The walls – lining inside clasp columns - Ground Floor, Room 54 Classroom cupboard – are presumed to contain asbestos.

Any change in its appearance should be recorded and passed to Property Services.

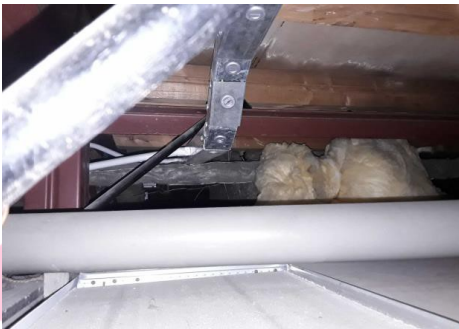
Item 116 Ref: 22-53098-1

The pipes – string to mmmf lagged metal pipes - Ground Floor, Room 55 Classroom - do not contain asbestos

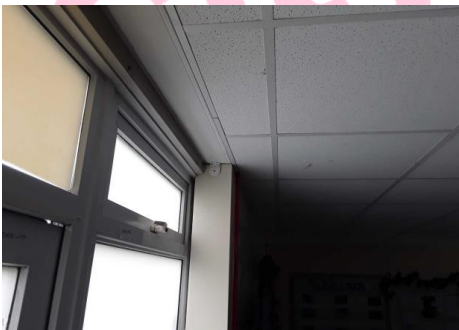
Item 117 Ref: Presumed

The walls – lining inside clasp columns - Ground Floor, Room 55 Classroom – are presumed to contain asbestos.

Any change in its appearance should be recorded and passed to Property Services.

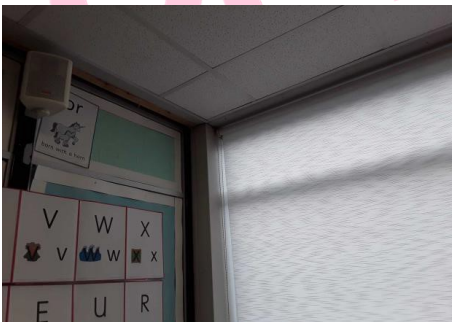
Item 120 Ref: Presumed

The walls – lining inside clasp
columns - Ground Floor,
Room 57, Classroom between
Classroom – are presumed to
contain asbestos.

Any change in its appearance
should be recorded and
passed to Property Services.

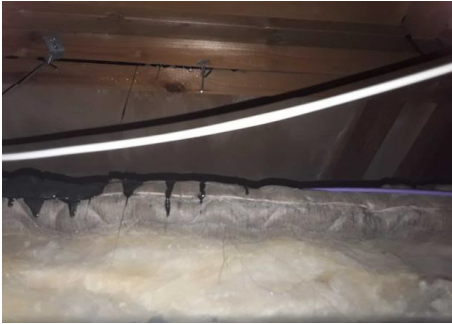
Item 121 Ref: 22-53098-1

The pipes – string to mmmf lagged metal pipes - Ground Floor, Room 58 Classroom - do not contain asbestos

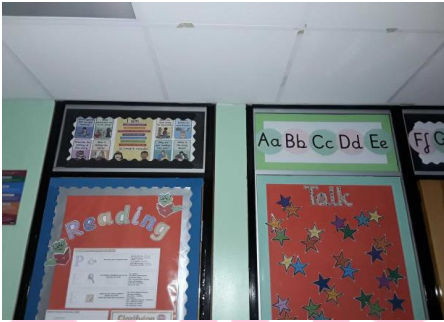
Item 122 Ref: Presumed

The walls – lining inside clasp columns - Ground Floor, Room 58 Classroom – are presumed to contain asbestos.

Any change in its appearance should be recorded and passed to Property Services.

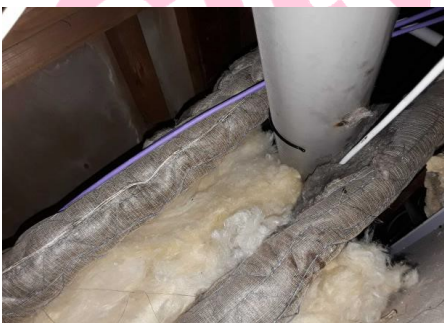
Item 123 Ref: 22-53098-1

The pipes – string to mmmf lagged metal pipes - Ground Floor, Room 59 Classroom cupboard - do not contain asbestos

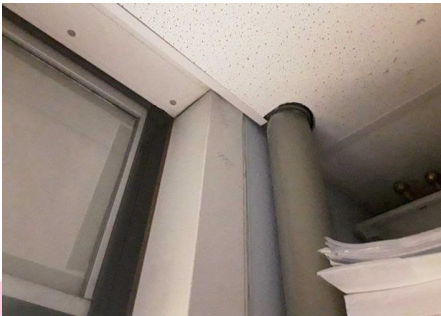
Item 125 Ref: Presumed

The walls – lining inside clasp
columns - Ground Floor,
Room 59 Classroom cupboard
– are presumed to contain
asbestos.

Any change in its appearance
should be recorded and
passed to Property Services.

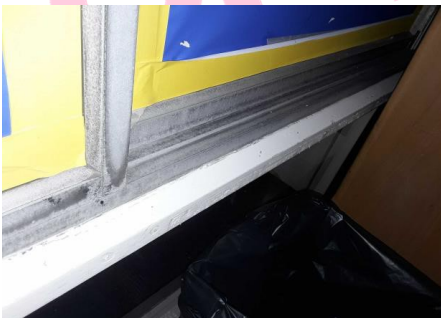
Item 126 Ref: 22-53098-11

The window – internal wood
windows - Ground Floor,
Room 60 Library - does not
contain asbestos

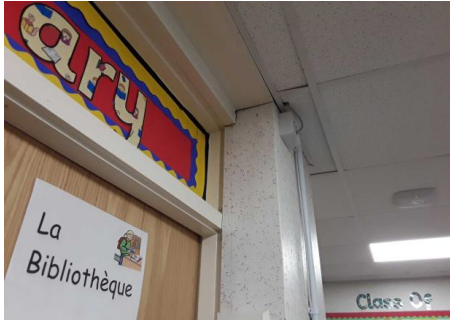
Item 127 Ref: Presumed

The walls – lining inside clasp columns - Ground Floor, Room 60 Library – are presumed to contain asbestos.

Any change in its appearance should be recorded and passed to Property Services.

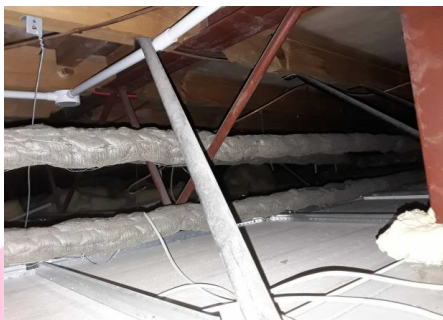
Item 128 Ref: 22-53098-1

The pipes – string to mmmf lagged metal pipes - Ground Floor, Room 61 Computer Room and store cupboard - do not contain asbestos

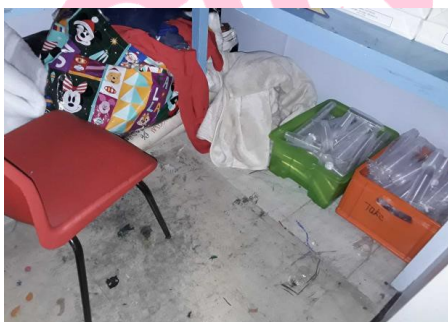
Item 129 Ref: 22-53098-12

The floor – tiles and adhesive - Ground Floor, Room 61 Computer Room and store cupboard - contains asbestos.

Any change in its appearance should be recorded and passed to Property Services.

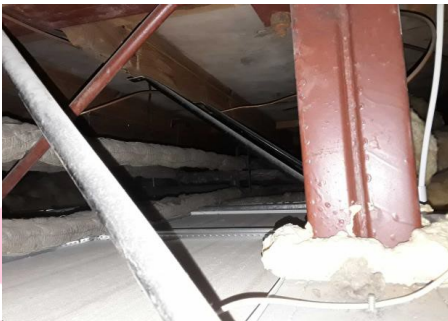
Item 131 Ref: 22-53098-1

The pipes – string to mmmf lagged metal pipes - Ground Floor, Room 62 Paper store cupboard - do not contain asbestos

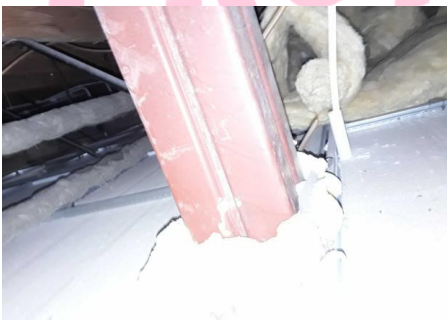
Item 132 Ref: Presumed

The walls – lining inside clasp columns - Ground Floor, Room 62 Paper store cupboard – are presumed to contain asbestos.

Any change in its appearance should be recorded and passed to Property Services.

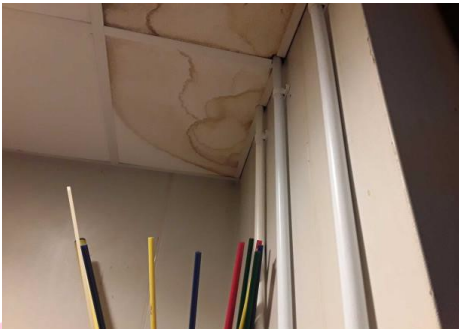
Item 134 Ref: Presumed

The walls – lining inside clasp columns - Ground Floor, Room 63 Main School hall store cupboard – are presumed to contain asbestos.

Any change in its appearance should be recorded and passed to Property Services.

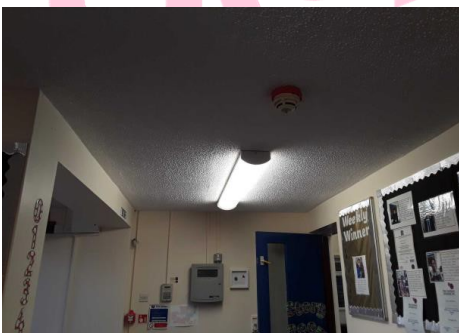
Item 135 Ref: 22-53098-13

The ceiling – textured coating - Ground Floor, Room 64, Entrance hall, Nursery - contains asbestos.

Any change in its appearance should be recorded and passed to Property Services.

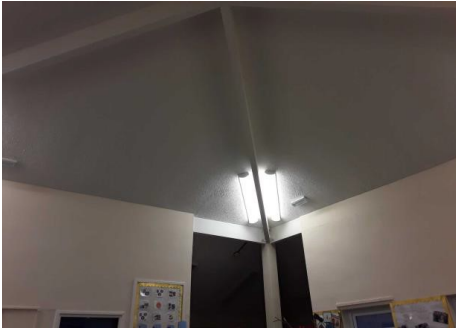
Item 136 Ref: 22-53098-13

The ceiling – textured coating
- Ground Floor, Room 65,
Main Nursery Area 1 -
contains asbestos.

Any change in its appearance
should be recorded and
passed to Property Services.

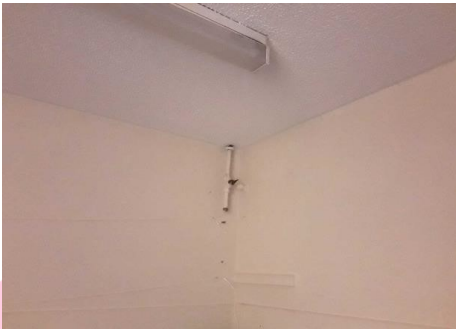
Item 137 Ref: Presumed

The pipes – stop taps
(Gaskets) – Ground Floor,
Room 65, Main Nursery Area
1 - are presumed to contain
asbestos.

Any change in its appearance
should be recorded and
passed to Property Services.

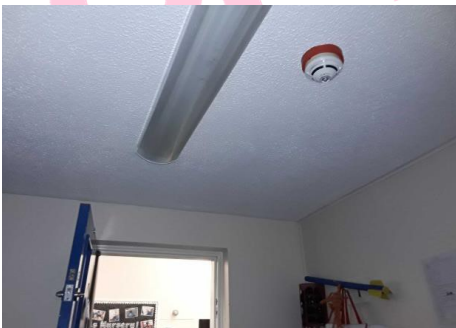
Item 138 Ref: 22-53098-13

The ceiling – textured coating
- Ground Floor, Room 66
Office, Nursery - contains
asbestos.

Any change in its appearance
should be recorded and
passed to Property Services.

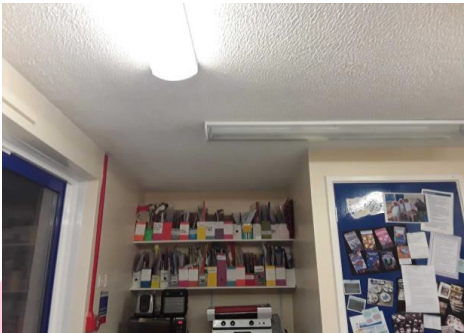
Item 140 Ref: 22-53098-13

The ceiling – textured coating
- Ground Floor, Room 68,
Kitchen, Nursery - contains
asbestos.

Any change in its appearance
should be recorded and
passed to Property Services.

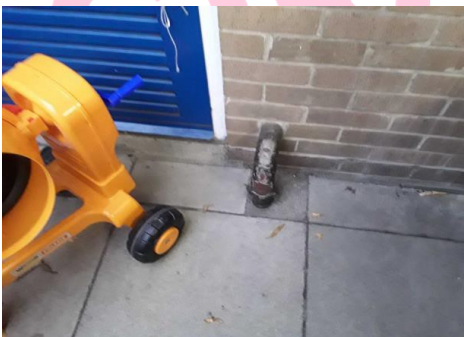
Item 141 Ref: 22-53098-14

The floor - intake pipe -
Ground Floor, Room 69,
External store area, Nursery -
does not contain asbestos.

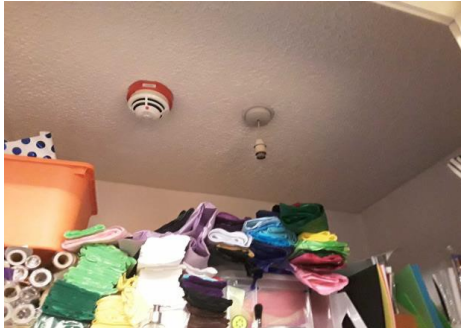
Item 142 Ref: 22-53098-13

The ceiling – textured coating
- Ground Floor, Room 71,
Kitchen Store Cupboard,
Nursery - contains asbestos.

Any change in its appearance
should be recorded and
passed to Property Services.

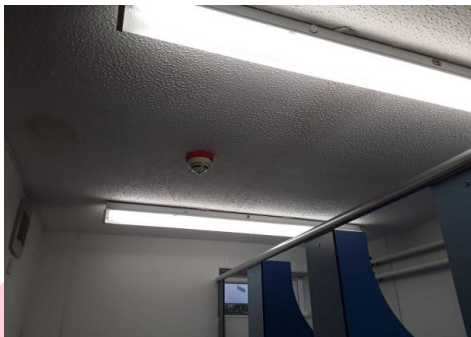
Item 143 Ref: 22-53098-13

The ceiling – textured coating
- Ground Floor, Room 72,
Nursery Toilets - contains
asbestos.

Any change in its appearance
should be recorded and
passed to Property Services.

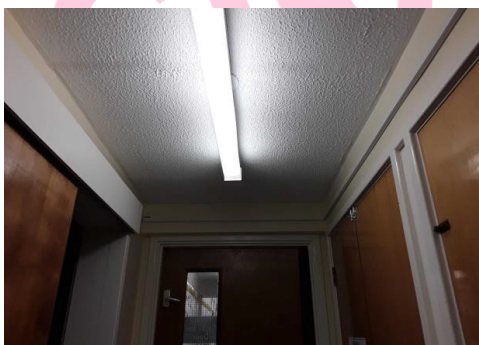
Item 144 Ref: 22-53098-13

The ceiling – textured coating
- Ground Floor, Room 73,
Corridor Nursery - contains
asbestos.

Any change in its appearance
should be recorded and
passed to Property Services.

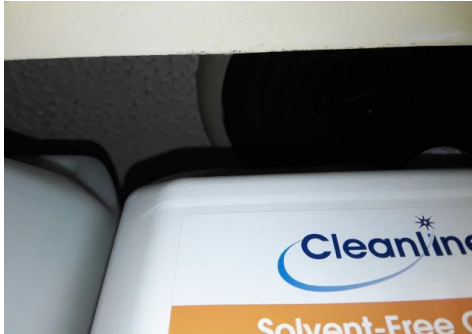
Item 145 Ref: 22-53098-13

The ceiling – textured coating
- Ground Floor, Room 74,
Cleaners Cupboard, Nursery -
contains asbestos.

Any change in its appearance
should be recorded and
passed to Property Services.

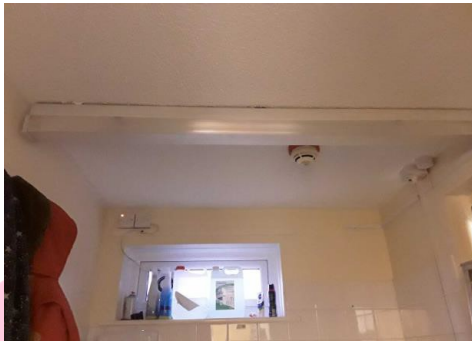
Item 146 Ref: 22-53098-13

The ceiling – textured coating
- Ground Floor, Room 76,
Cleaners Store Cupboard,
Nursery - contains asbestos.

Any change in its appearance
should be recorded and
passed to Property Services.

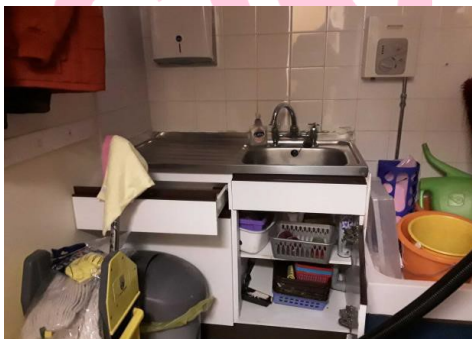
Item 147 Ref: 22-53098-16

The sink pad - Ground Floor,
Room 76, Cleaners Store
Cupboard, Nursery – does not
contain asbestos.

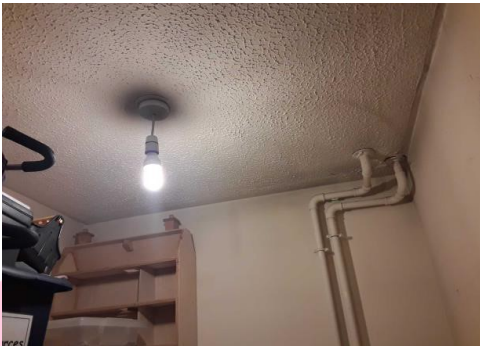
Item 149 Ref: 22-53098-13

The ceiling – textured coating
- Ground Floor, Room 78
Nursery area 2 store cupboard
- contains asbestos.

Any change in its appearance
should be recorded and
passed to Property Services.

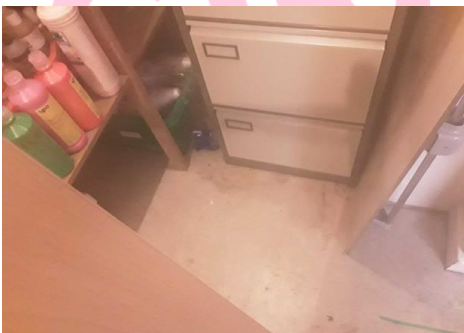
Item 150 Ref: 22-53098-20

The floor – tiles and adhesive
- Ground Floor, Room 78
Nursery area 2 store cupboard
- contains asbestos.

Any change in its appearance
should be recorded and
passed to Property Services.

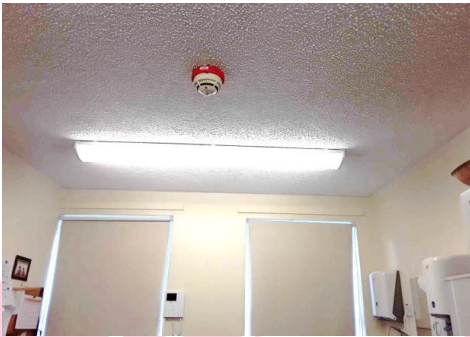
Item 152 Ref: 22-53098-13

The ceiling – textured coating
- Ground Floor, Room 80 Staff
Room Nursery - contains
asbestos.

Any change in its appearance
should be recorded and
passed to Property Services.

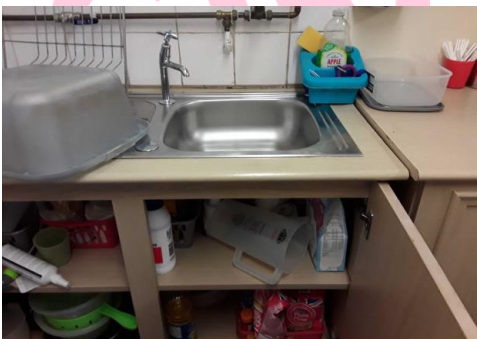
Item 153 Ref: 22-53098-17

The sink pad - Ground Floor,
Room 80 Staff Room Nursery
– does not contain asbestos.

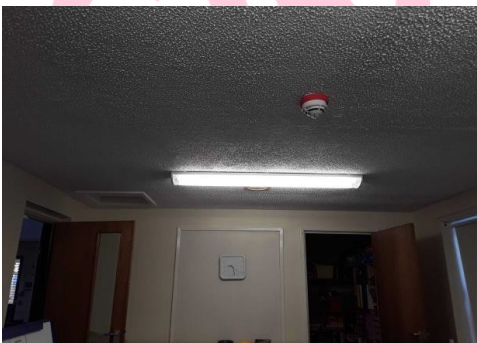
Item 156 Ref: 22-53098-13

The ceiling – textured coating
- Ground Floor, Room 82
Classroom Nursery - contains
asbestos.

Any change in its appearance
should be recorded and
passed to Property Services.

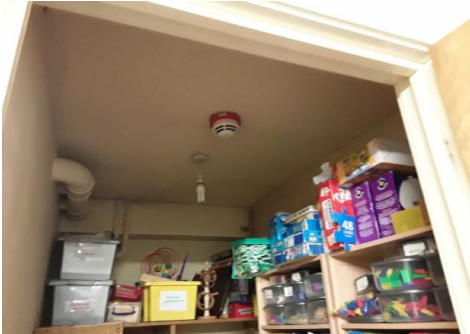
Item 157 Ref: 22-53098-13

The ceiling – textured coating
- Ground Floor, Room 83
Store Room Nursery -
contains asbestos.

Any change in its appearance
should be recorded and
passed to Property Services.

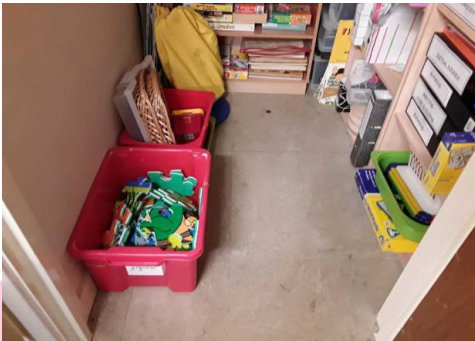
Item 158 Ref: 22-53098-20

The floor – tiles and adhesive
- Ground Floor, Room 83
Store Room Nursery -
contains asbestos.

Any change in its appearance
should be recorded and
passed to Property Services.

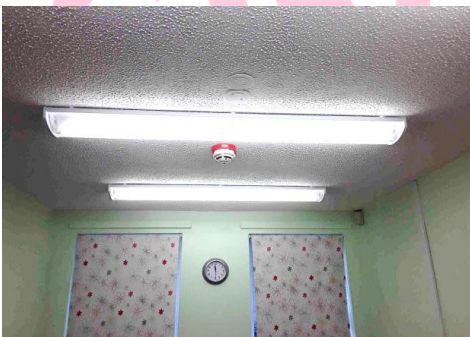
Item 159 Ref: 22-53098-13

The ceiling – textured coating
- Ground Floor, Room 84
Office Nursery - contains
asbestos.

Any change in its appearance
should be recorded and
passed to Property Services.

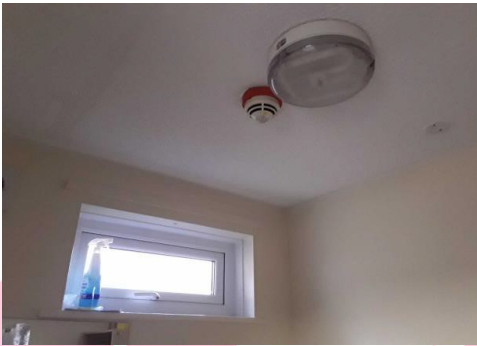
Item 161 Ref: 22-53098-13

The ceiling – textured coating
- Ground Floor, Room 88
Disabled Toilet Nursery -
contains asbestos.

Any change in its appearance
should be recorded and
passed to Property Services.

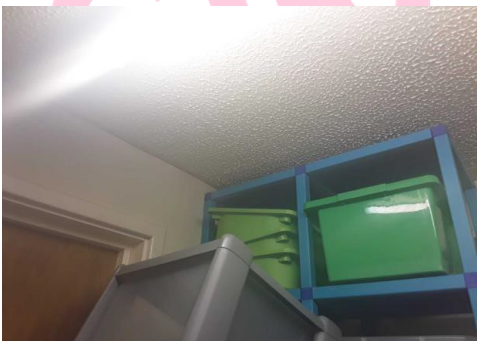
Item 162 Ref: 22-53098-13

The ceiling – textured coating
- Ground Floor, Room 89
Nursery area 2 Store
cupboard 1- contains
asbestos.

Any change in its appearance
should be recorded and
passed to Property Services.

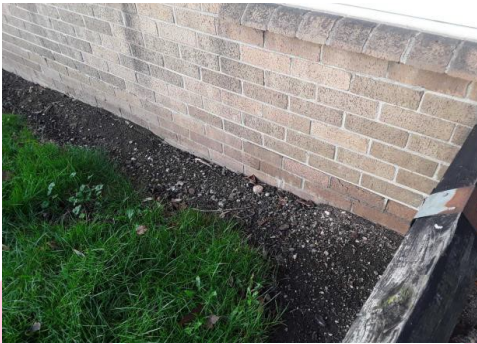
Item 167 Ref: 22-53098-21

The damp proof course -
Room 94, Externals of nursery
- contains asbestos.

Any change in its appearance
should be recorded and
passed to Property Services.

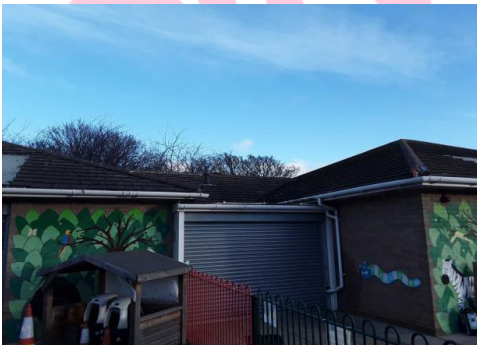
Item 168 Ref: Presumed

The roof – ridge vents - Room
94, Externals of nursery – is
presumed to contain
asbestos.

Any change in its appearance
should be recorded and
passed to Property Services.

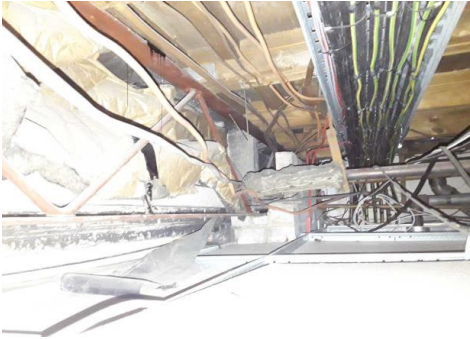
Item 169 Ref: 22-53098-1

The pipes – string to mmmf lagged metal pipes - Ground Floor, Room 98 Boiler Room - do not contain asbestos

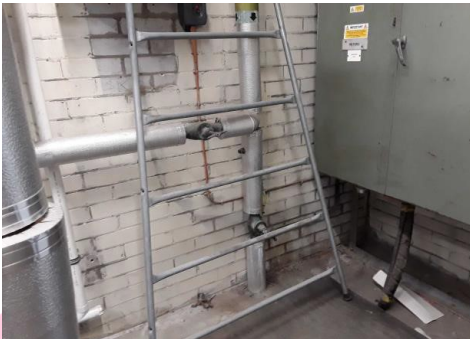
Item 170 Ref: Presumed

The pipes – Stop taps (Gaskets) - Ground Floor, Room 98 Boiler Room – are presumed to contain asbestos.

Any change in its appearance should be recorded and passed to Property Services.

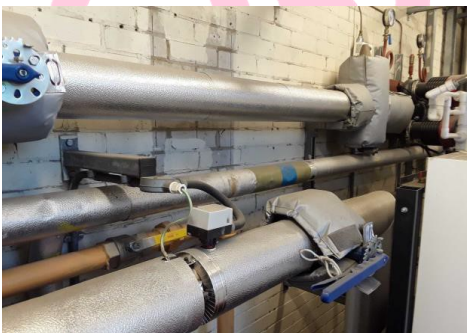
Item 171 Ref: 22-53098-24

The walls – residual insulation to walls - Ground Floor, Room 98 Boiler Room - do not contain asbestos

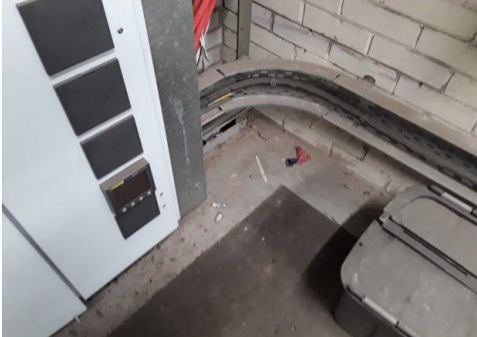
Item 172 Ref: 22-53098-25

The floor – redundant barrel fuses - Ground Floor, Room 98 Boiler Room - do not contain asbestos

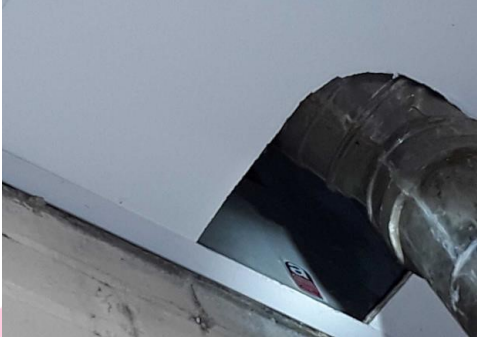
Item 173 Ref: Presumed

The walls – firebreak above suspended ceiling tiles between boiler room and kitchen and hall area of school – Ground Floor, Room 98 Boiler Room - are presumed to contain asbestos.

Any change in its appearance should be recorded and passed to Property Services.

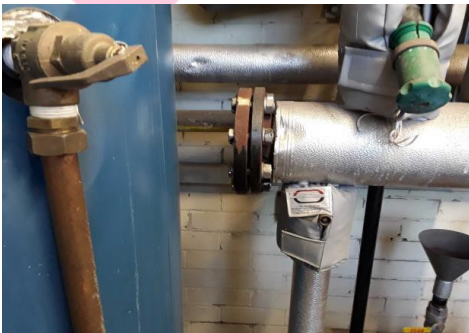
Item 174 Ref: 22-53098-27

The pipes – flange (Gaskets) - Ground Floor, Room 98 Boiler Room - do not contain asbestos

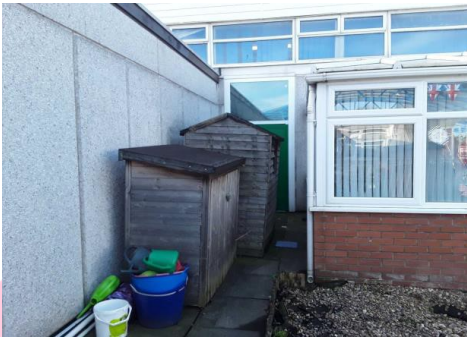
Item 176 Ref: 22-53098-28

The roof – shed roof felts - Ground Floor, Room 101,
Sheds in school courtyard – does not contain asbestos.

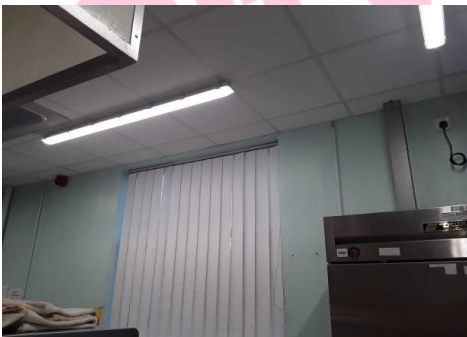
Item 177 Ref: Presumed

The walls – lining inside clasp columns - Ground Floor,
Room 104 Kitchen - are presumed to contain asbestos.

Any change in its appearance should be recorded and passed to Property Services.

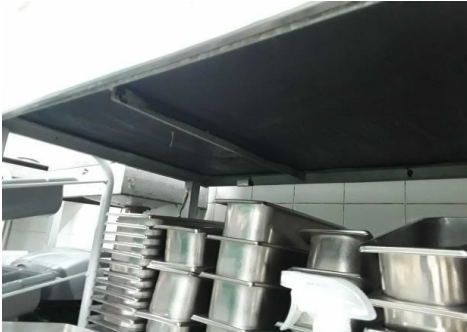
Item 178 Ref: 22-53098-30

The sink pad – coating to underside of drainers – Ground Floor, Room 104 Kitchen - does not contain asbestos.

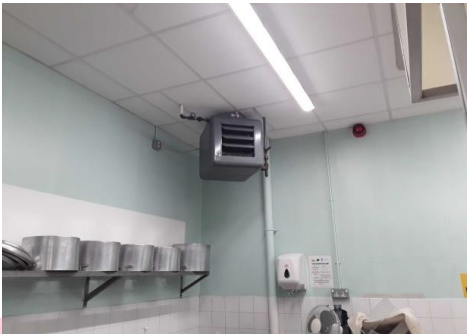
Item 179 Ref: Presumed

The vessels – lining inside ceiling heater - Ground Floor, Room 104 Kitchen - are presumed to contain asbestos.

Any change in its appearance should be recorded and passed to Property Services.

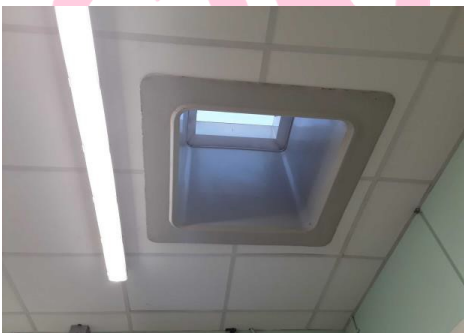
Item 180 Ref: Presumed

The ceiling – textile rope seal to fibreglass skylight - Ground Floor, Room 104 Kitchen - is presumed to contain asbestos.

Any change in its appearance should be recorded and passed to Property Services.

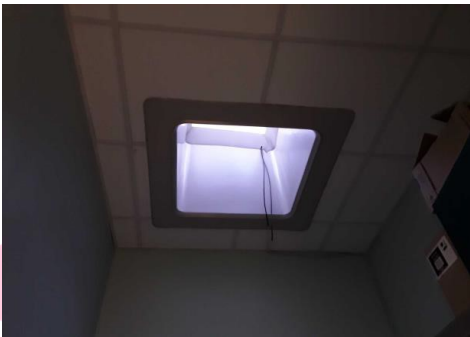
Item 182 Ref: Presumed

The ceiling – textile rope seal to fibreglass skylight - Ground Floor, Room 105 Kitchen Office - is presumed to contain asbestos.

Any change in its appearance should be recorded and passed to Property Services.

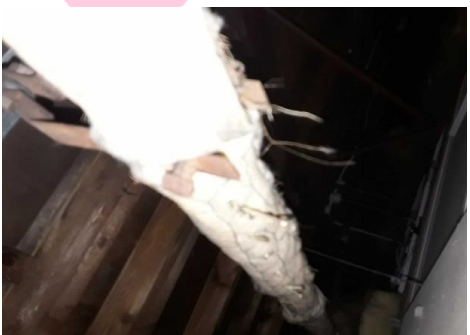
Item 183 Ref: 22-53098-1

The pipes – string to mmmf lagged metal pipes - Ground Floor, Room 106 Kitchen Pantry - do not contain asbestos

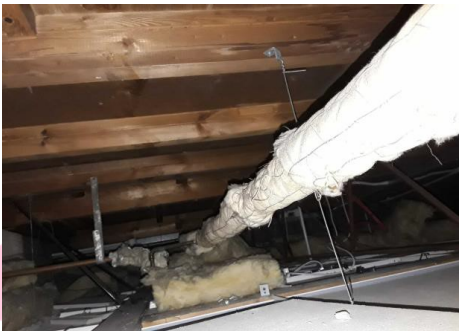
Item 185 Ref: 22-53098-1

The pipes – string to mmmf lagged metal pipes - Ground Floor, Room 107 Kitchen Store Cupboard - do not contain asbestos

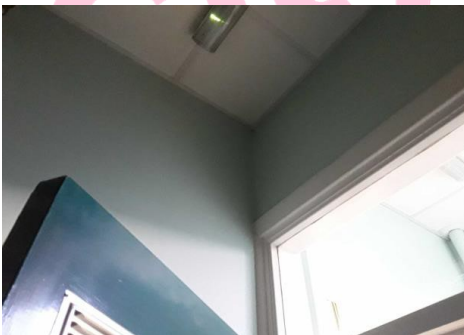
Item 186 Ref: Presumed

The walls – lining inside clasp columns - Ground Floor, Room 107 Kitchen Store Cupboard - are presumed to contain asbestos.

Any change in its appearance should be recorded and passed to Property Services.

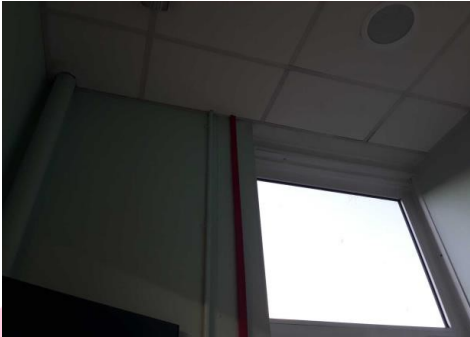
Item 188 Ref: Presumed

The walls – lining inside clasp columns - Ground Floor, Room 108 Kitchen Fire Exit Hallway - are presumed to contain asbestos.

Any change in its appearance should be recorded and passed to Property Services.

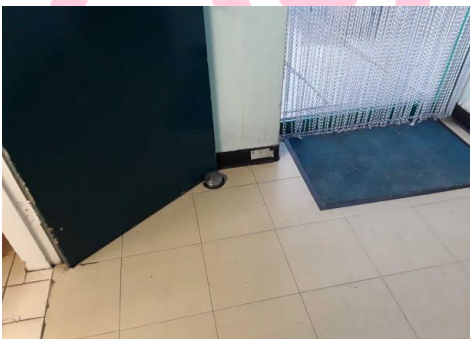
Item 189 Ref: 22-53098-31

The floor – tiles and adhesive - Ground Floor, Room 108 Kitchen Fire Exit Hallway - contains asbestos.

Any change in its appearance should be recorded and passed to Property Services.

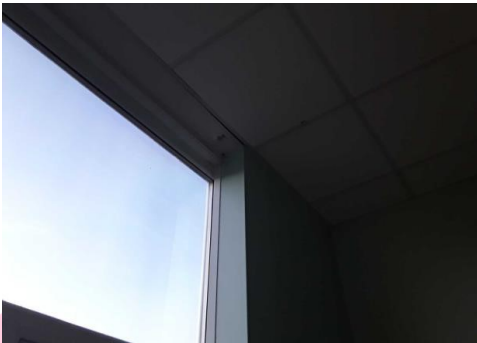
Item 191 Ref: Presumed

The walls – lining inside clasp columns - Ground Floor, Room 109 Kitchen Staff Cloakroom - are presumed to contain asbestos.

Any change in its appearance should be recorded and passed to Property Services.

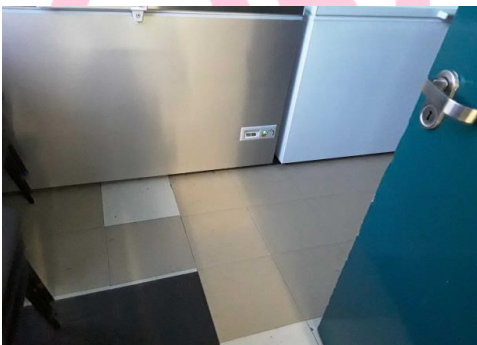
Item 192 Ref: 22-53098-31

The floor – tiles and adhesive - Ground Floor, Room 109 Kitchen Staff Cloakroom - contains asbestos.

Any change in its appearance should be recorded and passed to Property Services.

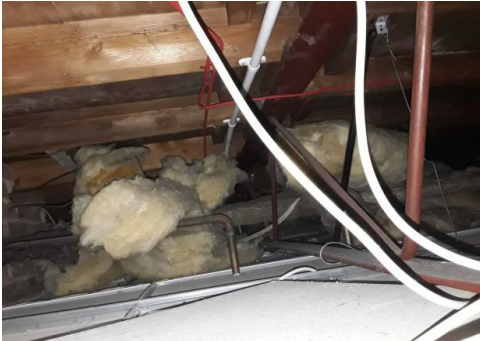
Item 193 Ref: 22-53098-1

The pipes – string to mmmf lagged metal pipes - Ground Floor, Room 110 Kitchen Staff Toilet - do not contain asbestos

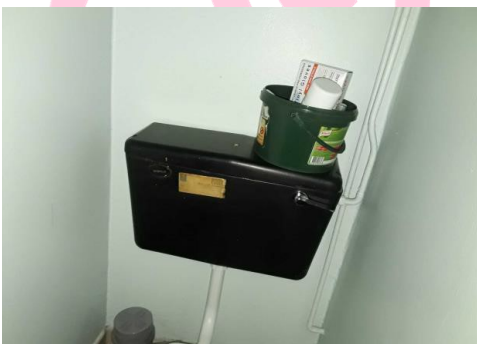
Item 195 Ref: 22-53098-32

The toilet cistern – Ground Floor, Room 110 Kitchen Staff Toilet - contains asbestos.

Any change in its appearance should be recorded and passed to Property Services.

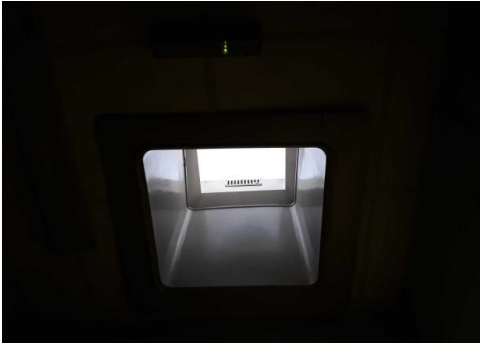
Item 196 Ref: Presumed

The ceiling – textile rope seal to fibreglass skylight - Ground Floor, Room 110 Kitchen Staff Toilet - is presumed to contain asbestos.

Any change in its appearance should be recorded and passed to Property Services.

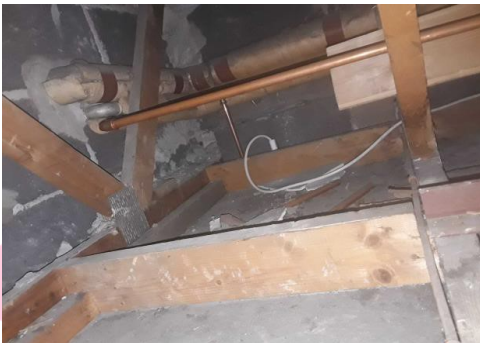
Item 197 Ref: 22-53098-34

The floor - 1st Floor, Room 111 Loft above boiler room in nursery – does not contain asbestos.

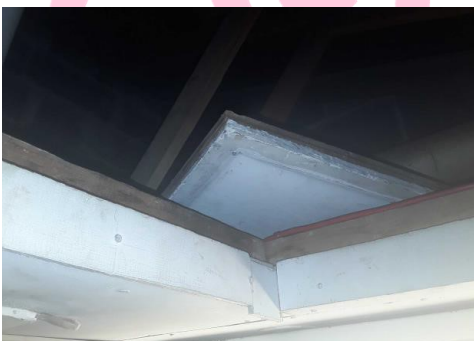
Item 198 Ref: 22-53098-35

The door hatch - 1st Floor, Room 111 Loft above boiler room in nursery – does not contain asbestos.
