ASBESTOS SURVEY REPORT FOR ROSSMERE ACADEMY, CATCOTE ROAD, HARTLEPOOL, TS25 3JL.

Rossmere Academy, Hartlepool

Date: 13 February 2025

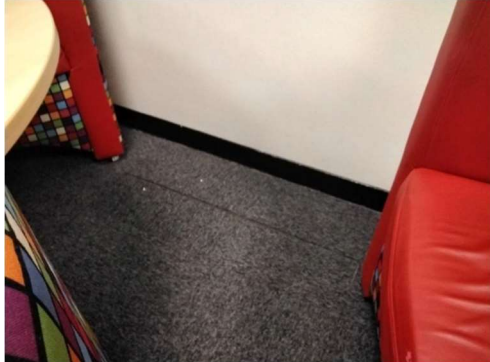
19	As KX001580	Wall Skirting	Block A Ground Floor Hallway/Passageway (Room 020)	Contains asbestos - Any change in appearance should be recorded and passed to Property Services.

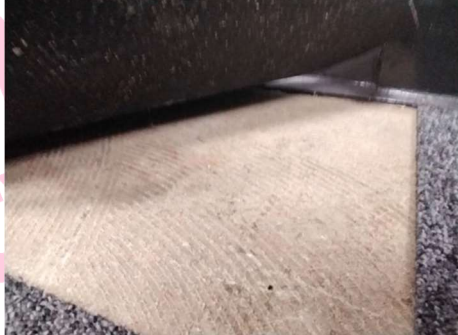
20	KX001581	Floor adhesive residue under carpet and screed	Block A Ground Floor Hallway/Passageway (Room 020)	Contains asbestos - Any change in appearance should be recorded and passed to Property Services.

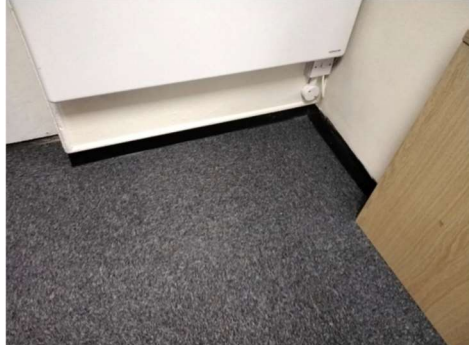
21	As KX001580	Wall Skirting	Block A Ground Floor Reception (Room 020 b & c)	Contains asbestos - Any change in appearance should be recorded and passed to Property Services.

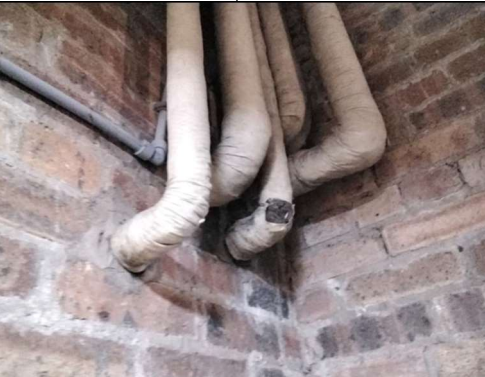
24	KX001585	Pipework insulation string binding to fibreglass	Block A Ground Floor Stairwell/Staircase (Room 017)	Contains asbestos - Any change in appearance should be recorded and passed to Property Services.

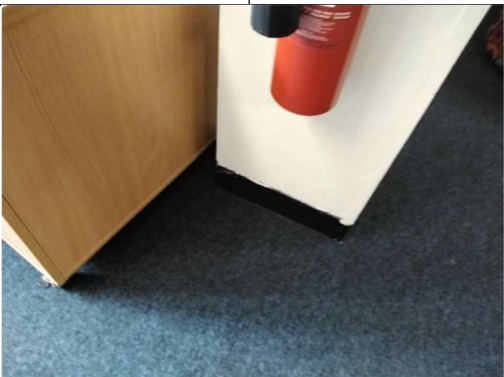
66	As KX001592	Wall skirting	Block A Ground Floor Corridor (Room 61)	Contains asbestos - Any change in appearance should be recorded and passed to Property Services.

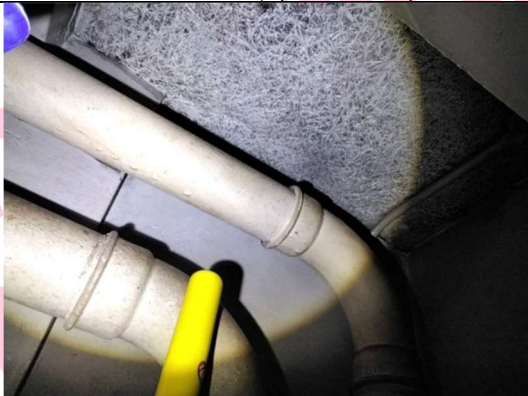
68	As KX001591	Ceiling	Block A Ground Floor Cleaners Cupboard (Room 035)	Does not contain asbestos.

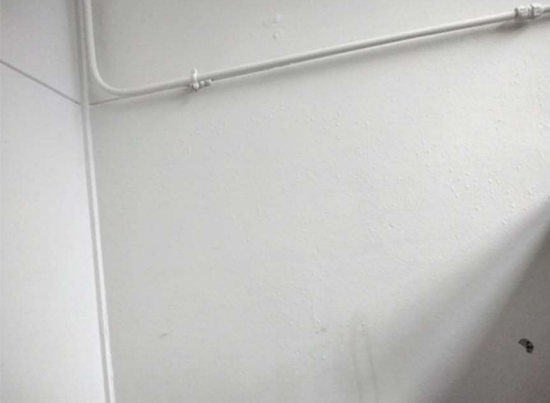
163	As KX001625	Wall coating fire flex paint	Block B Ground Floor Toilets (Room 129)	Does not contain asbestos.

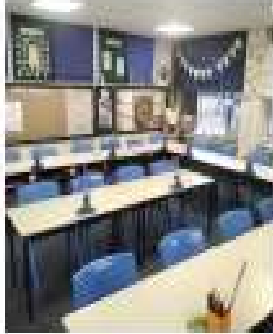
178	CF010792	Floor tile below screed	Ground Floor Classroom (Room 008)	Low Risk
Photo 1: Wide Angle		Photo 2: Close-up

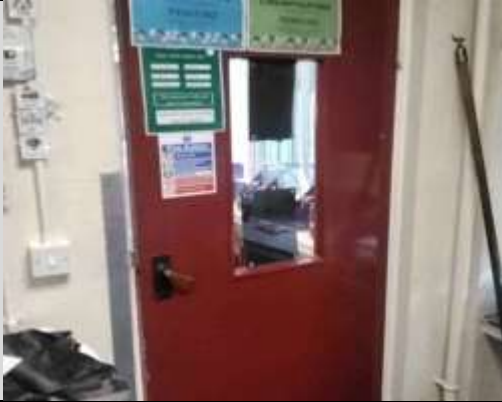
179	CF010791	Mastic to beading within door	Ground Floor Classroom (Room 008)	No Risk

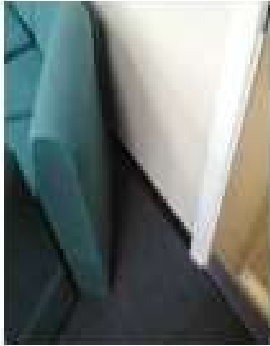
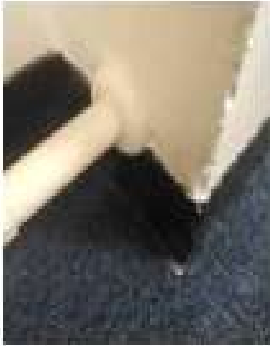
180	CF010789	Floor tile	Ground Floor Staff Room (Room 041)	Low Risk
Photo 1: Wide Angle		Photo 2: Close-up

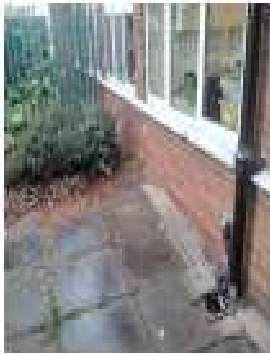
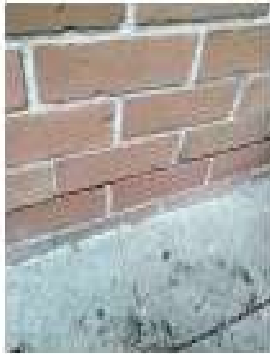
181	CF010794	Damp proof course	External to staff room (E/001)	Low Risk
Photo 1: Wide Angle		Photo 2: Close-up
