### ASBESTOS SURVEY REPORT FOR SUB STATION, PORT OF SUNDERLAND

**SUB STATION 047,  
PORT OF SUNDERLAND**

**Premises Manager / Samo: - Tenant      Date: 31<sup>st</sup> July 2023**

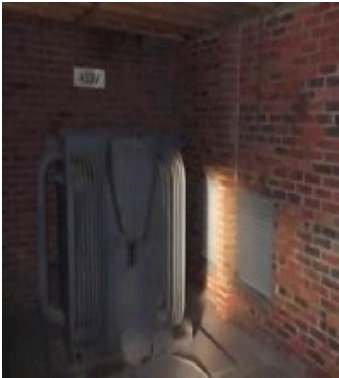
Room 1 of the sub station was accessed, and no suspect materials were found.

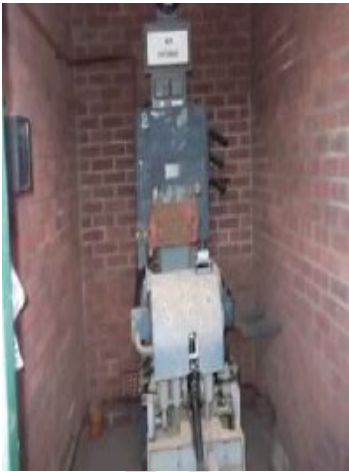
Room 2 of the sub station was accessed, and no suspect materials were found.

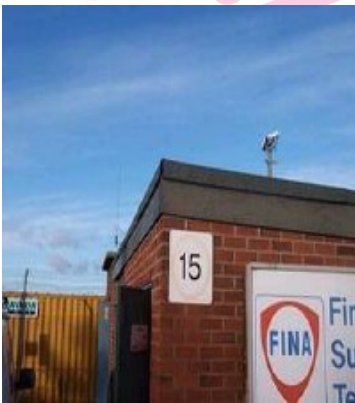
**Item 1 Ref: VP002200**

VP002200 – Bitumen to flat roof (External) (Item 1) No Risk

The bitumen to the flat roof does not contain asbestos.

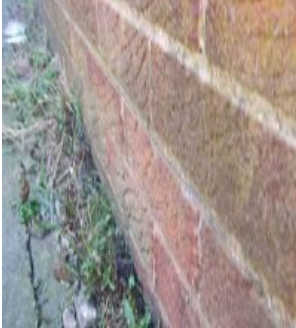
**Item 2 - Ref: VP002201**

VP002201 – Damp proof course (External) (Item 2) Very Low Risk

The damp proof course to the external of the sub station contains asbestos. Any change in its appearance should be recorded and passed to Property Services.
