ASBESTOS SURVEY REPORT FOR SHED 8, THE PORT, SUNDERLAND,
SR1 2BU

**Asbestos Register for
SHED 8, THE PORT, SUNDERLAND, SR1 2BU**

Plan of Building and Samples Location

Photographs of Areas Sampled

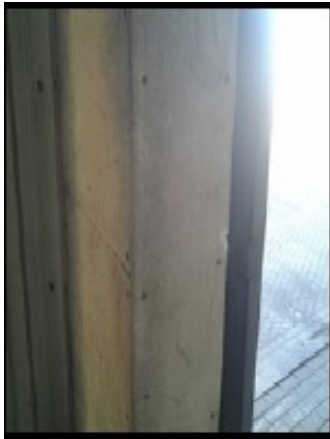
Item 1 Ref: 44423-1

The column boxing in the warehouse (Room 001) does not contain asbestos.

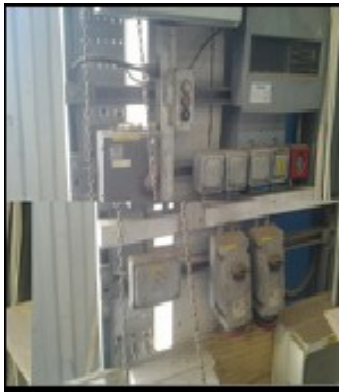
Item 2 Ref: Presumed

It was presumed asbestos was present in Electrics however due to live supply no access was possible (Warehouse) (Room 001).

Any change in its appearance should be recorded, and passed to Property Services.

Further investigation is required.

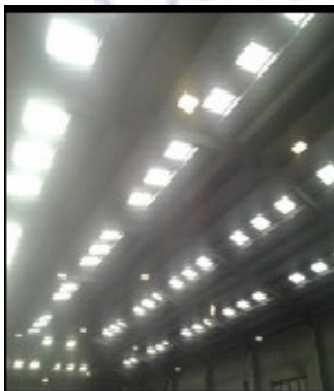
Presumed

It was presumed asbestos was present in the skylights, however due to height no access was possible (Warehouse) (Room 001).

Further investigation is required.
