ASBESTOS SURVEY REPORT FOR BARNWELL ACADEMY, PENSHAW

Asbestos Register for

**BARNWELL ACADEMY,
PENSHAW**

Date: 06 February 2025

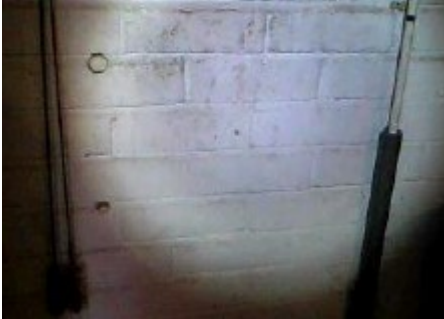
Item 46 Ref: AD000532

The debris to wall in Room 1 Boiler House does not contain asbestos.

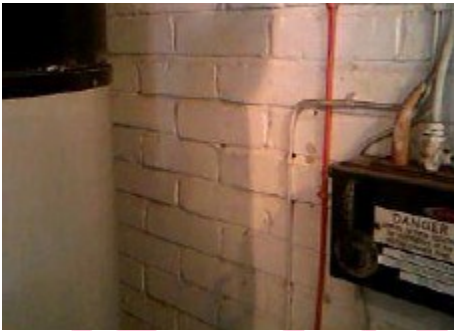
Item 47 Ref: AD000533

The debris to wall in Room 1 Boiler House does not contain asbestos.

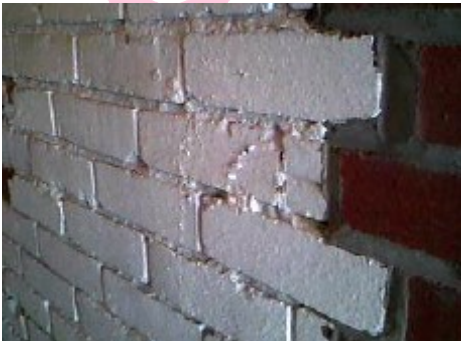
Item 48 Ref: AD000534

The debris to wall in Room 1 Boiler House does not contain asbestos.

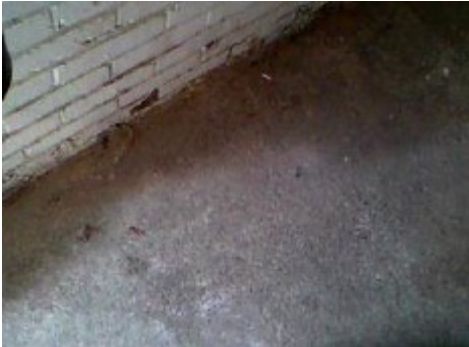
Item 49 Ref: AD000535

The debris to wall in Room 1 Boiler House does not contain asbestos.

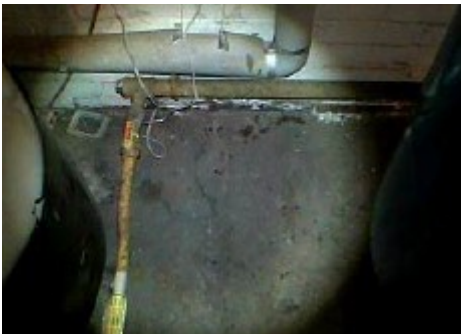
Item 50 Ref: AD000536

The debris to wall in Room 1 Boiler House does not contain asbestos.

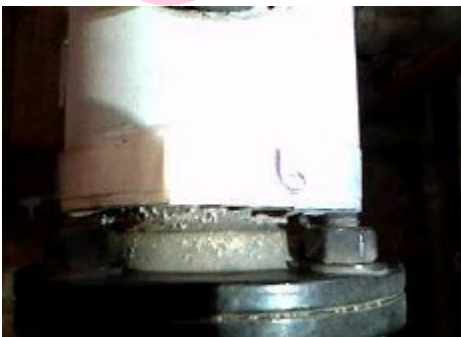
Item 51 Ref: AD000537

The debris around gasket in Room 1 Boiler House does not contain asbestos.

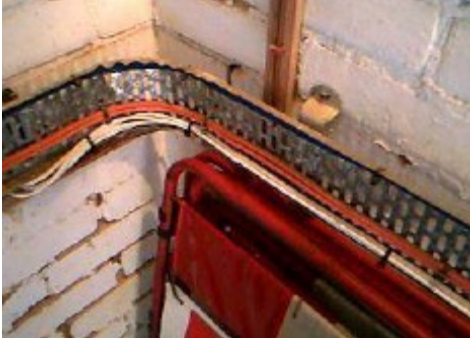
Item 52 Ref: AD000538

The debris to cable tray in Room 1 Boiler House does not contain asbestos.

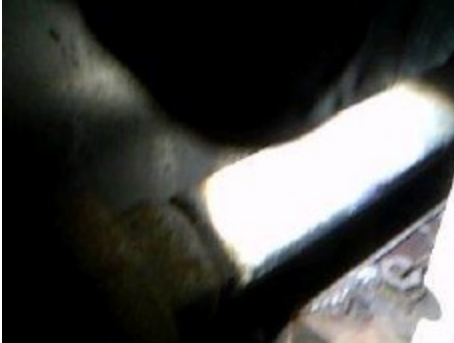
Item 58 Ref: AD000543

The rope to boiler 3 in Room 1 Boiler House does not contain asbestos.

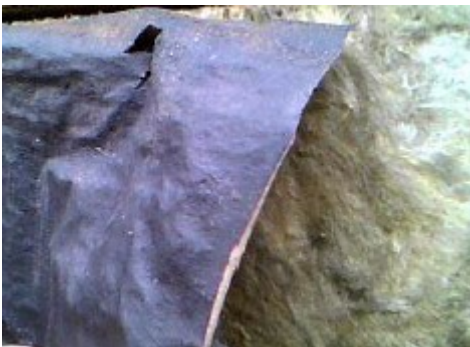
Item 60 Ref: BB002313

The builders paper in Room 6 external does not contain asbestos.

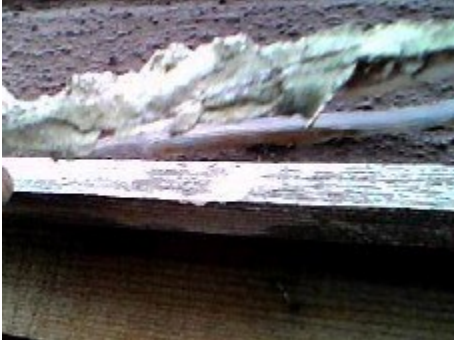
Item 61 Ref: BB002314

The sealant in Room 6 external does not contain asbestos.
