### **ASBESTOS SURVEY REPORT FOR FULWELL INFANT ACADEMY SCHOOL, SUNDERLAND**

## **Asbestos Register for FULWELL INFANT ACADEMY**

**Date: 01 February 2024**

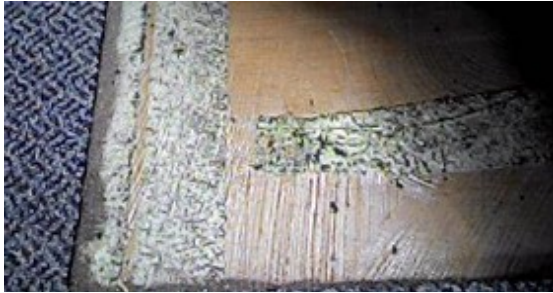
**Item 70 – Ref: As EB000313**

The Beige vinyl tiles in Room 3 Class 2 do not contain asbestos.
