### **ASBESTOS SURVEY REPORT FOR SOUTH HYLTON PRIMARY SCHOOL, SUNDERLAND**

### **Asbestos Register for SOUTH HYLTON PRIMARY SCHOOL, SUNDERLAND**

**Date: 13 June 2024**

South Hylton Primary School - Last updated 13/06/2024 - Version 2

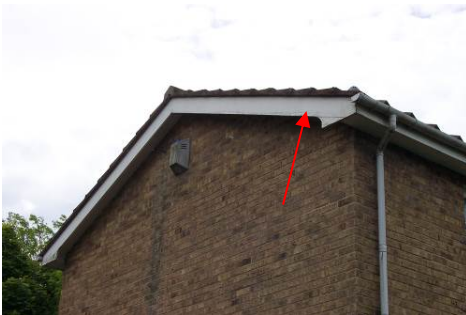
**Caretakers House - Demolished**

**Presumed**

The cement fillet to the apex on the Caretakers house was presumed to contain asbestos.

***This has now been demolished.***

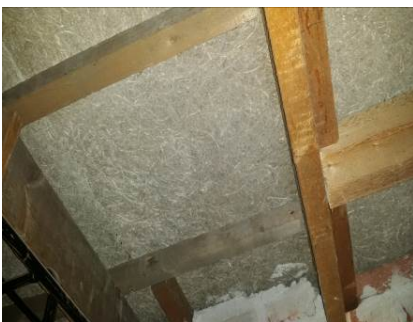
**Item 29 – As 107247-1**

The underside of the roof in the void above the hall corridor does not contain asbestos.

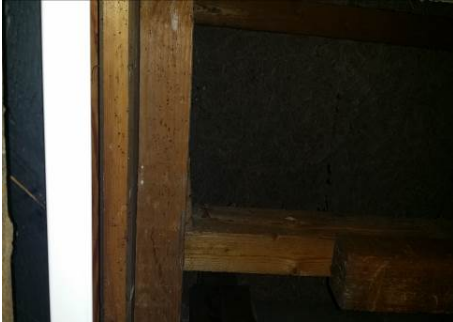
**Item 30 – As 107247-1**

The underside of the roof in the void above the corridor does not contain asbestos.

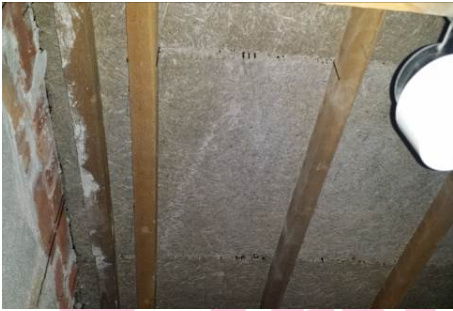
**Item 31 – Ref: 107247-4**

The underside of the roof in the void above the cleaners store does not contain asbestos.

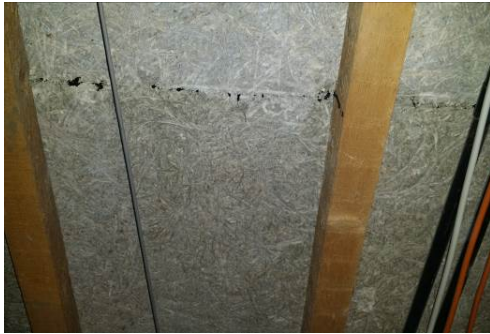
**Item 33 – As 107247-4**

The underside of the roof in the void above the kitchen does not contain asbestos.

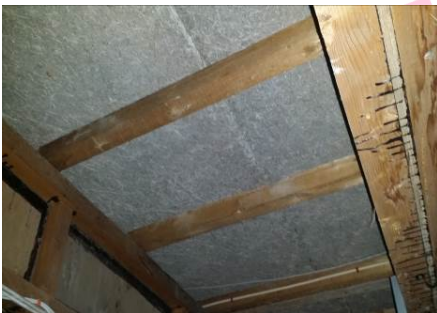
**Item 37 – As 107247-4**

The underside of the roof in the void above the quiet area does not contain asbestos.

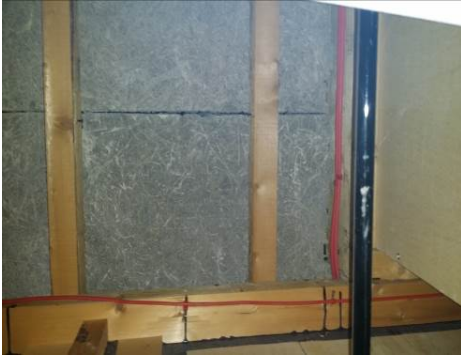
**Item 42 – Ref:107247-8**

The underside of the roof in the void above the deputy heads office does not contain asbestos.

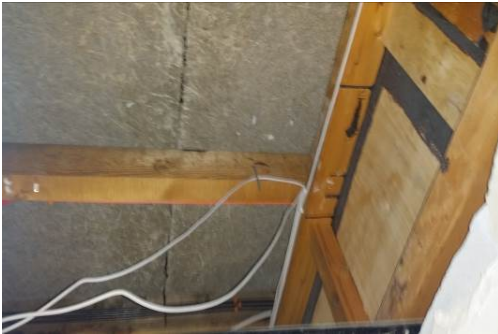
**Item 43 – As 107247-8**

The underside of the roof in the void above the store does not contain asbestos.

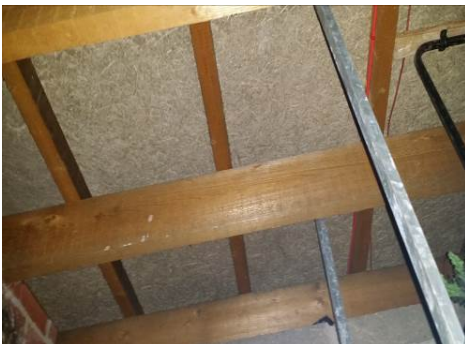
**Item 44 – As 107247-8**

The underside of the roof in the void above the store does not contain asbestos.

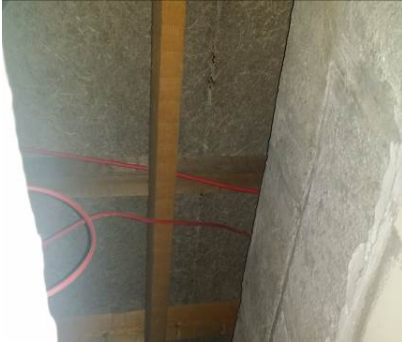
**Item 45 – Ref:107247-8**

The underside of the roof in the void above the store does not contain asbestos.

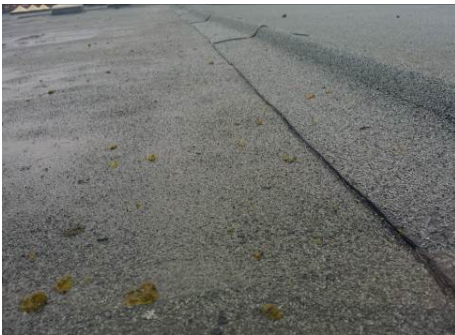
**Item 46 – Ref: 107247-9**

The roof felt to the external does not contain asbestos.

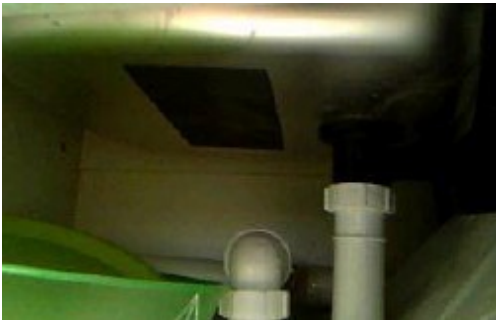
**Item 58 – Ref BB000981**

The Sink Pad in Room 13 (Infants current sink area) does not contain asbestos.

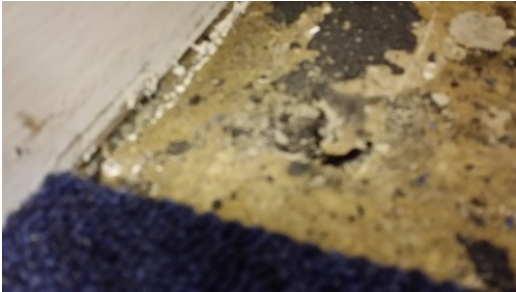
**Item 61 – Ref 76223-1**

The Floor black composite (001/classroom) does not contain asbestos.

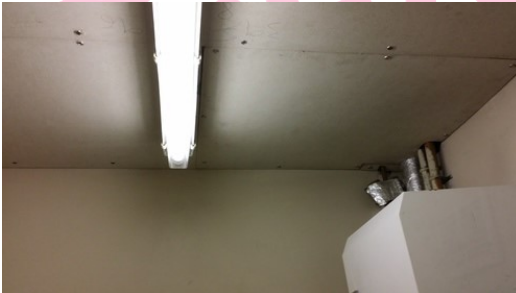
**Item 62 – Ref 76223-2**

The Ceiling (002/boiler cupboard) does not contain asbestos.

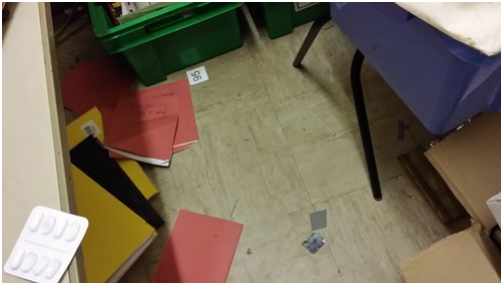
**Item 63 – Ref 76223-3**

The Vinyl tile floor covering (002/boiler cupboard) does not contain asbestos.

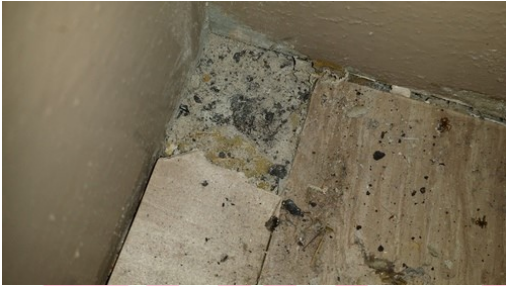
**Item 64 – Ref As 76223-1**

The Floor black composite (002/boiler cupboard) does not contain asbestos.

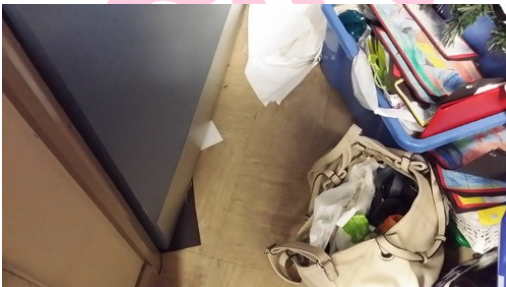
**Item 65 – Ref As 76223-3**

The Vinyl tile floor covering (003/store cupboard) does not contain asbestos.

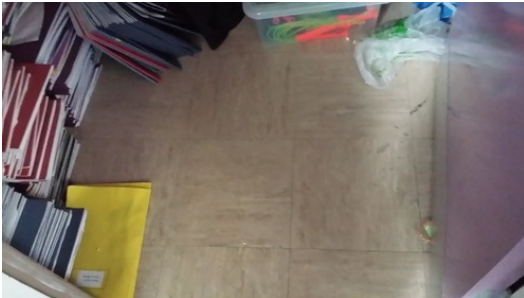
**Item 67 – Ref As 76223-3**

The Vinyl tile floor covering (004/store cupboard) does not contain asbestos.

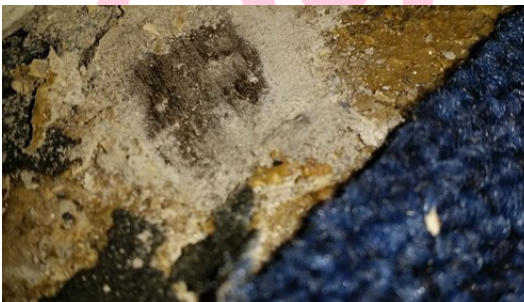
**Item 68 – Ref As 76223-1**

The Floor black composite (004/store cupboard) does not contain asbestos.

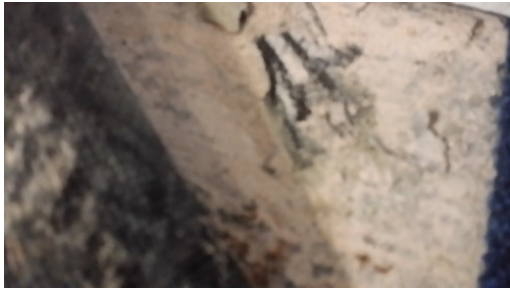
**Item 69 – Ref As 76223-1**

The Floor black composite (005/classroom) does not contain asbestos.

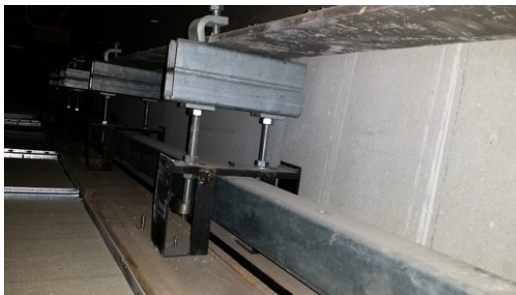
**Item 70 – Ref 76223-4**

The Firebreak (insulating board) (005/classroom-void above) does not contain asbestos.

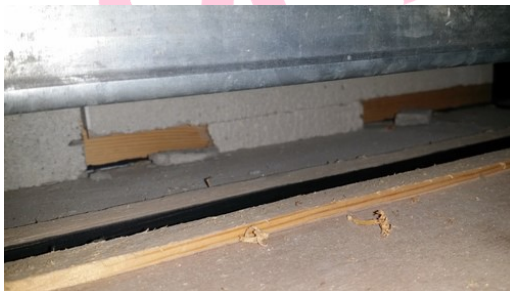
**Item 71 – Ref As 76223-4**

The Debris adjacent firebreak (insulating board) (005/classroom-void above) does not contain asbestos.

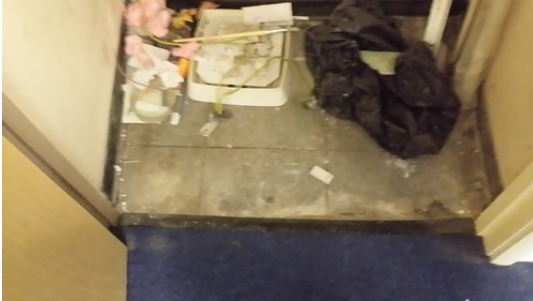
**Item 72 – Ref 76223-5**

The Vinyl floor tile incl. bitumen adhesive (008/DB1 cupboard) does not contain asbestos.

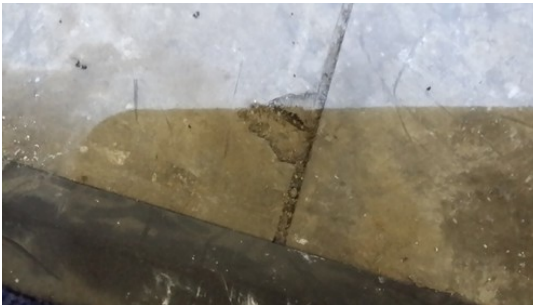
**Item 73 – Ref As 76223-1**

The Floor (008/DB1 cupboard) does not contain asbestos.

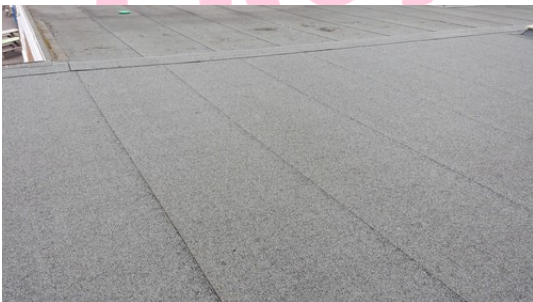
**Item 74 – Ref 76223-7**

The Flat roof (externals localised to proposed classroom extension) does not contain asbestos.

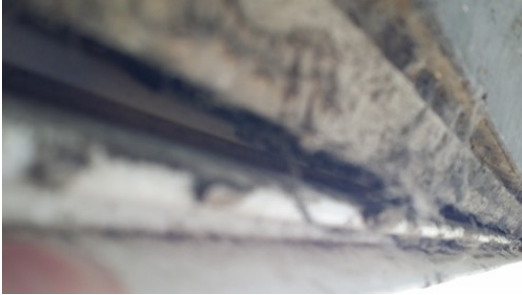
**Item 75 – Ref 76223-6**

The Felt layer behind plastic fascia (externals localised to proposed classroom extension) does not contain asbestos.
