ASBESTOS SURVEY REPORT FOR MARKET PLACE DEPOT, HOUGHTON LE SPRING,

Asbestos Register for Market Place Depot, Houghton le Spring

Premises Manager / Samo: - Tenant Date: 01 October 2024

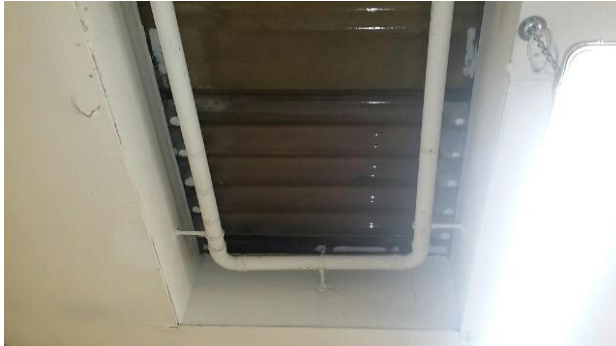
Item 1 Ref: Presumed

Presumed - Skylight panels (Rm 0/08) (Item 1) - Low Risk

The skylight panels in the office (Rm 0/08) are presumed to contain asbestos.

Any changes in the appearance should be recorded and passed to Property Services.

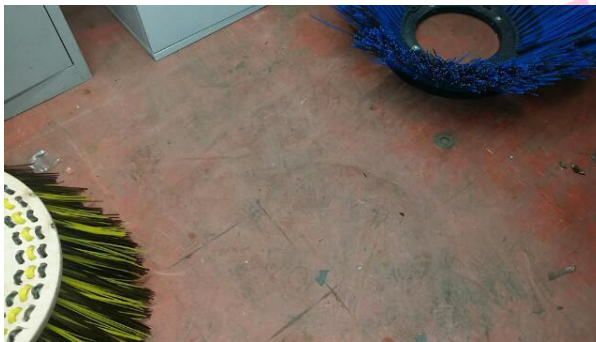
Item 2 Ref: 01

The floor tiles in the Store Room (Rm 0/09) do not contain asbestos.

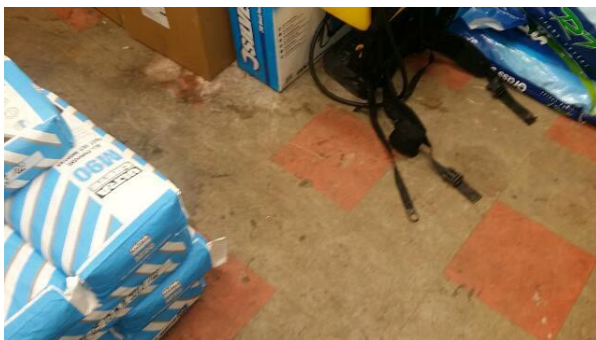
Item 3 Ref: 02

The floor tiles in the Store Room (Rm 0/10) do not contain asbestos.

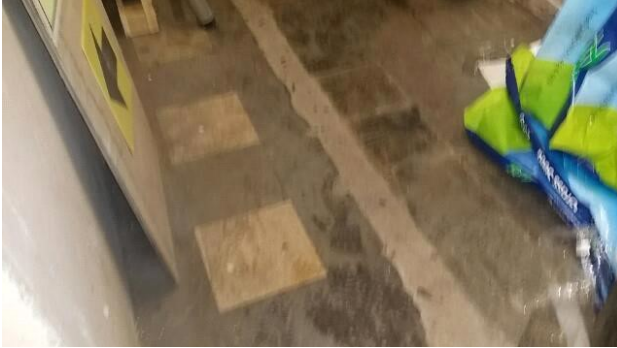
Item 4 Ref: 03

The floor tiles in the Entrance Hall (Rm 0/11) do not contain asbestos.

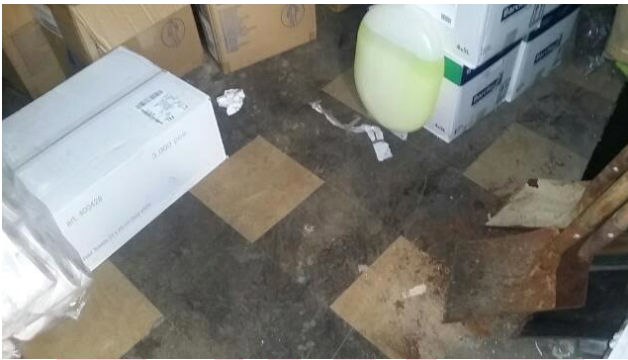
Item 5 Ref: As 03

The floor tiles in the Store room (Rm 0/12) do not contain asbestos.

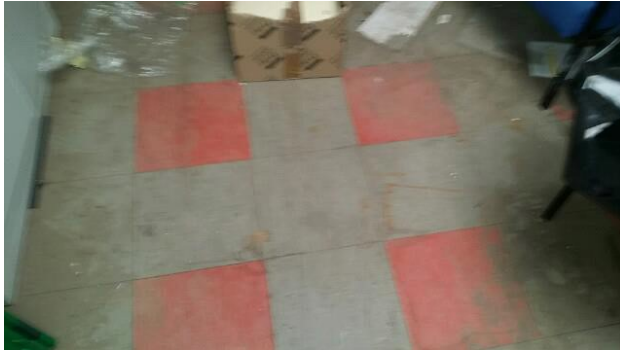
Item 7 Ref: As 02

The floor tiles in the Store Room (Rm 0/14) do not contain asbestos.

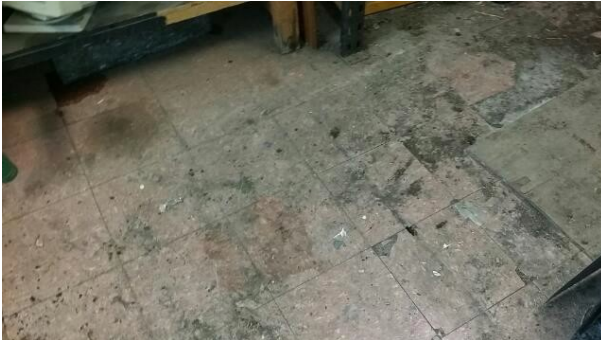
Item 10 Ref: 04

The floor tiles in the Store Room (Rm 0/19) do not contain asbestos.

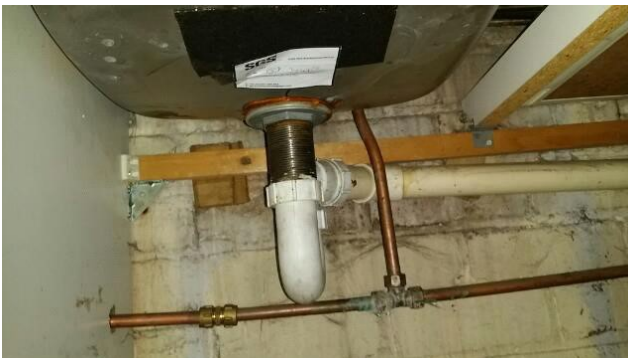
Item 12 Ref: 05

The sink pad in Kitchen (Rm 0/23) does not contain asbestos.

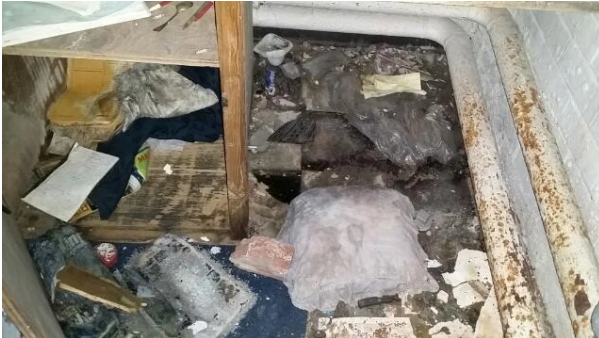
Item 13 Ref: 06

The floor tiles in the Store Room (Rm 0/26) contain asbestos.

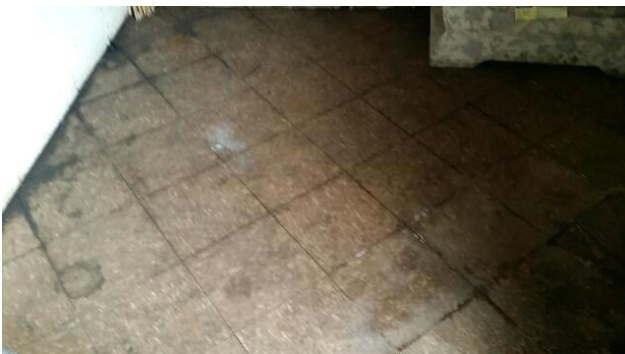
Item 18 Ref: 08

The floor tiles in the Rest Room (Rm 0/36) do not contain asbestos.

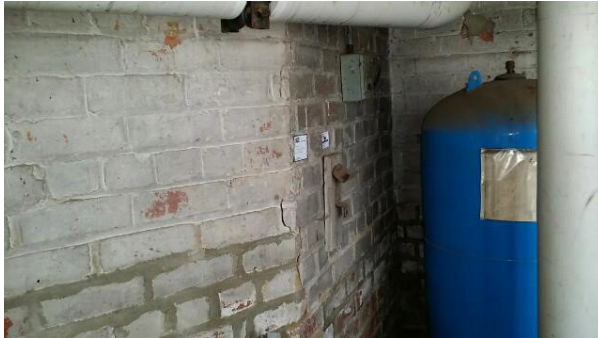
Item 25 Ref: 12

The debris to rear of tank in the Boiler Room (Rm 0/40) does not contain asbestos.

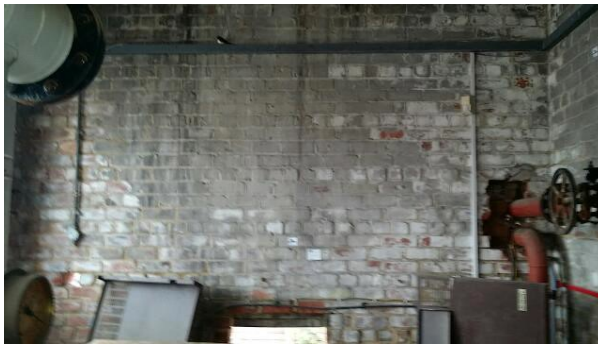
Item 26 Ref: 11

The debris to wall right hand side of boiler in the Boiler Room (Rm 0/40) does not contain asbestos.

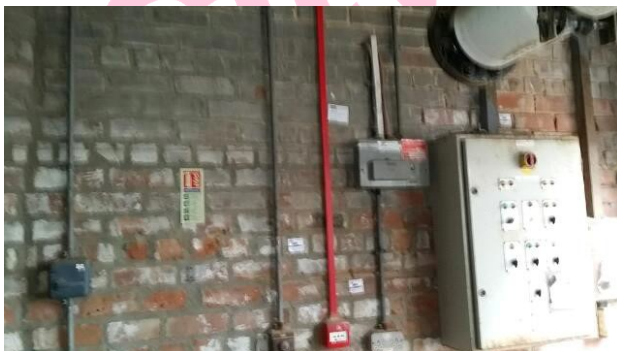
Item 27 Ref: 13

The debris to wall left hand side of electrical equipment in the Boiler Room (Rm 0/40) does not contain asbestos.

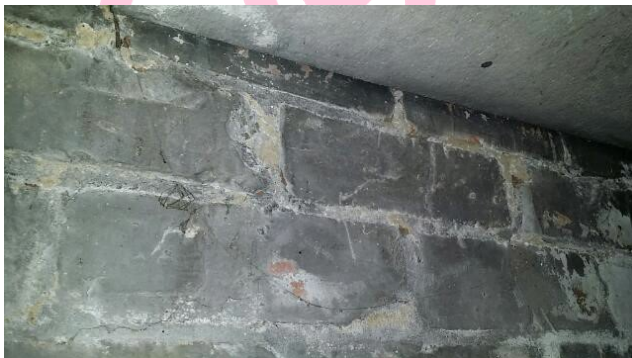
Item 30 Ref: As 19

The debris to cobwebs in the Boiler Room (Rm 0/40) contained asbestos.

An Environmental clean was carried out in the Boiler Room in October 2016. This has now been removed.

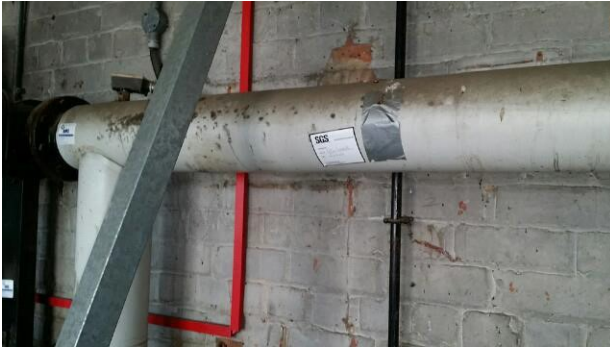
Item 31 Ref: 15

The pipework insulation in the Boiler Room (Rm 0/40) does not contain asbestos.

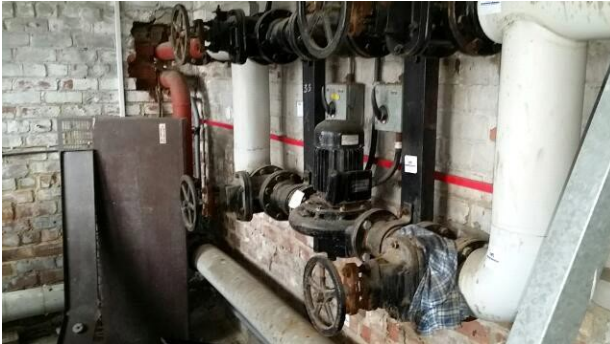
Item 32 Ref: 09

The gaskets in the Boiler Room (Rm 0/40) do not contain asbestos.

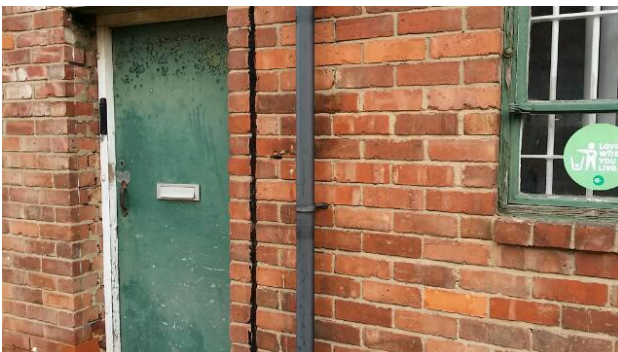
Item 60 Ref: 29

The jointing compound to the
wall (External) does not
contain asbestos.

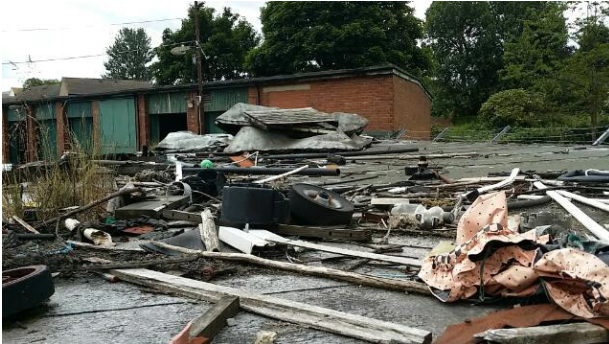
Item 61 Ref: 30

The felt to the shed roof (External) does not contain asbestos.

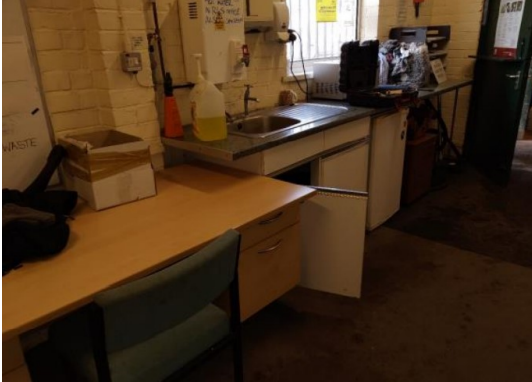
Item 67 Ref: 21-30764-2

The sink pad in Area 3/Refuge Office does not contain asbestos.

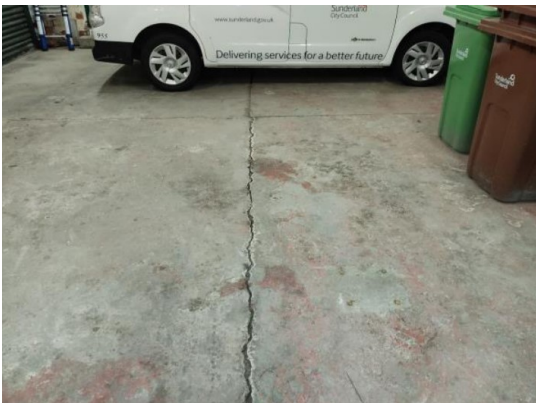
Item 68 Ref: 21-30764-3

The putty on floor in Area 4/Garage and Store Area does not contain asbestos.

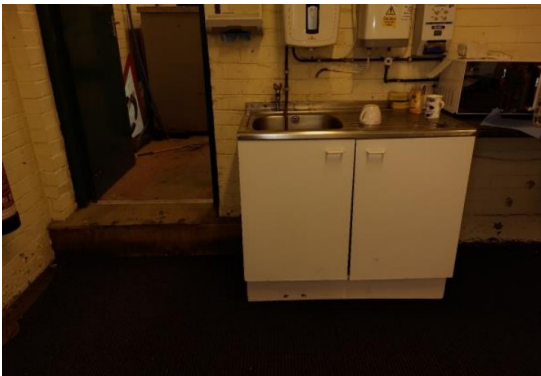
Item 69 Ref: 21-30764-4

The sink pad in Area 6/Ground Office does not contain asbestos.

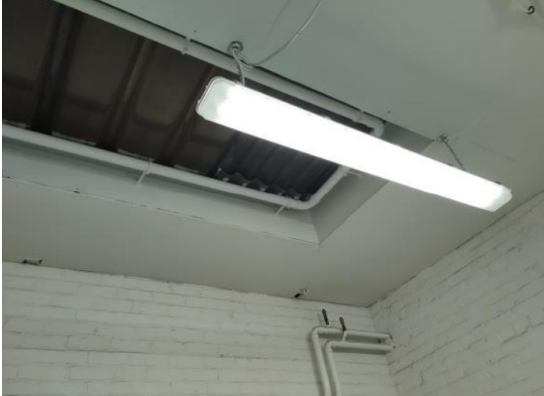
Item 70 Ref: Presumed

The corrugated Sheet ceiling in Area 6/Ground Office is presumed to contains asbestos.

Any change in its appearance should be recorded and passed to Property Services.

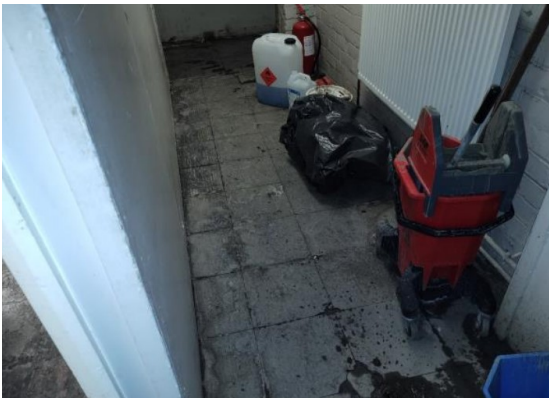
Item 71 Ref: 21-30764-10

The floor tiles and adhesive in Area 12/Hall does not contain asbestos.

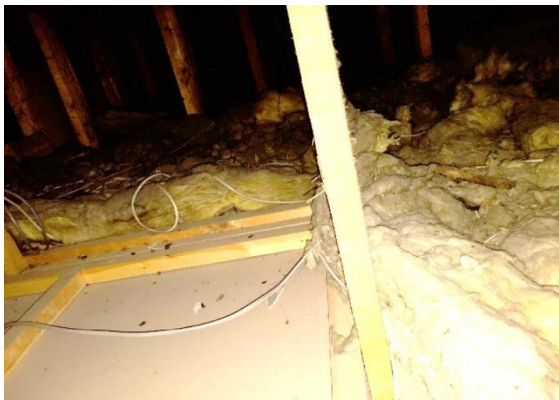
Item 74 Ref: 21-30764-9

The debris in Area 198/Loft space above areas 8,9,10 and 11 contains asbestos.

Any change in its appearance should be recorded and passed to Property Services.

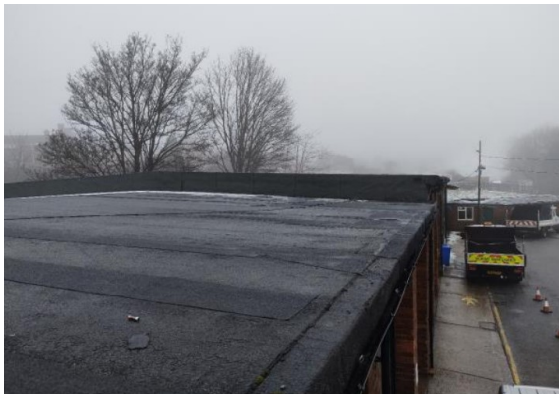
Item 75 Ref: 21-30764-13

The roof felt in Area 24/External roofs above garages and mess hall does not contain asbestos.

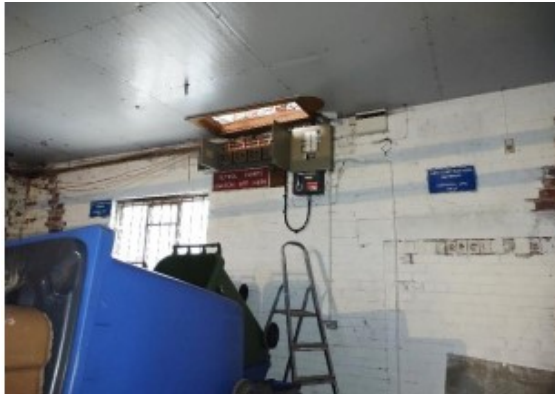
Item 82 Ref: Presumed

The flash guards within live equipment (Bin Store Wall around DB) are presumed to contain asbestos.

Removed 2023

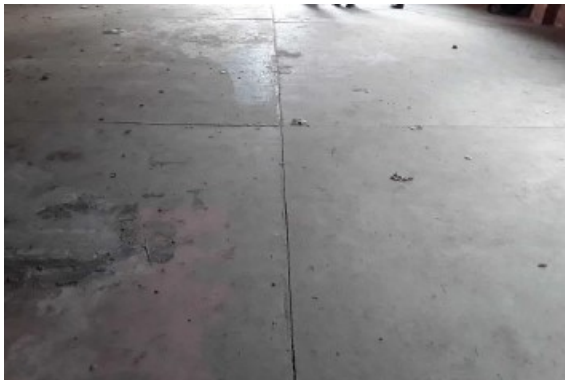
Item 84 Ref: 22-46862-11

The expansion joints to concrete floor slabs in Warehouse 2 contains asbestos.

Removed 2023

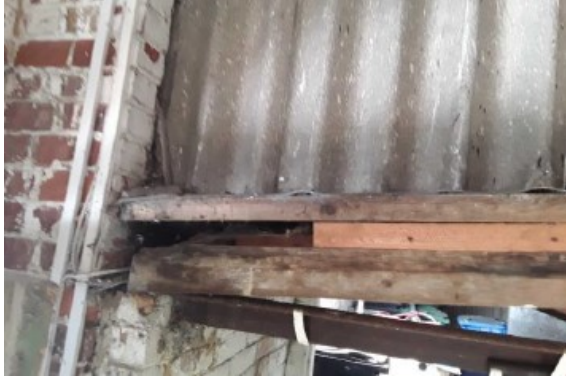
Item 85 Ref: 22-46862-3

The flashing to cement walls above doorway in Warehouse 2 does not contain asbestos.

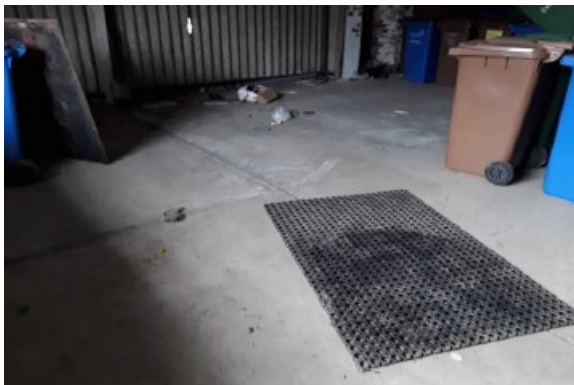
Item 86 Ref: 22-46862-11

The expansion joints to concrete floor slabs in Warehouse 3 contains asbestos.

Removed 2023

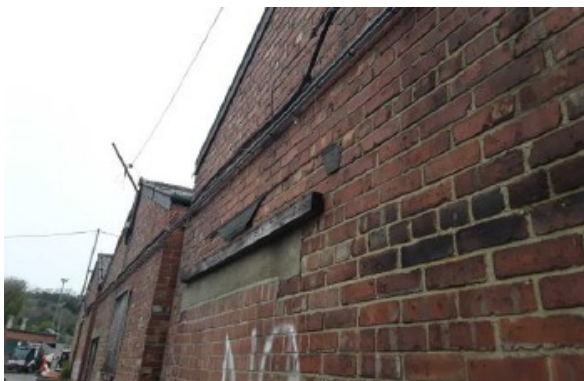
Item 93 Ref: 22-46862-17

The wall flashing (External) does not contain asbestos.

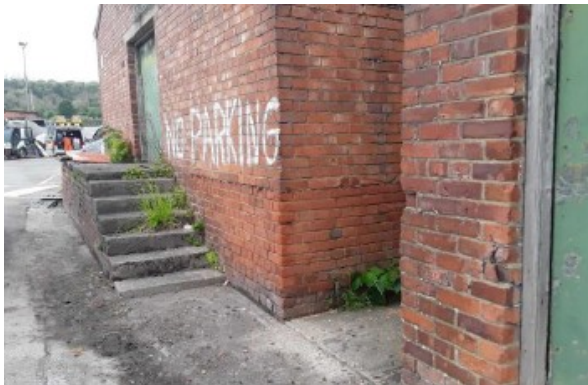
Item 95 Ref: 22-46862-19

The damp proof course (External) does not contain asbestos.
